## **Preliminary Site Investigation Environmental Site History**

148 Rouse Street, Tenterfield, NSW, 2372

**Prepared for Jack Thomas, Nutrien  
Harcourts**

**August 2021**

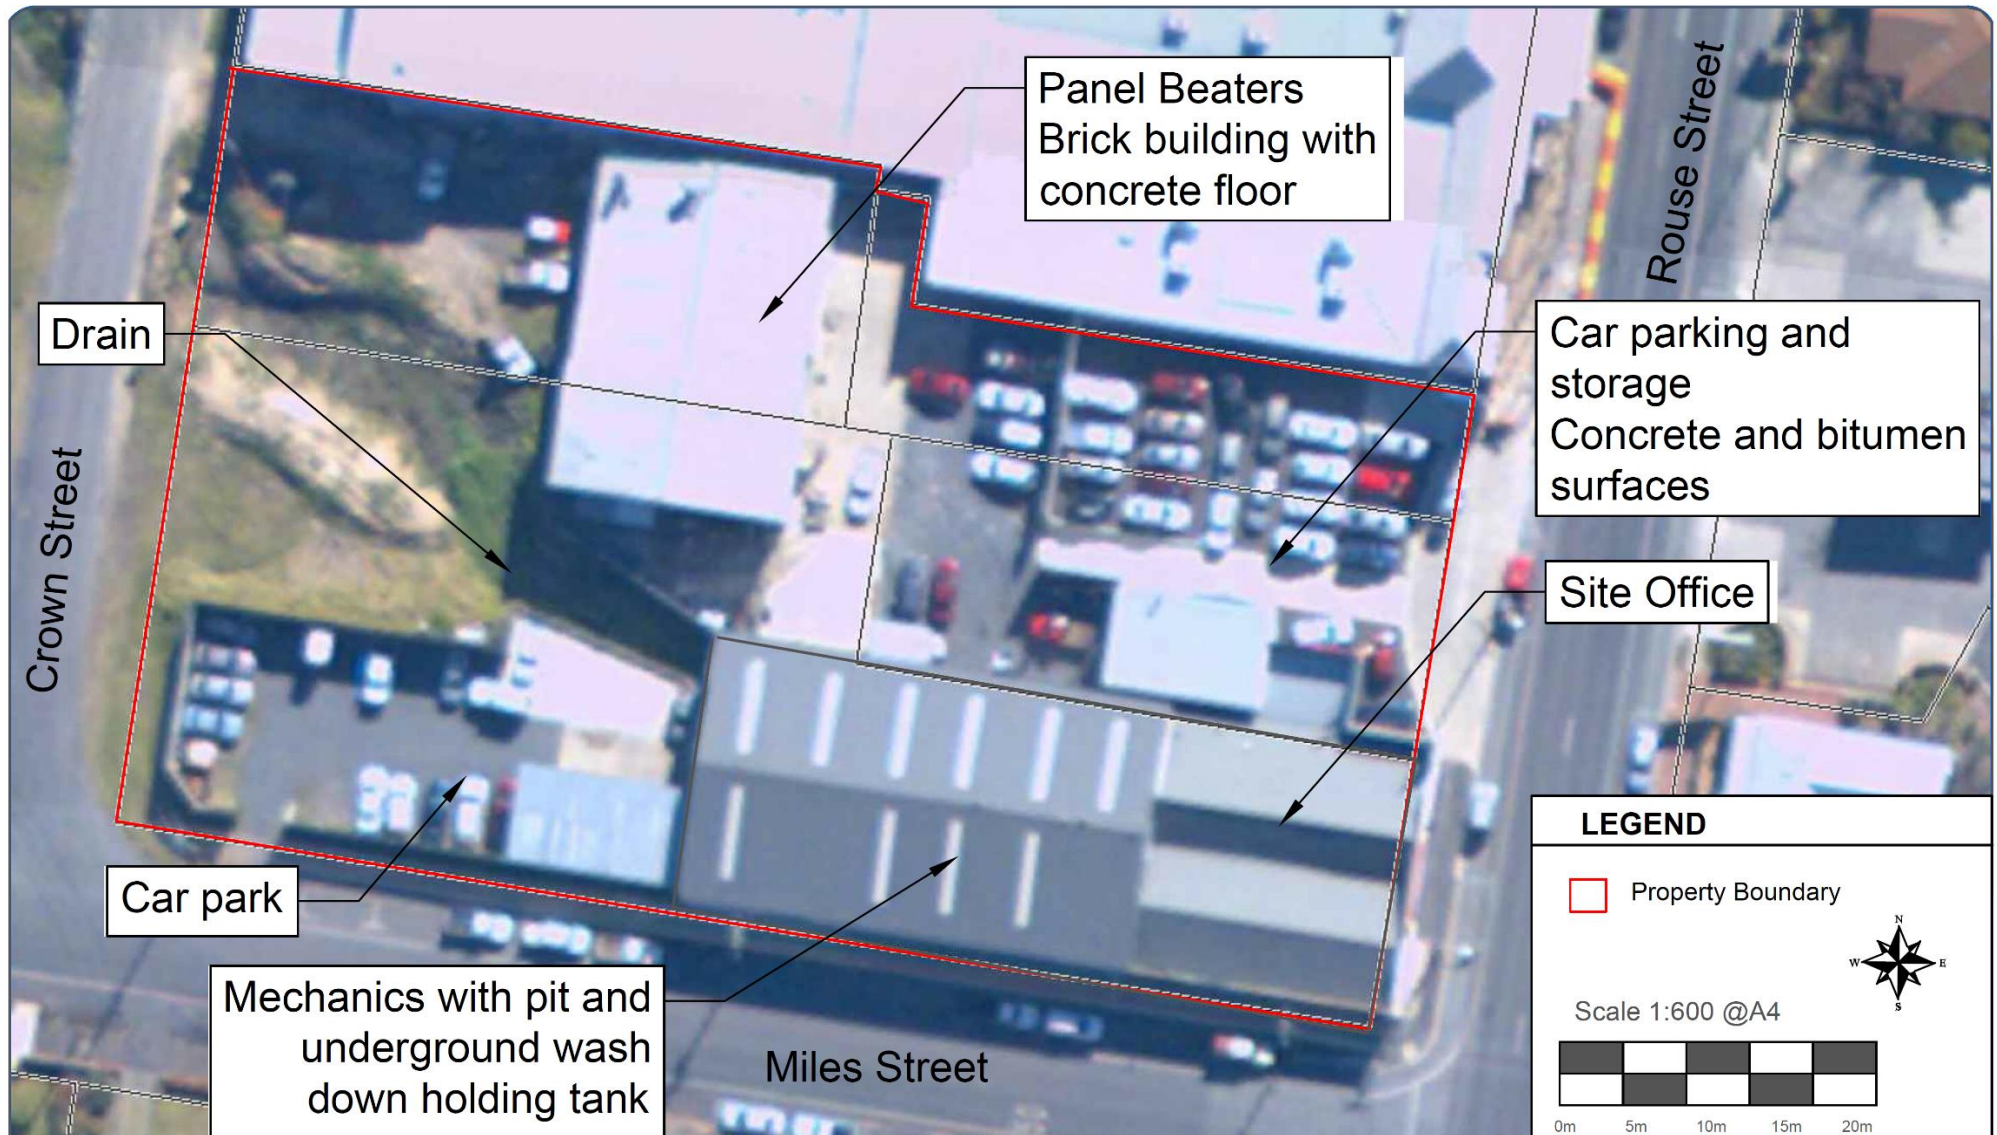
## Site map

Contaminating Infrastructure has been identified on the site map in **Appendix A**.

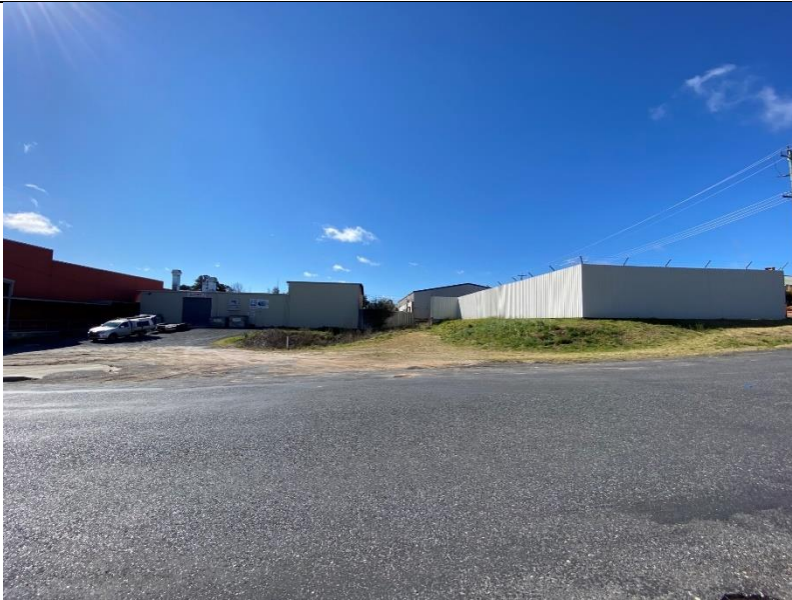
**Plate A- 24/08/2021**  
Wester Workshop (Panel beaters). View Northern western corner of the site looking east.

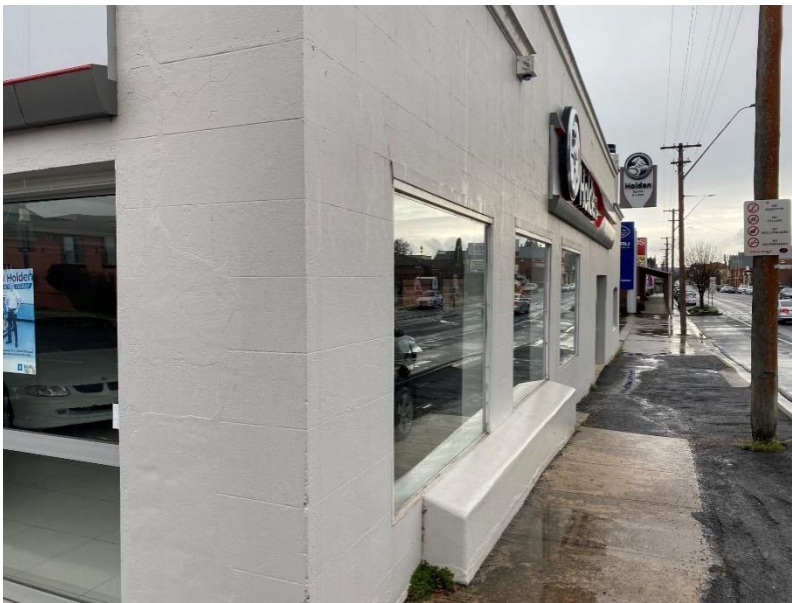
According to the site photographs (**Appendix D**) and discussions the sites external concrete and bitumen surfaces were in very good condition. Both buildings are also in good condition. The Sexton and Green workshop area is currently in good condition and has been kept tidy and clean with very limited oil stains present on the concrete surface. The wash down drain is of new condition and has been replaced recently.

**Plate B- 24/08/2021**  
Sexton and Green building. South-eastern corner. Looking north.

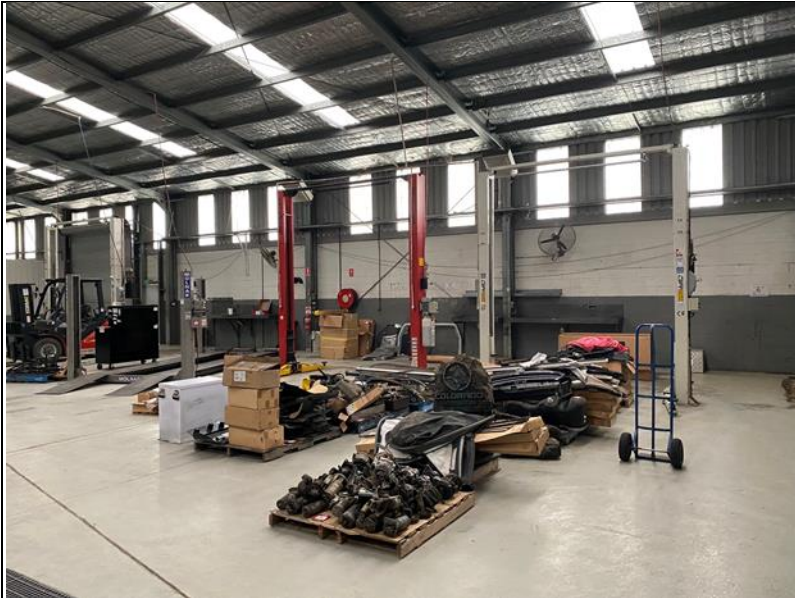
**Plate G- 24/08/2021**  
Sexton and Green building.  
Mechanic. Hoists.

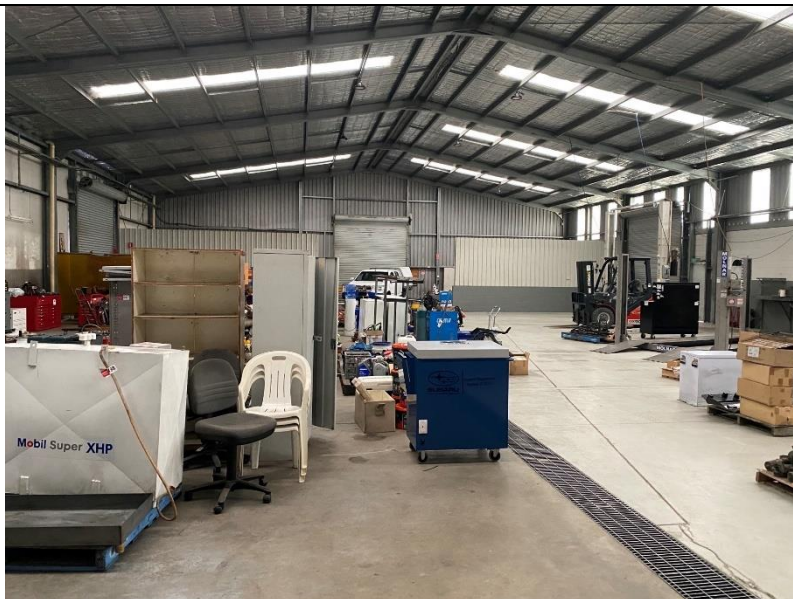
**Plate H- 24/08/2021**  
Sexton and Green building.  
Mechanics. Storage.

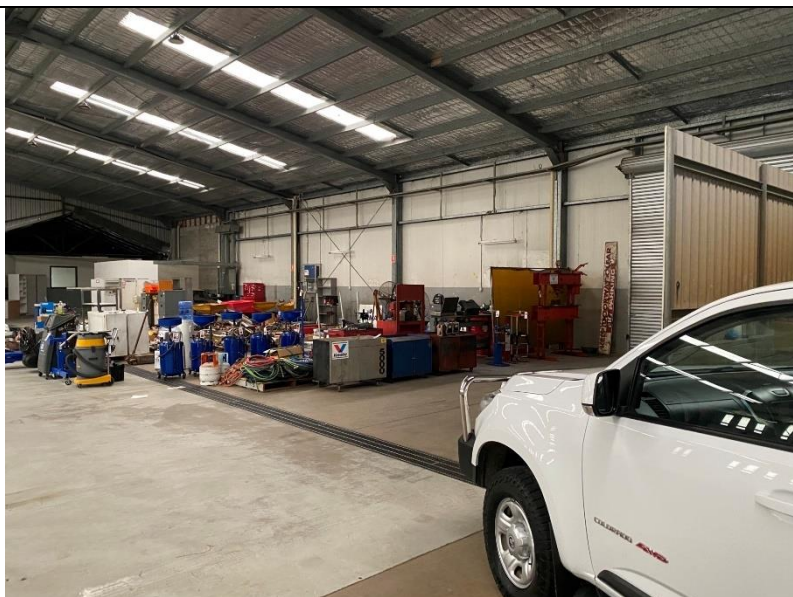
**Plate I- 24/08/2021**  
Sexton and Green building.  
Mechanics. Storage.

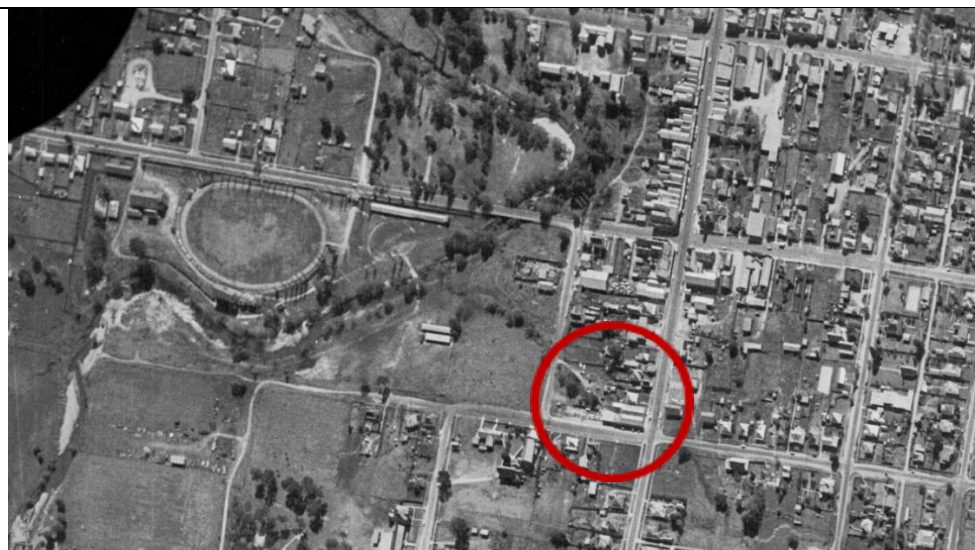
Date Source	Site
28/05/1967 NSW Historical Imagery	<p>The photograph is black and white and of good quality</p> <p><b>The site</b> The Sexton and Green building is present along the corner of Rouse Street and Miles Street. Some car parking is visible to the west. The area directly to the west of the Sexton and Green building is undeveloped. The north-western portion of the site is partially vegetated. The drain is present flowing to the north-west.</p> <p><b>Surrounding Land</b> The site directly to the west is cleared and grassed. Some trees are present. Residential premises are present directly north, east and south of the site. Industrial/commercial premises are present further to the north.</p>
3/04/1975 NSW Historical Imagery	<p>The photograph is black and white and of poor quality</p> <p><b>The site</b> The Sexton and Green building is present along the corner of Rouse Street and Miles Street. Some car parking is visible to the west. The area directly to the west of the Sexton and Green building is undeveloped. The north-western portion of the site is partially vegetated. The drain is present flowing to the north-west.</p> <p><b>Surrounding Land</b> The site directly to the west is cleared and grassed. Some trees are present. Residential premises are present directly north, east and south of the site. Industrial/commercial premises are present further to the north.</p> <p>The site is largely unchanged from the previous Historical Image</p>

**Plate K (1967)**  
Aerial View: Spatial  
viewer, 148 Rouse  
Street, Tenterfield.  
AEC red circle

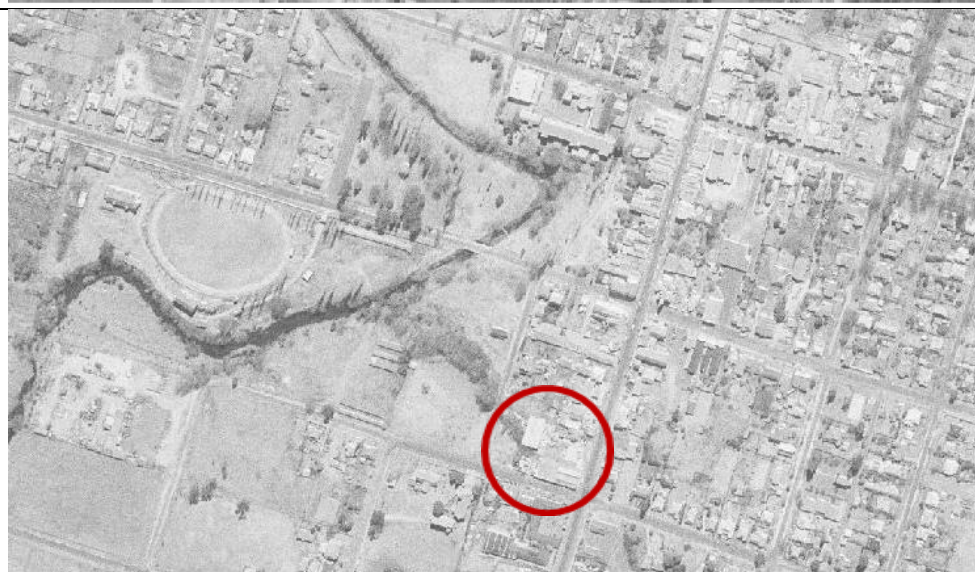
<b>1/08/1985</b> <b>NSW</b> <b>Historical</b> <b>Imagery</b>	<p>The photograph is black and white and of poor quality</p> <p><b>The site</b>  The Sexton and Green Building is present along the corner of Rouse Street and Miles Street. Directly north of the building is clear and contains a concrete surface. Car parking is still visible to the west. A shed/building has been erected within the western portion of the site. The north-western portion of the site contains some vegetation.</p> <p><b>Surrounding Land</b>  The site directly to the west is cleared and grassed. Some trees are present. Residential premises are present directly north, east and south of the site. Industrial/commercial premises are present further to the north.</p>
<b>1993</b> <b>Google Earth</b> <b>Image</b>	<p>The photograph is colour and of good quality</p> <p><b>The site</b>  The Sexton and Green building is present along the corner of Rouse Street and Miles Street. Directly north of the building is clear and contains a concrete surface. Cars are visible parked in this area. Car parking is visible to the west, taking up a small portion of this area. The western carpark is fenced. A shed/building is present within the western portion of the site. The north-western portion of the site contains some vegetation and grass surfaces.</p> <p><b>Surrounding Land</b>  The site directly to the west is cleared and grassed. Some trees are present. Residential premises are present directly to the north, east and south of the site. Industrial/commercial premises are present further to the north. Some commercial land uses are visible across Rouse Street to the south.</p>

**Plate M (1985)**  
Aerial View: Spatial  
viewer, 148 Rouse  
Street, Tenterfield.  
AEC red circle.

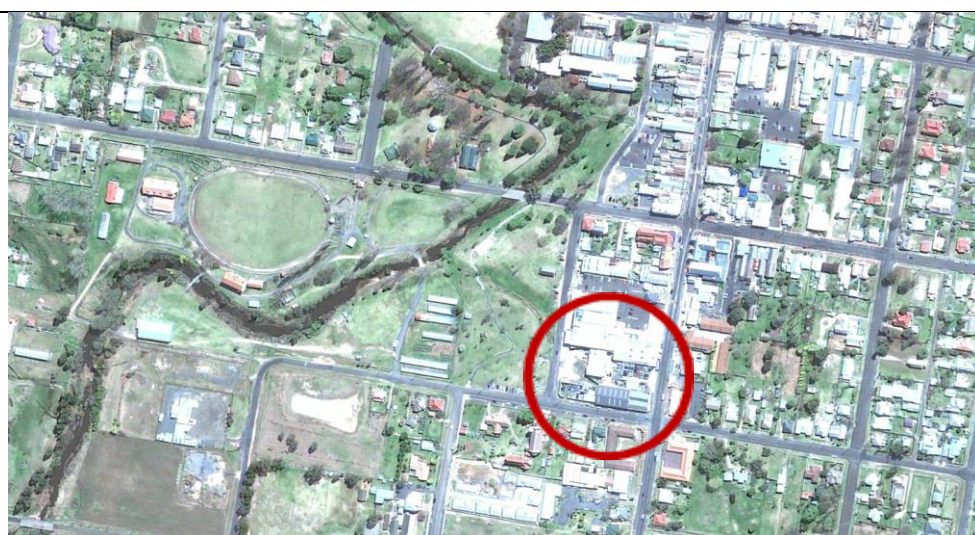
<b>2010</b> <b>Google Earth</b> <b>Image</b>	<p>The photograph is colour and of good quality</p> <p><b>The site</b>  The Sexton and Green building is present along the corner of Rouse Street and Miles Street. Directly north of the building is clear and contains a concrete surface. Many cars are visible parked in this area. Car parking is visible to the west, this carpark has expanded further west. The western carpark is fenced. A shed/building is present within the western portion of the site. The north-western portion of the site has been cleared.</p> <p><b>Surrounding Land</b>  The site directly to the west is cleared and grassed. Some vegetation has been removed. A shopping centre is present directly north of the site. Residential premises are present directly to the south. Industrial/commercial premises are present further to the north and north-east. The areas north and northeast have expanded to include more commercial land uses. More commercial land use is viable further south.</p>

**Plate O (2010)**  
Aerial View: Google  
Earth, 148 Rouse  
Street, Tenterfield.  
AEC red circle.

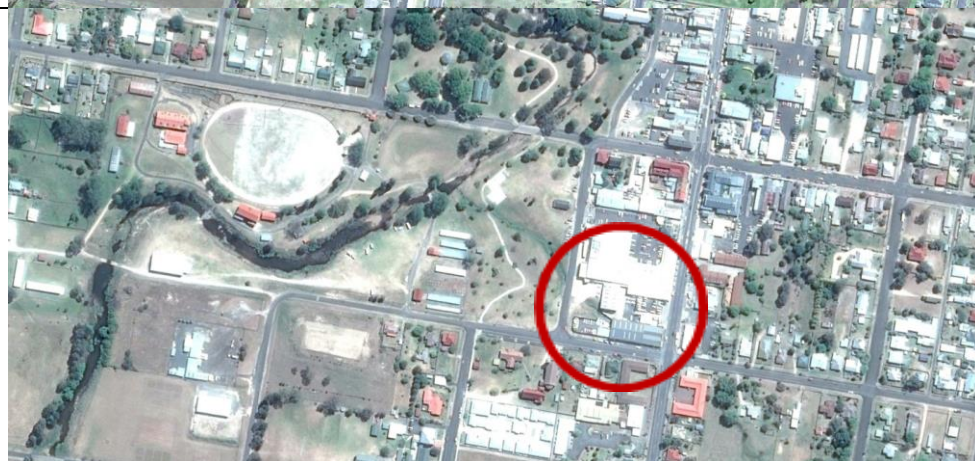
<b>2013</b> <b>Google</b> <b>Earth</b>	<p>The photograph is colour and of good quality</p> <p><b>The site</b>  The Sexton and Green building is present along the corner of Rouse Street and Miles Street. Directly north of the building is clear and contains a concrete surface. Many cars are visible parked in this area. Car parking is visible to the west. The western carpark is fenced. A shed/building is present within the western portion of the site. The north-western portion of the site is cleared.</p> <p><b>Surrounding Land</b>  The site directly to the west is cleared and grassed. Some vegetation has been removed. A shopping centre is present directly north of the site. Residential premises are present directly to the south. Industrial/commercial premises are present further to the north and north-east and further south.</p>
<b>2021</b> <b>Google</b> <b>Earth</b>	<p>The photograph is colour and of good quality</p> <p><b>The site</b>  The Sexton and Green building is present along the corner of Rouse Street and Miles Street. Directly north of the building is clear and contains a concrete surface. Some cars are visible parked in this area. Car parking is visible to the west. The western carpark is fenced. A shed/building is present within the western portion of the site. The north-western portion of the site is cleared.</p> <p><b>Surrounding Land</b>  The site directly to the west is cleared and grassed. A shopping centre is present directly north of the site. Residential premises are present directly to the south. Industrial/commercial premises are present further to the north and north-east and further south.</p> <p>The site is largely unchanged from the previous Historical Image</p>

**Plate P (2013)**  
Aerial View: Google  
Earth, 148 Rouse  
Street, Tenterfield.  
AEC red circle.
