# Tree Assessment Report - Tree Protection Zones

Clarence Street (between High Street & East Street), Tenterfield

Report 1 of 10 - Tree ID 001-021

18.02.2026 09:00 AEST

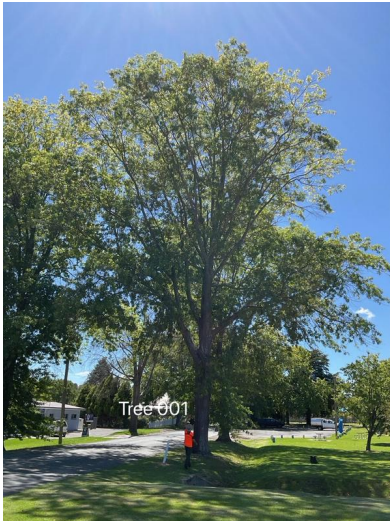
Photo 3

This tree appears to be in good condition. It has some large deadwood present in the crown and some scarring near the buttress that appears to have healed. This tree has been planted less than 2 metres from the roadway. There has been a drain installed less than 1 metre from the southern side of the buttress which is a major encroachment inside the Tree Protection Zone (TPZ) and the Structural Root Zone (SRZ). The extent of the encroachments could be severely detrimental to the future health and development of this tree. Given the history of this species in this area, it is advisable that if the tree is to be retained that resistograph testing be carried out to ascertain the structural integrity of the tree.

If the tree is to be retained, remove the deadwood and apply a 10% weight reduction to the outer northern canopy that overhangs the highway and monitor the tree for changes in health and structure. If the resistograph testing confirms structural decay then the tree should be removed and the stump ground.

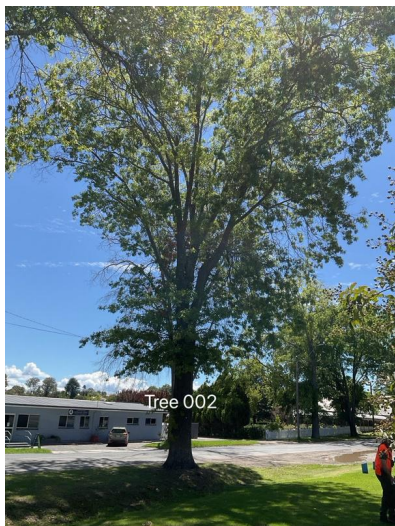
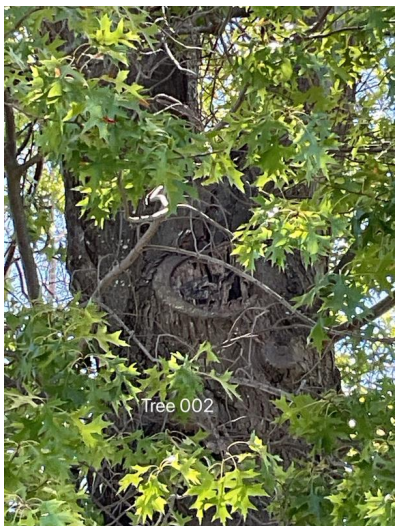
This tree appears to be in good condition. It has lost some significant limbs in recent storm events. There is a dead hanging limb present in the tree and it has a large southern lower leader that joins the main trunk approximately 6m from the ground. Approximately 50cm below this junction there is a significant old pruning wound where a large limb was removed. This wound is showing major signs of decay which extends down into the main trunk. This decay has significantly impacted the stability of the tree. There is further decay present on the vertical leaders. Due to the significant decay in the trunk, this tree is unstable and dangerous and is no longer suitable for retention.

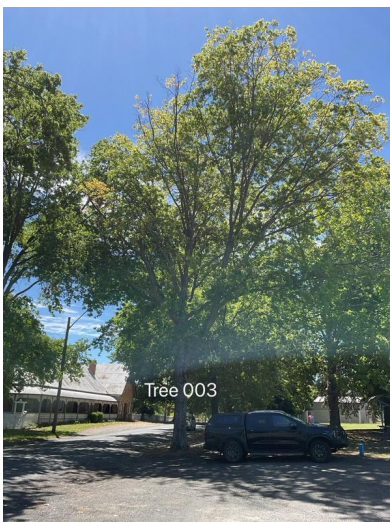
Photo 6

inside the TPZ and SRZ. It has a significant number of wounds present near the root crown. There is dieback present in the tips of the canopy and yellowing in the foliage in the canopy which are signs of Armillaria or Phytophthora infection (see attached fact sheet). The significant incursions into the TPZ and SRZ, along with the damage to the tree near the crown have exposed the tree and allowed the infection to spread throughout the tree. The structural integrity of this tree will be compromised. This tree is unstable and dangerous and is no longer suitable for retention in this position.

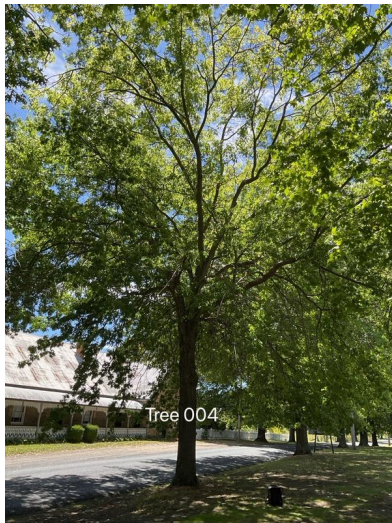
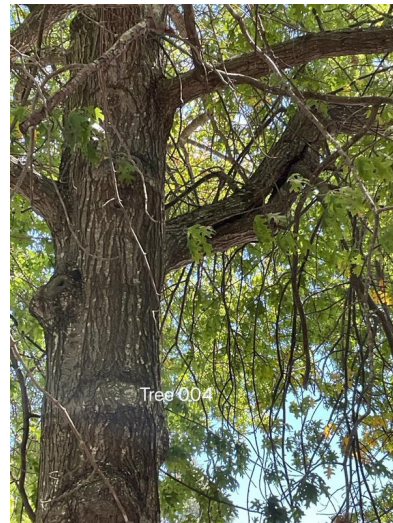
This tree is situated 2m from the roadway. There has been excavation works inside the TPZ and SRZ and there is damage to the exposed roots less than 1m from the buttress. This tree has an extensive canopy that extends out and over the roadway and hangs low less than 1.5m from the ground. The large lower lateral limb that grows to the east has a significant shear crack present that makes the large lower lateral limb unstable and dangerous. There is also deadwood present in the crown.

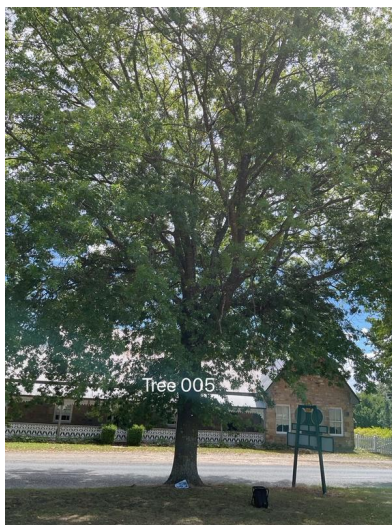
Photo 9

This tree appears to be in good condition. There are some large dead limbs present in the crown and some broken dangerous hangers present. The canopy hangs down very low over the roadway and the park. There is a small amount of yellowing present in some of the canopy leaves. There is a phone line that runs underneath the northern part of the canopy. There also is epicormic growth present on the trunk. Given the history of this species in this area, it is advisable that if the tree is to be retained that resistograph testing be carried out to ascertain the structural integrity of the tree.

Remove the deadwood, dangerous broken hanging limbs

and the epicormic growth. Lift the canopy over the park to minimum of 3m from the ground and over the roadway to be a minimum of 6m from the ground and monitor the tree for changes in health and structure. If the resistograph testing confirms structural decay then the tree should be removed and the stump ground.

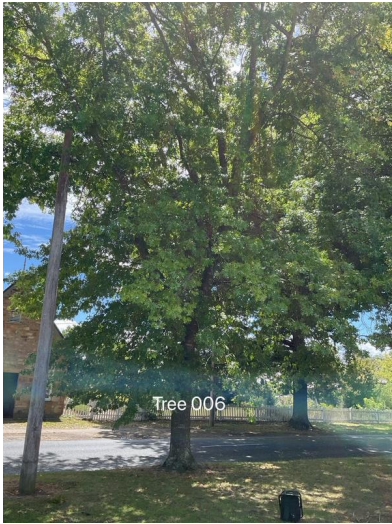
Photo 10

This tree appears to be in good condition. There are some large dead limbs present in the crown and some broken dangerous hangers present. The canopy hangs down very low over the roadway and the park. There is a small amount of yellowing present in some of the canopy leaves. There is a phone line that runs underneath the northern part of the canopy and epicormic growth present. Given the history of this species in this area, it is advisable that if the tree is to be retained that resistograph testing be carried out to ascertain the structural integrity of the tree.

Remove the deadwood, broken hanging limbs and epicormic growth. Lift the canopy to be 3m above the ground. Apply a 20% balanced weight reduction to the canopy to the north over the roadway and south over the park. Remove the large low eastern lateral limb and monitor the tree for changes in health and structure.

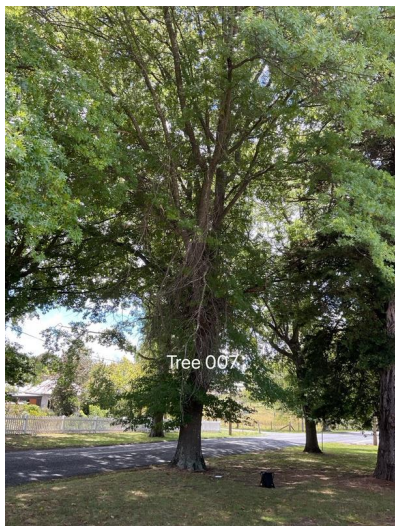
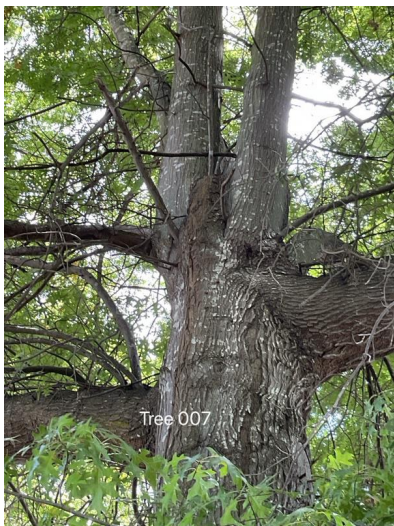
This tree has a significant amount of deadwood present in the crown. It has an overdeveloped southwestern canopy. There is a multi-stemmed codominant structure approximately 7m from the ground in the main trunk. There is scarring and reactive tissue present at the junction of this structure, this will be unstable and will fail in the future. There is epicormic growth present on the trunk and an historic wound present approximately 2m from the ground on the southern side. The epicormic growth on the trunk could be a sign of declining health. The codominant structure in the crown is likely to fail in the future. Given the history of this species in this area, it is advisable that if the tree is to be retained that resistograph testing be carried out to ascertain the structural integrity of the tree.

the resistograph testing confirms structural decay then the tree should be removed and the stump ground.

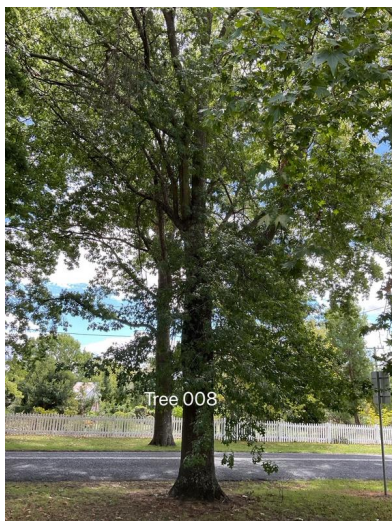
Photo 13

There is deadwood and epicormic growth present in the crown. Although this tree appears to be in good condition, there is significant scarring at the base of the trunk and top of the root crown. This scarring may allow infection with Armillaria and/or Phytophthora in the future. Given the history of this species in this area, it is advisable that if the tree is to be retained that resistograph testing be carried out to ascertain the structural integrity of the tree.

If to be retained, remove the deadwood and epicormic growth and monitor the tree for changes in health and structure. If the resistograph testing confirms structural decay then the tree should be removed and the stump ground.

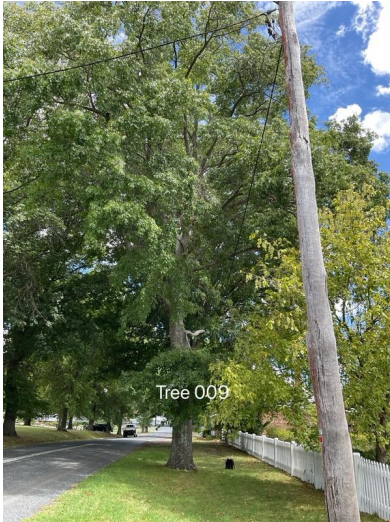
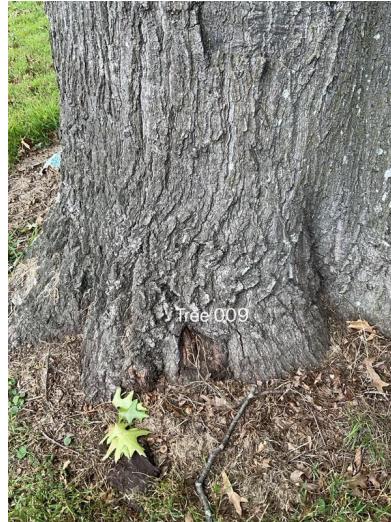
This tree appears to be in good condition. It has some large deadwood present in the crown and epicormic growth on the trunk. There is a wound at the base of the trunk near the root crown and there has been a major limb removed 6m from the ground on the northern side of the tree. There is evidence of fungal infection at this wound site. Removal of such a large limb in this position on this species is poor arboricultural practice. This wound will not heal and the tree will decay badly at this point. The decay will eventually extend down to the main trunk and root crown which will severely compromise the structural integrity of the tree in the future.

Alternatively, due to likely further decay and poor future prospects, then the tree should be removed and the stump ground.

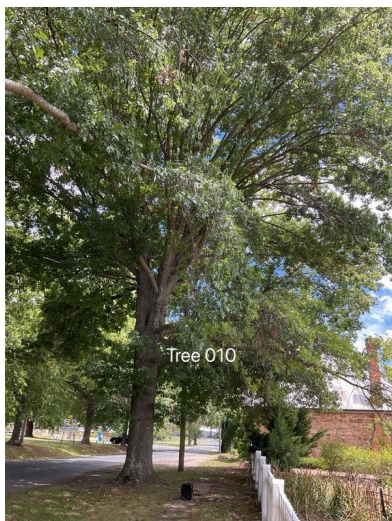
Photo 18

There is deadwood and epicormic growth present. The canopy hangs very low over the roadway and the adjacent property. There is a large low lateral limb that grows to the northeast approximately 60cm below a large wound. This lateral limb appears to be failing. The tree is weeping from the underside of the limb and a cavity it present under the limb. Given the history of this species in this area, it is advisable that if the tree is to be retained that resistograph testing be carried out to ascertain the structural integrity of the tree.

If to be retained, apply a 20% weight reduction to outer lower canopy. Remove the deadwood and epicormic growth and monitor the tree for changes in health and structure. If the resistograph testing confirms structural decay then the tree should be removed and the stump ground.

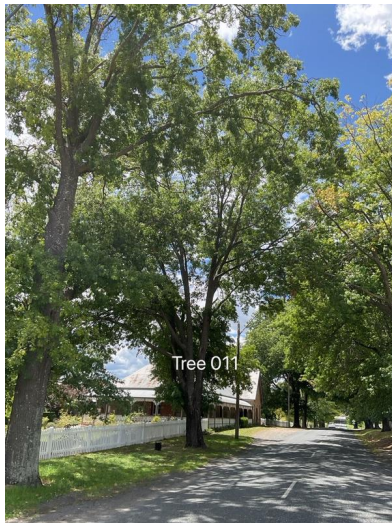
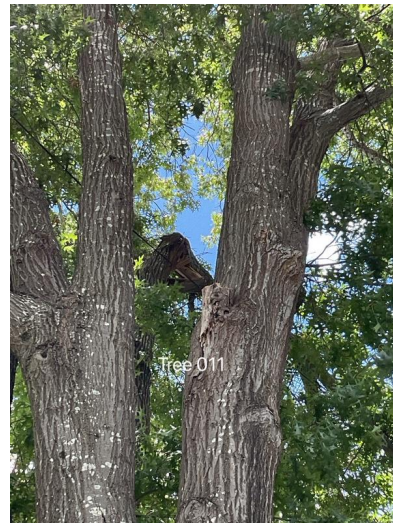
This tree is unstable. It leans heavily to the north and it is now pushing on the phone line running through the canopy. The tree has a large broken leader that has come down and is still connected and hanging in the crown. If it was to fail it would cause significant damage to the heritage property to the east. This tree is dangerous and poses an unacceptable risk.

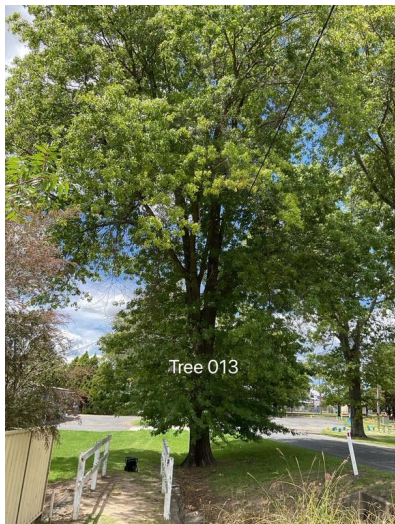
Photo 24

This tree has a considerable amount of epicormic growth present on the trunk and some deadwood present in the crown. It has a large codominant structure with scarring and reactive tissue present at the leader junction. The excessive epicormic growth could be sign of vascular decay. The

If to be retained, remove the deadwood and epicormic growth and monitor the tree for changes in health and structure. If the resistograph testing confirms structural decay then the tree should be removed and the stump ground.

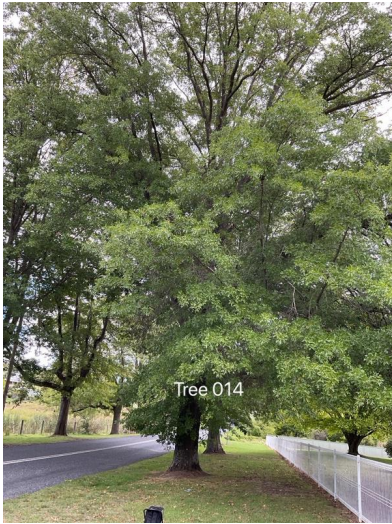
Photo 25

This tree appears to be in good condition. It has an overly developed southern canopy with excess weight present and low hanging limbs. It has significant epicormic growth present and some deadwood in the canopy. The epicormic growth could be a sign of vascular decay. Given the history of this species in this area, it is advisable that if the tree is to be retained that resistograph testing be carried out to ascertain the structural integrity of the tree.

If to be retained, apply a 20% weight reduction to the outer southern canopy. Lift the canopy to be 4m from the ground. Remove epicormic growth. If the resistograph testing confirms structural decay then the tree should be removed and the stump ground.

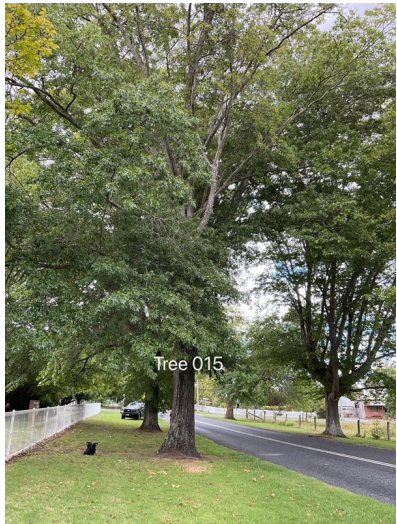
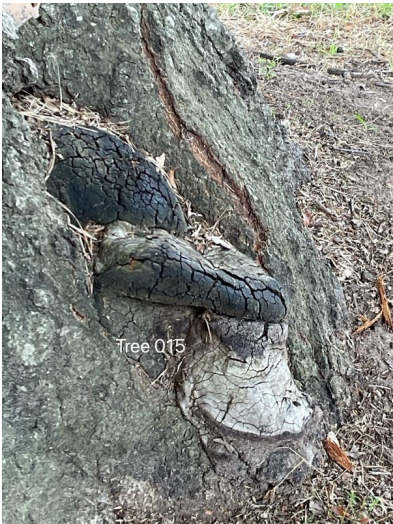
This tree has significant decay present at the root crown with Ganoderma fungal flowers present at several sites at the base. This tree will be unstable and is likely to fail in the future.

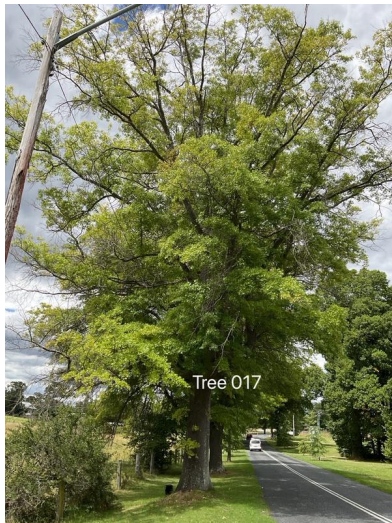
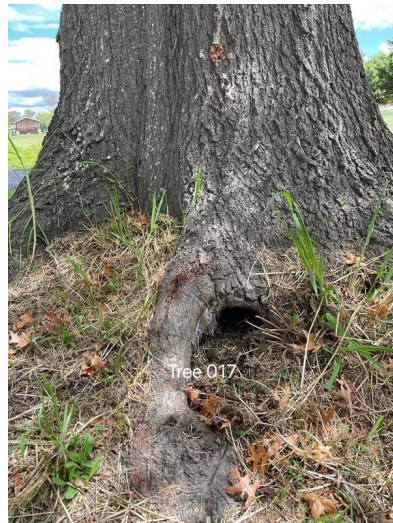
There is dieback present in the tips of the canopy and yellowing in the foliage in the canopy which are signs of Armillaria or Phytophthora infection (see attached fact sheet). It also has significant visual decay at the root crown. This tree will be unstable and is unsuitable for retention.

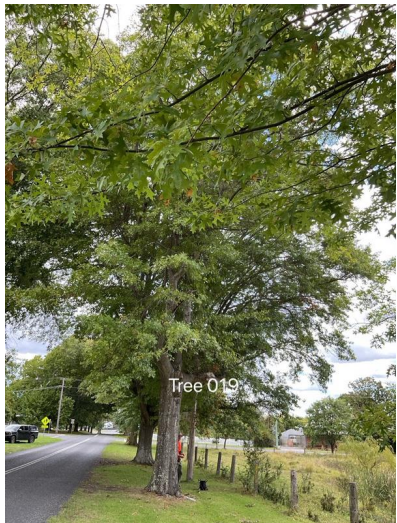
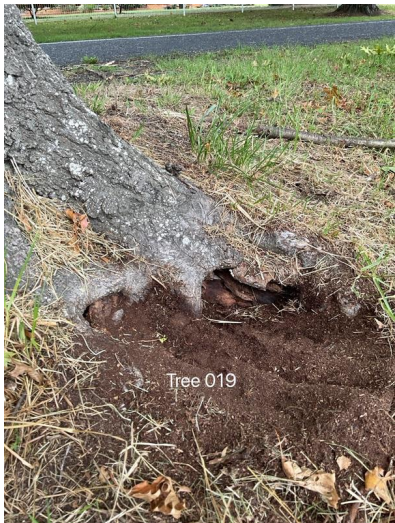
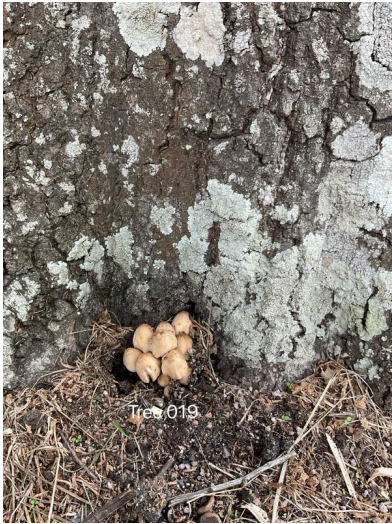
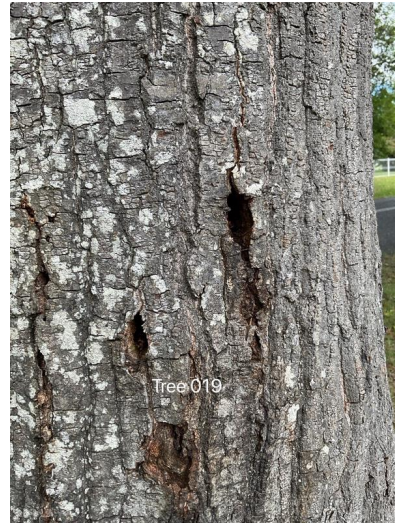
This tree is in serious decline, with significant root crown rot and Armillaria fungus infection at the base indicating infection. There is also significant borer damage. This tree will be unstable and is unsuitable for retention.

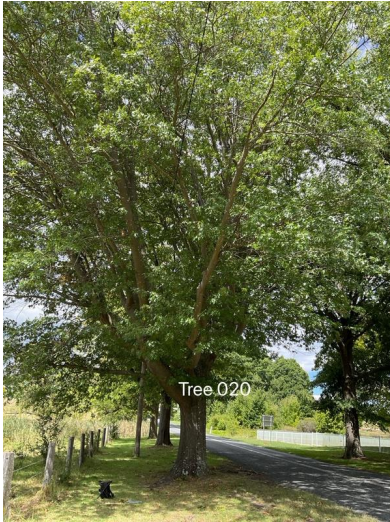
Photo 36

This tree is starting to show signs of Armillaria and/or Phytophthora infection. It has some yellowing foliage in the crown and signs of decay at the top of the root crown. Given the proximity to other infected trees, it is likely it is infected and will become unstable and is unsuitable for retention.

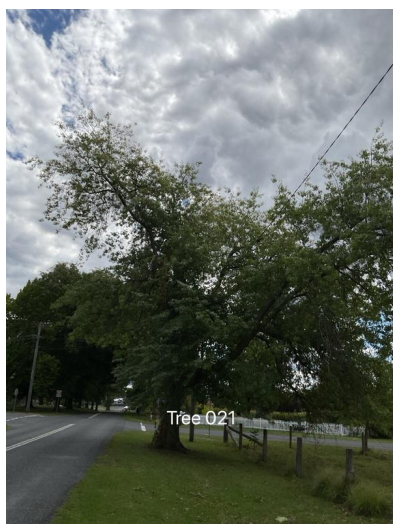
Photo 37

This tree has lost a significant limb in recent storm events. The loss of the limb has significantly damaged the tree. It is also showing signs of Armillaria and/or Phytophthora infection with dieback present in the tips of the canopy and yellowing in the foliage in the canopy. This tree is unstable and dangerous and is unsuitable for retention.
