Tree Assessment Report - Tree Protection Zones

3 Mar 2026

Cowper Street (between Pelham Street & New England Highway),
Tenterfield.

Report 10 of 10 - Tree ID 189-203

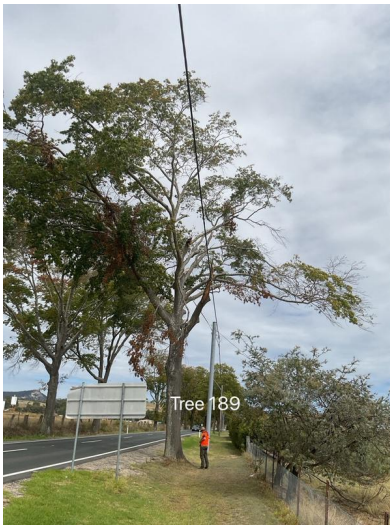
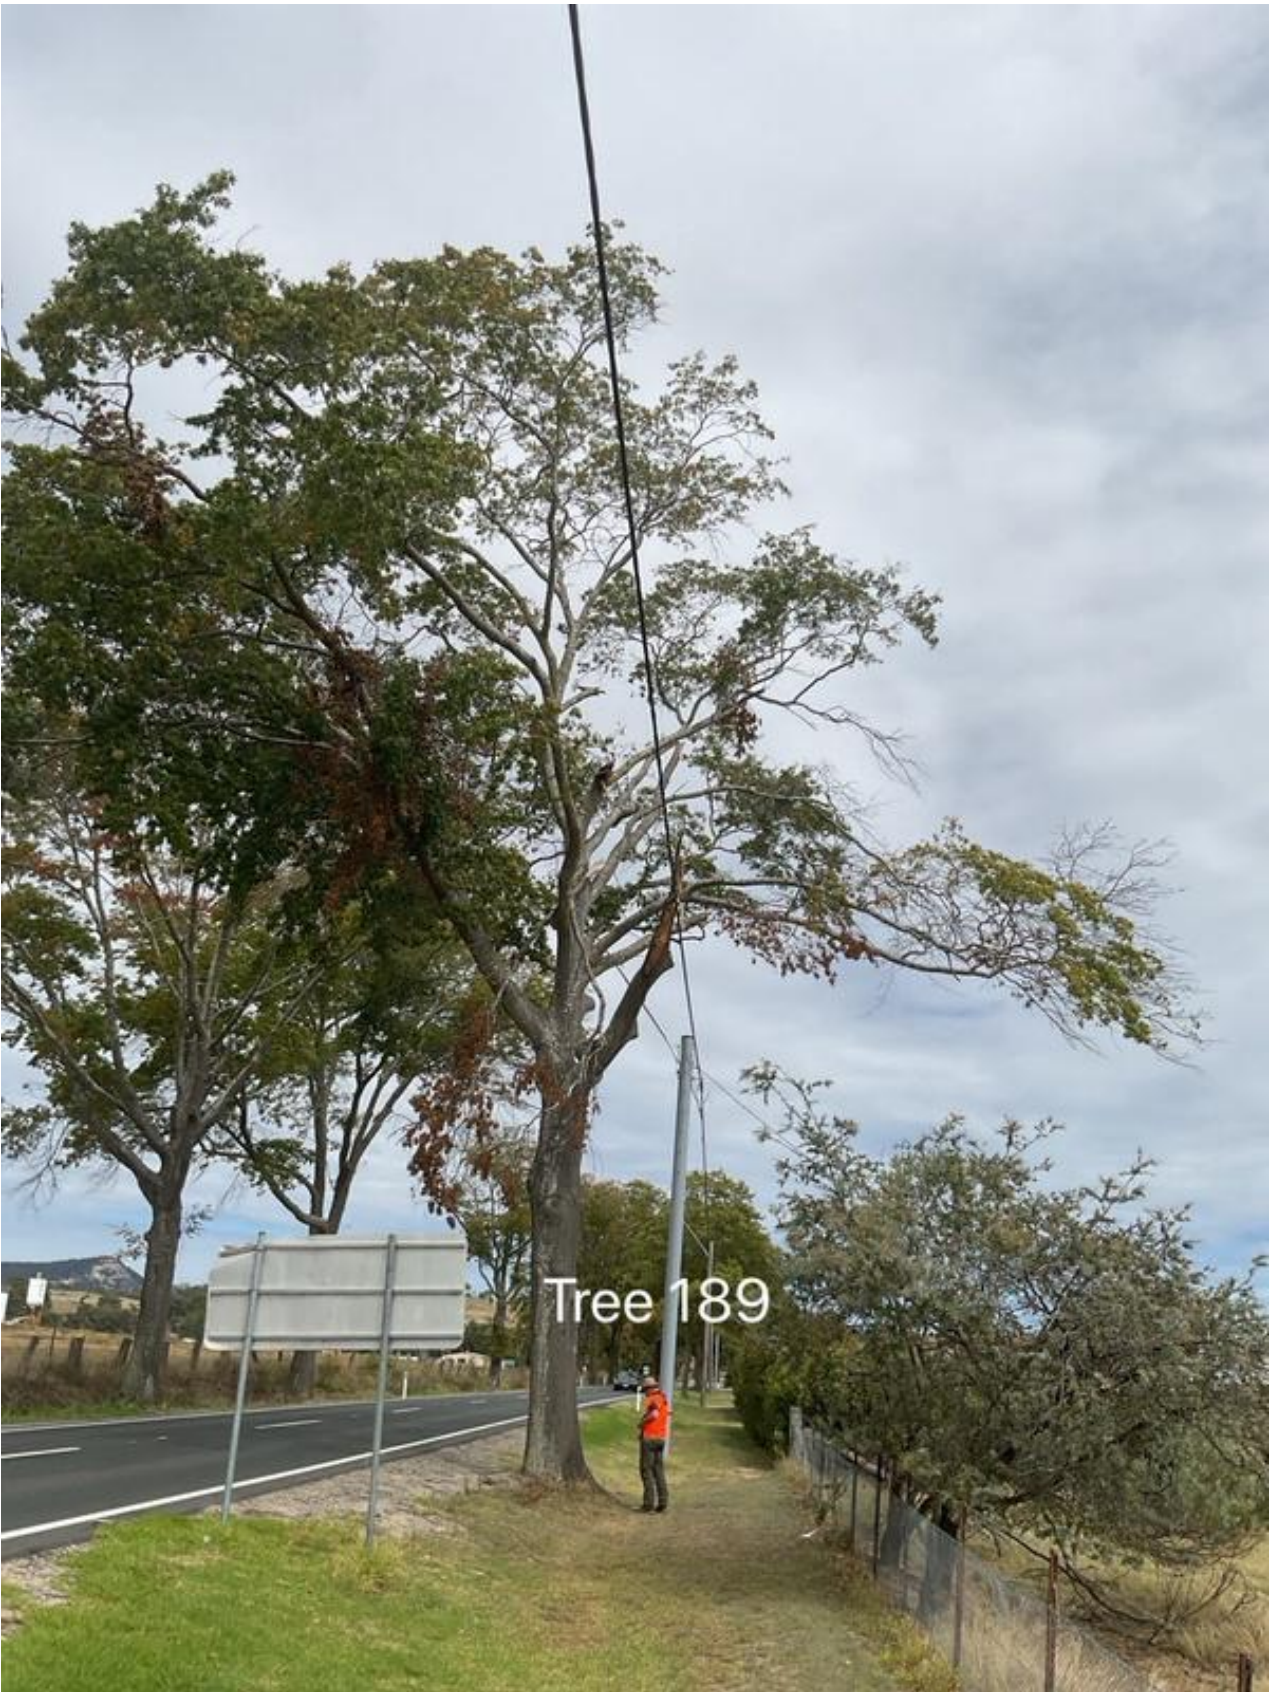
Photo 3

This tree has last lost a substantial amount of its canopy in a recent storm event. There are still large dangerous broken hanging limbs present in the crown. There is decay and dieback present in the crown. It is not possible to correctly prune this tree to make the tree safe for retention. The tree is dangerous and unstable should be removed.

Remove the tree and grind the stump.

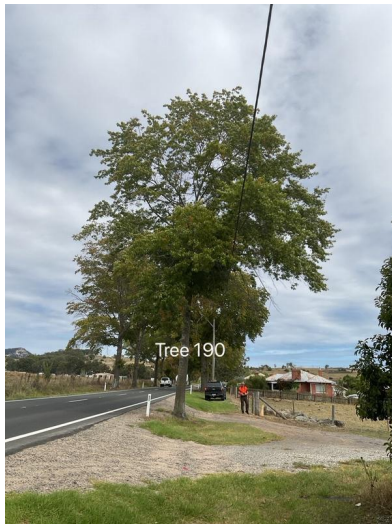
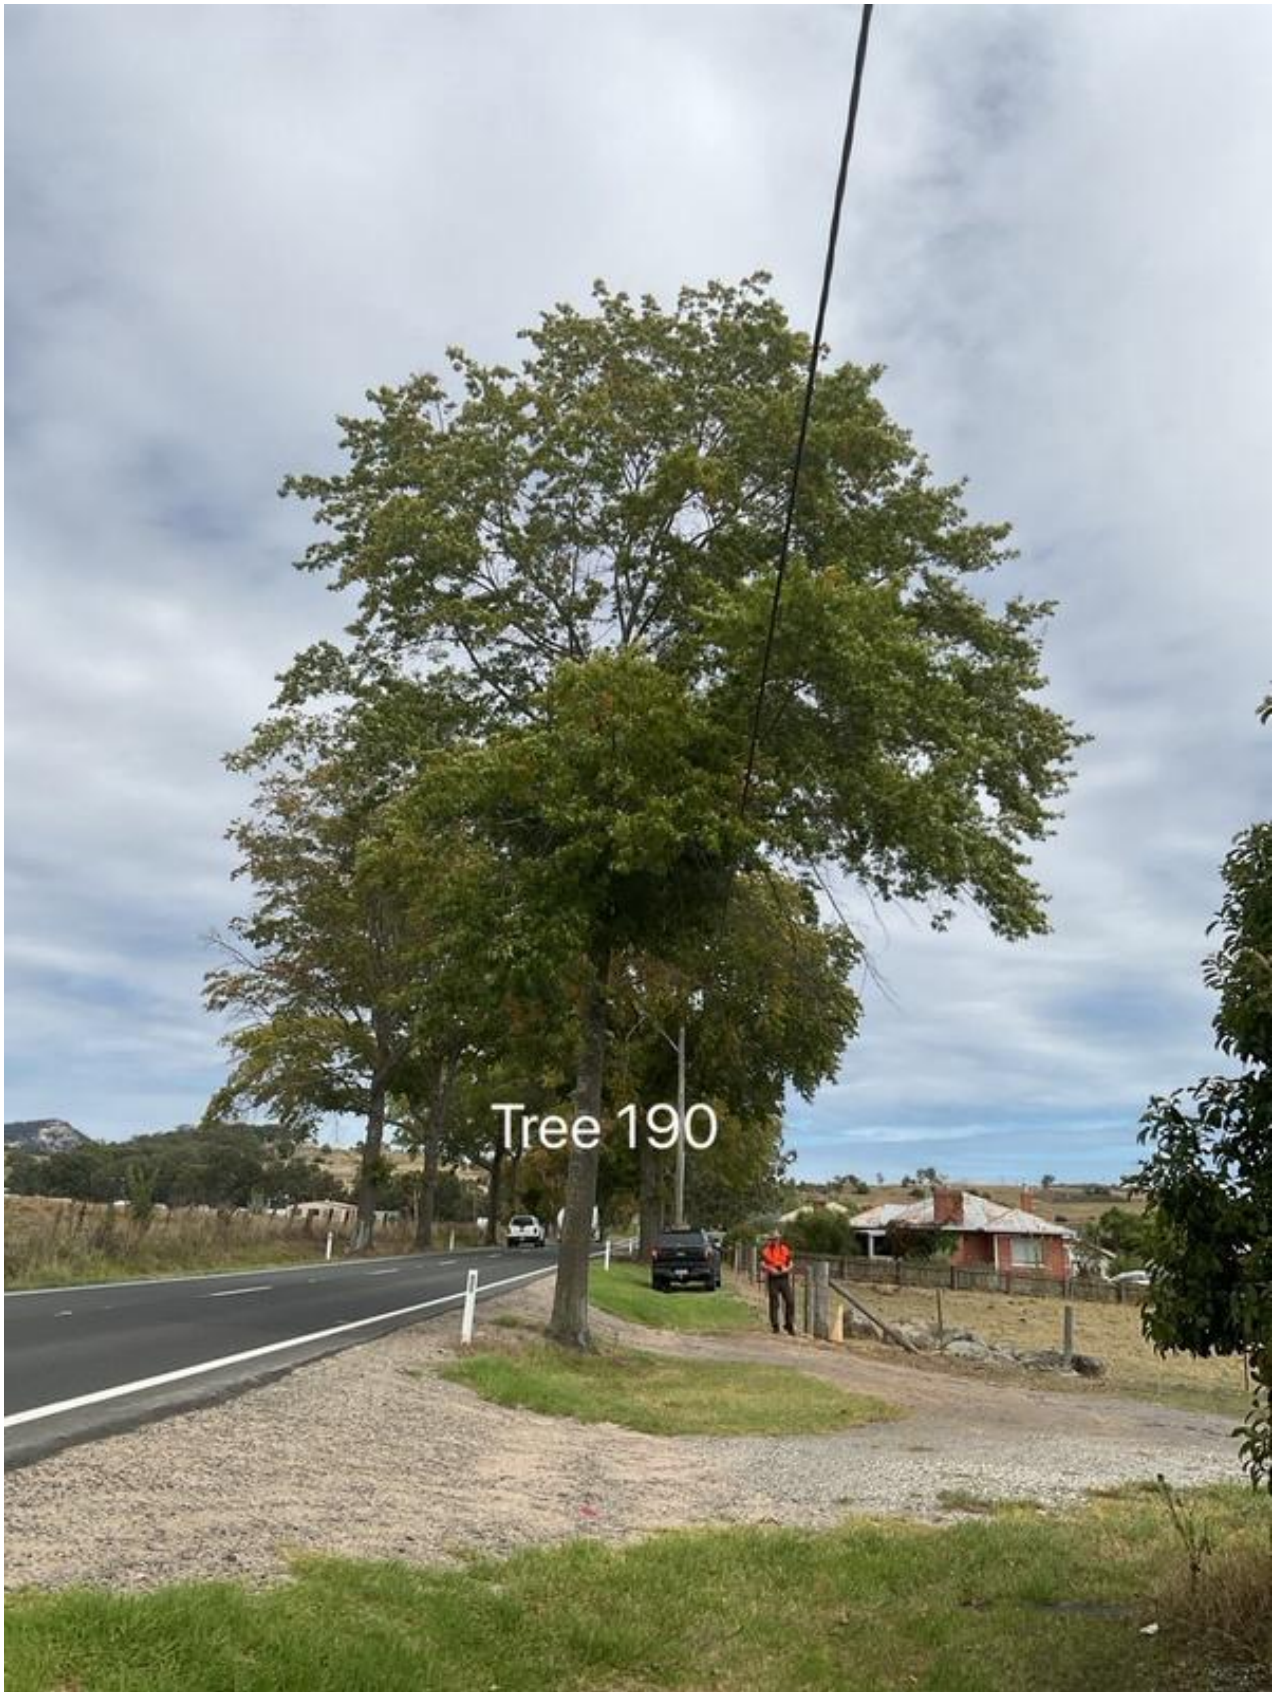
Photo 4

This tree has lost several limbs in a recent storm event. Two of these limbs are still present in the tree. They are hanging dangerously over the highway. There is a small amount of epicormic growth present on the trunk.

Remove the broken and damaged limbs. Remove epicormic growth. Monitor the tree for changes in health and structure.

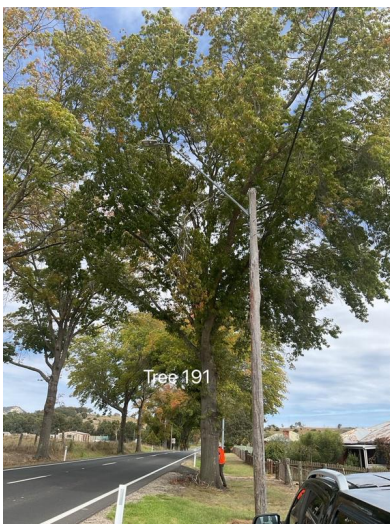
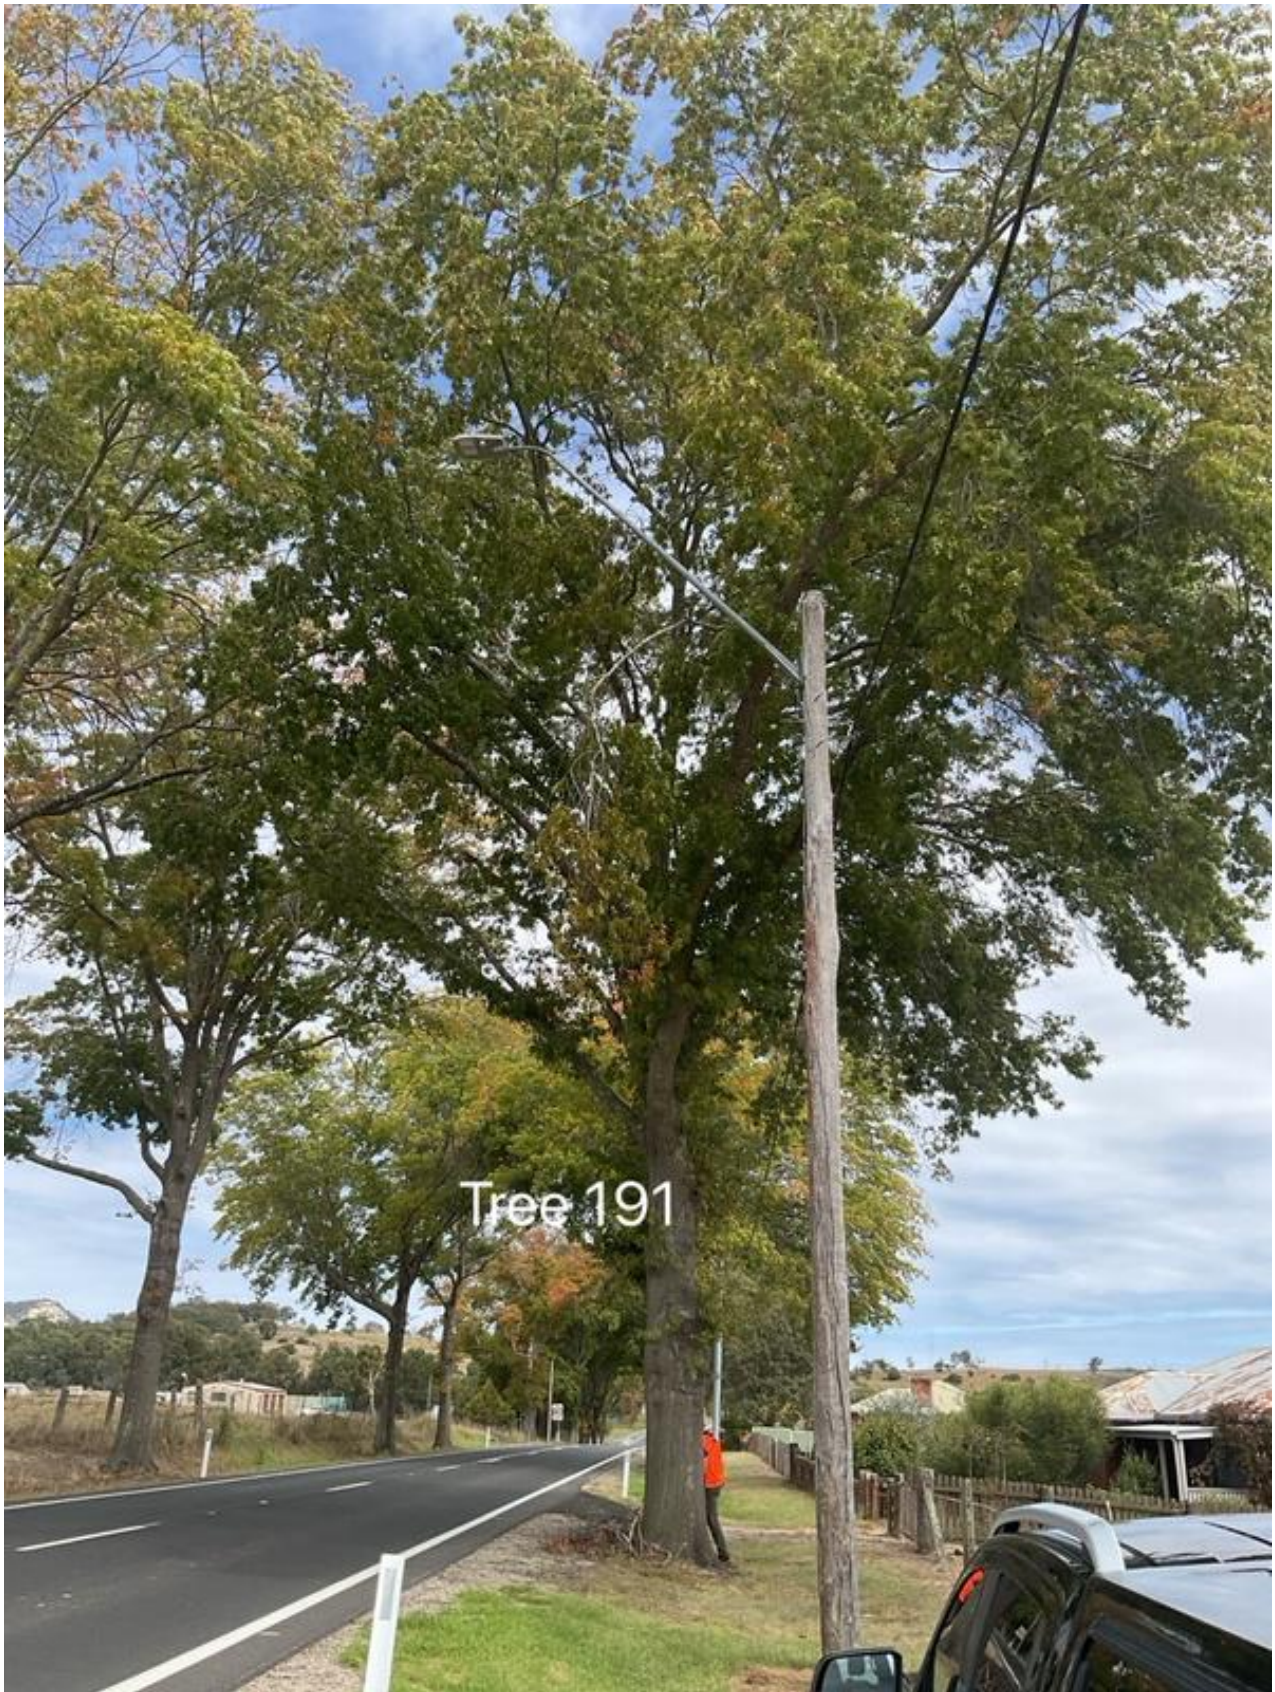
Photo 5

This tree appears to be in good condition. It has recently lost a large part of the western canopy in the recent storm event. The remainder of the western leader hangs over the power line and has excess weight

present. This leader will become unstable due to the damage above the limb junction. The tree has epicormic growth on the trunk and lower leaders which is a sign of vascular decline. The canopy extends well to the east and the north and there is some excess weight present in the southern limbs that overhang over the highway. There are some significant wounds at the root crown on the northern side of the tree that will cause issues in the future. The tree is only suitable for retention in the short term with remedial works.

Remove lower western leader completely (as will be a short term retention). Remove the epicormic growth. Remove the remaining leader to the west back to the main western leader junction. Apply a 20% weight reduction to the northern and eastern canopy and a 15% weight reduction to the canopy over the highway. Remove any remaining deadwood and hangers. Monitor the tree for changes in health and structure.

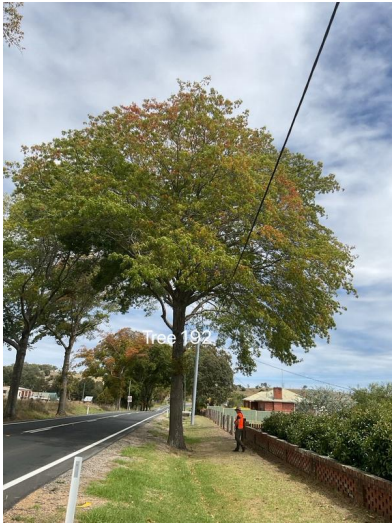
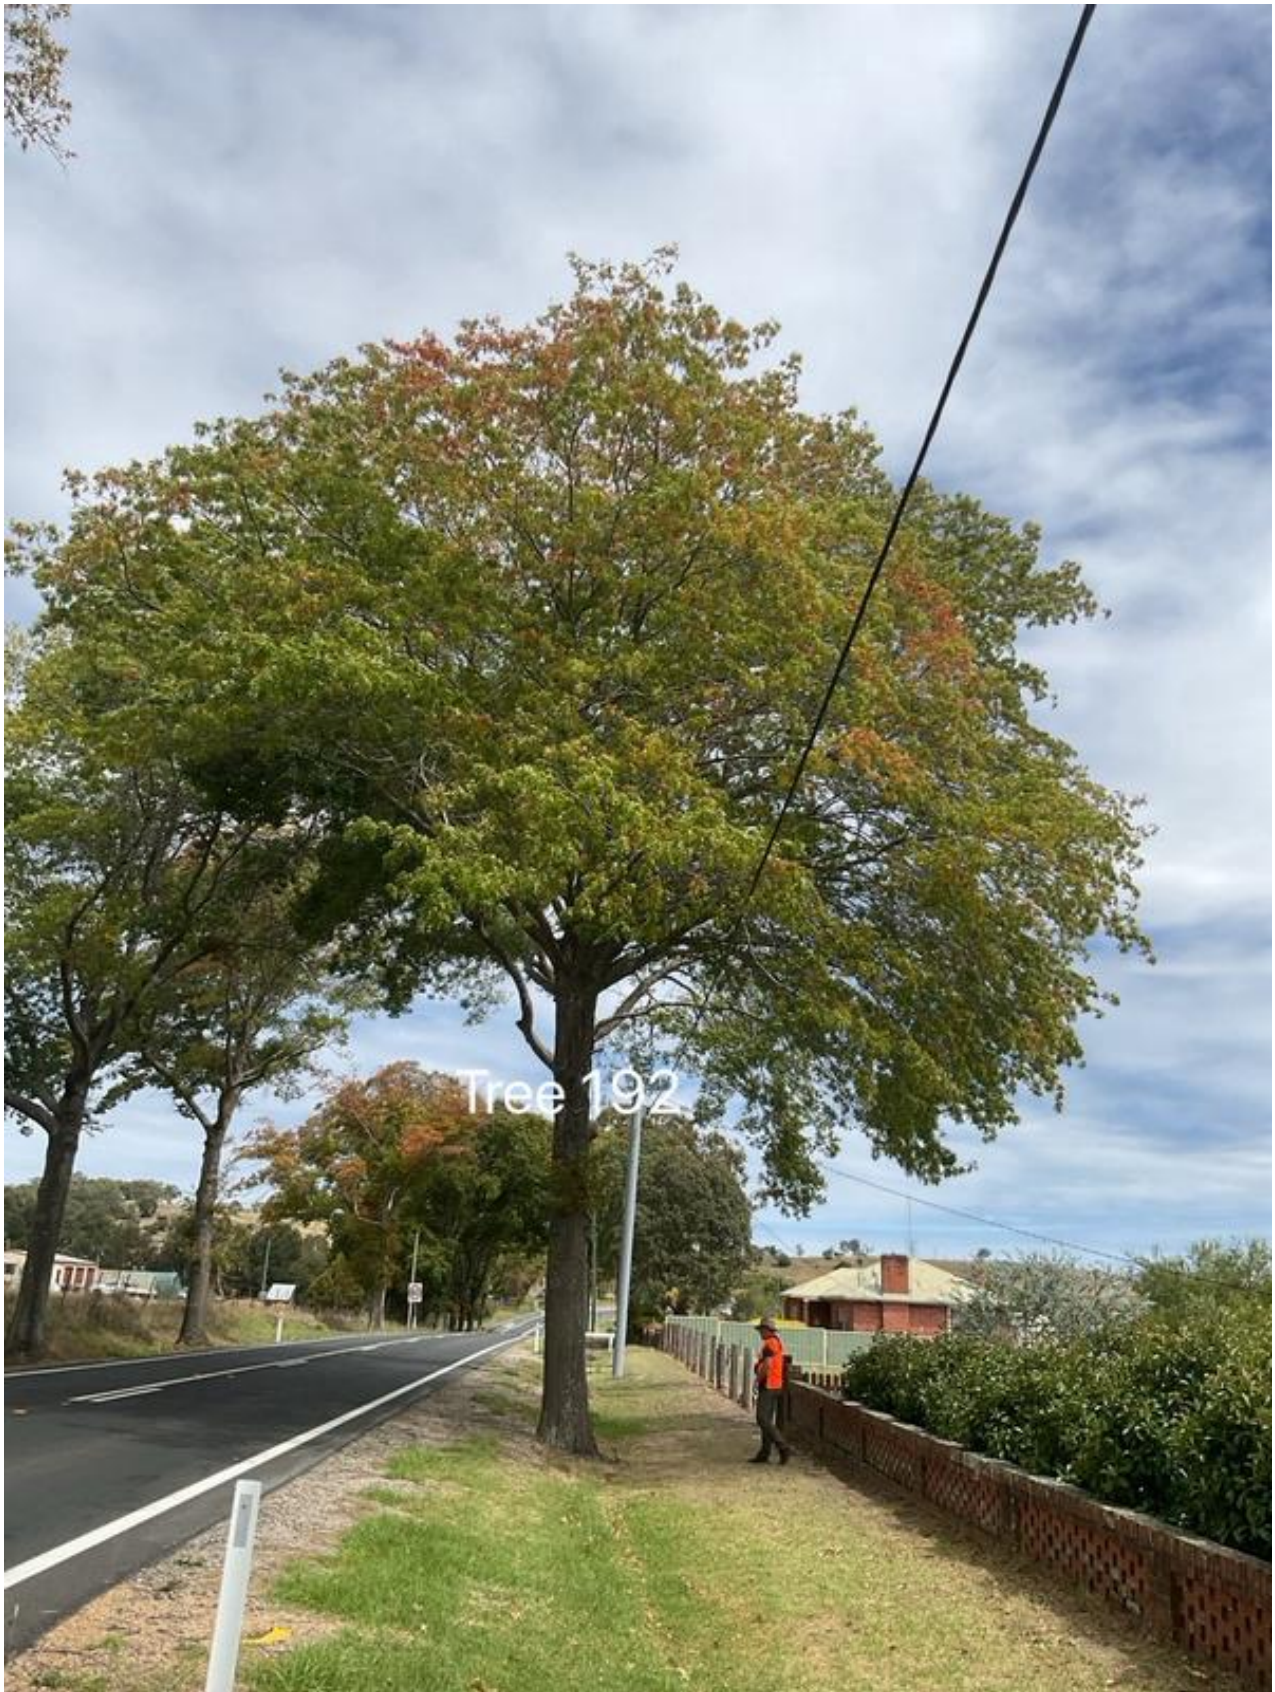
Photo 6

This tree appears to be in good condition. It has some damage near the root crown and some decay present. The canopy is overdeveloped to the north and hangs low over the property on the northern side of the road. There is some deadwood present in the crown and a small amount of epicormic growth present on the trunk.

Remove the deadwood and epicormic growth. Apply a 10% weight reduction in the outer lower northern canopy. Monitor the tree for changes in health and structure.

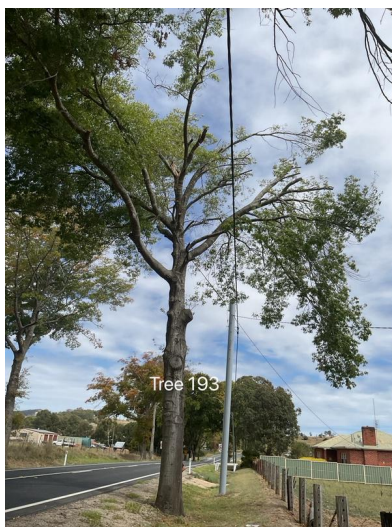
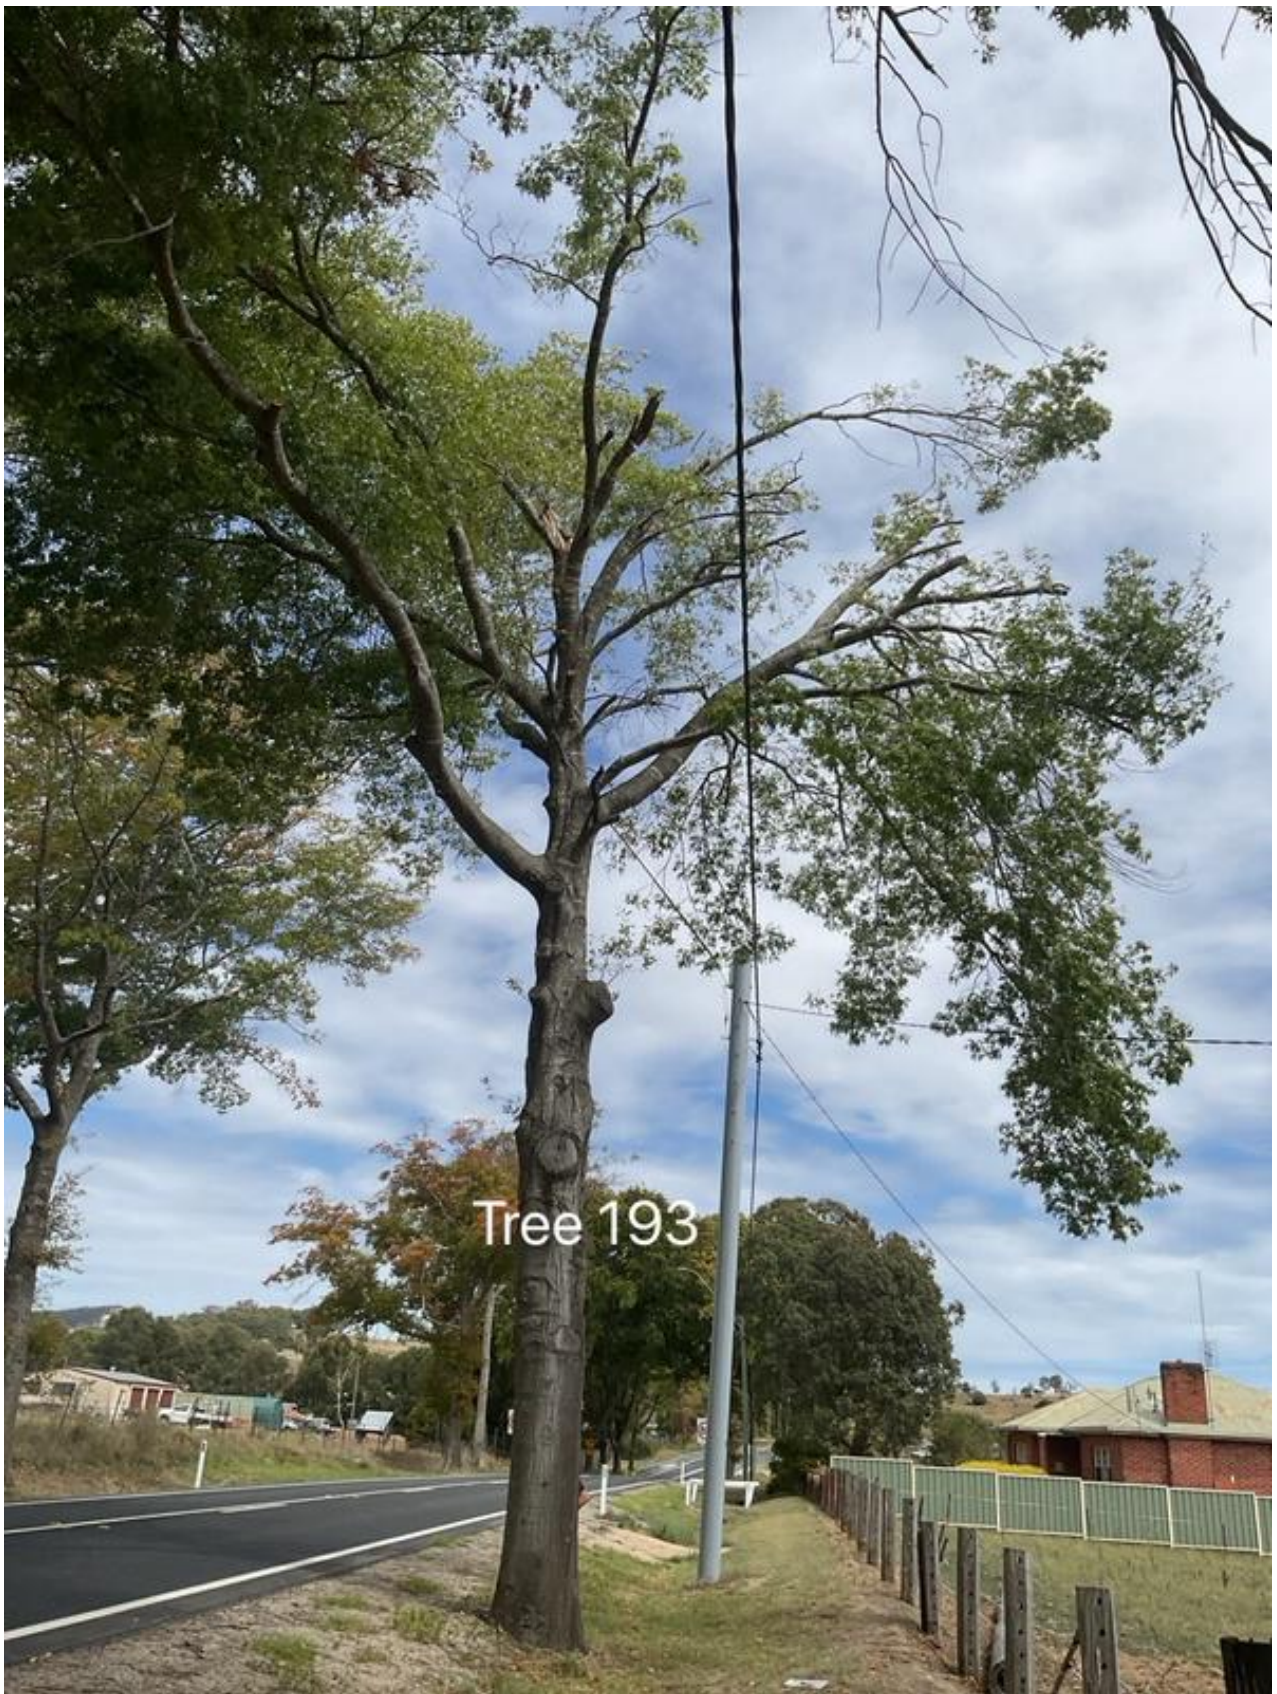
Photo 7

This tree has been very badly damaged in a recent storm event. This has left the crown very badly unbalanced. The tree will not recover to be a viable specimen for retention due to the significant damage.

Remove the tree and grind the stump.

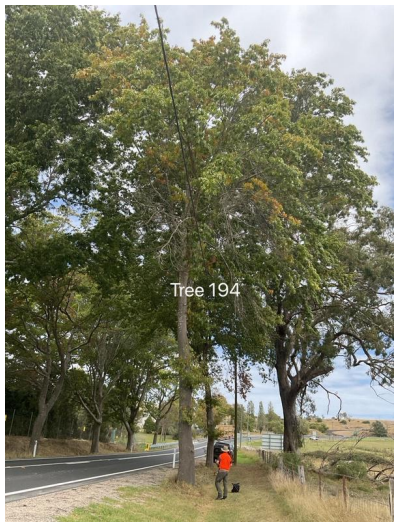
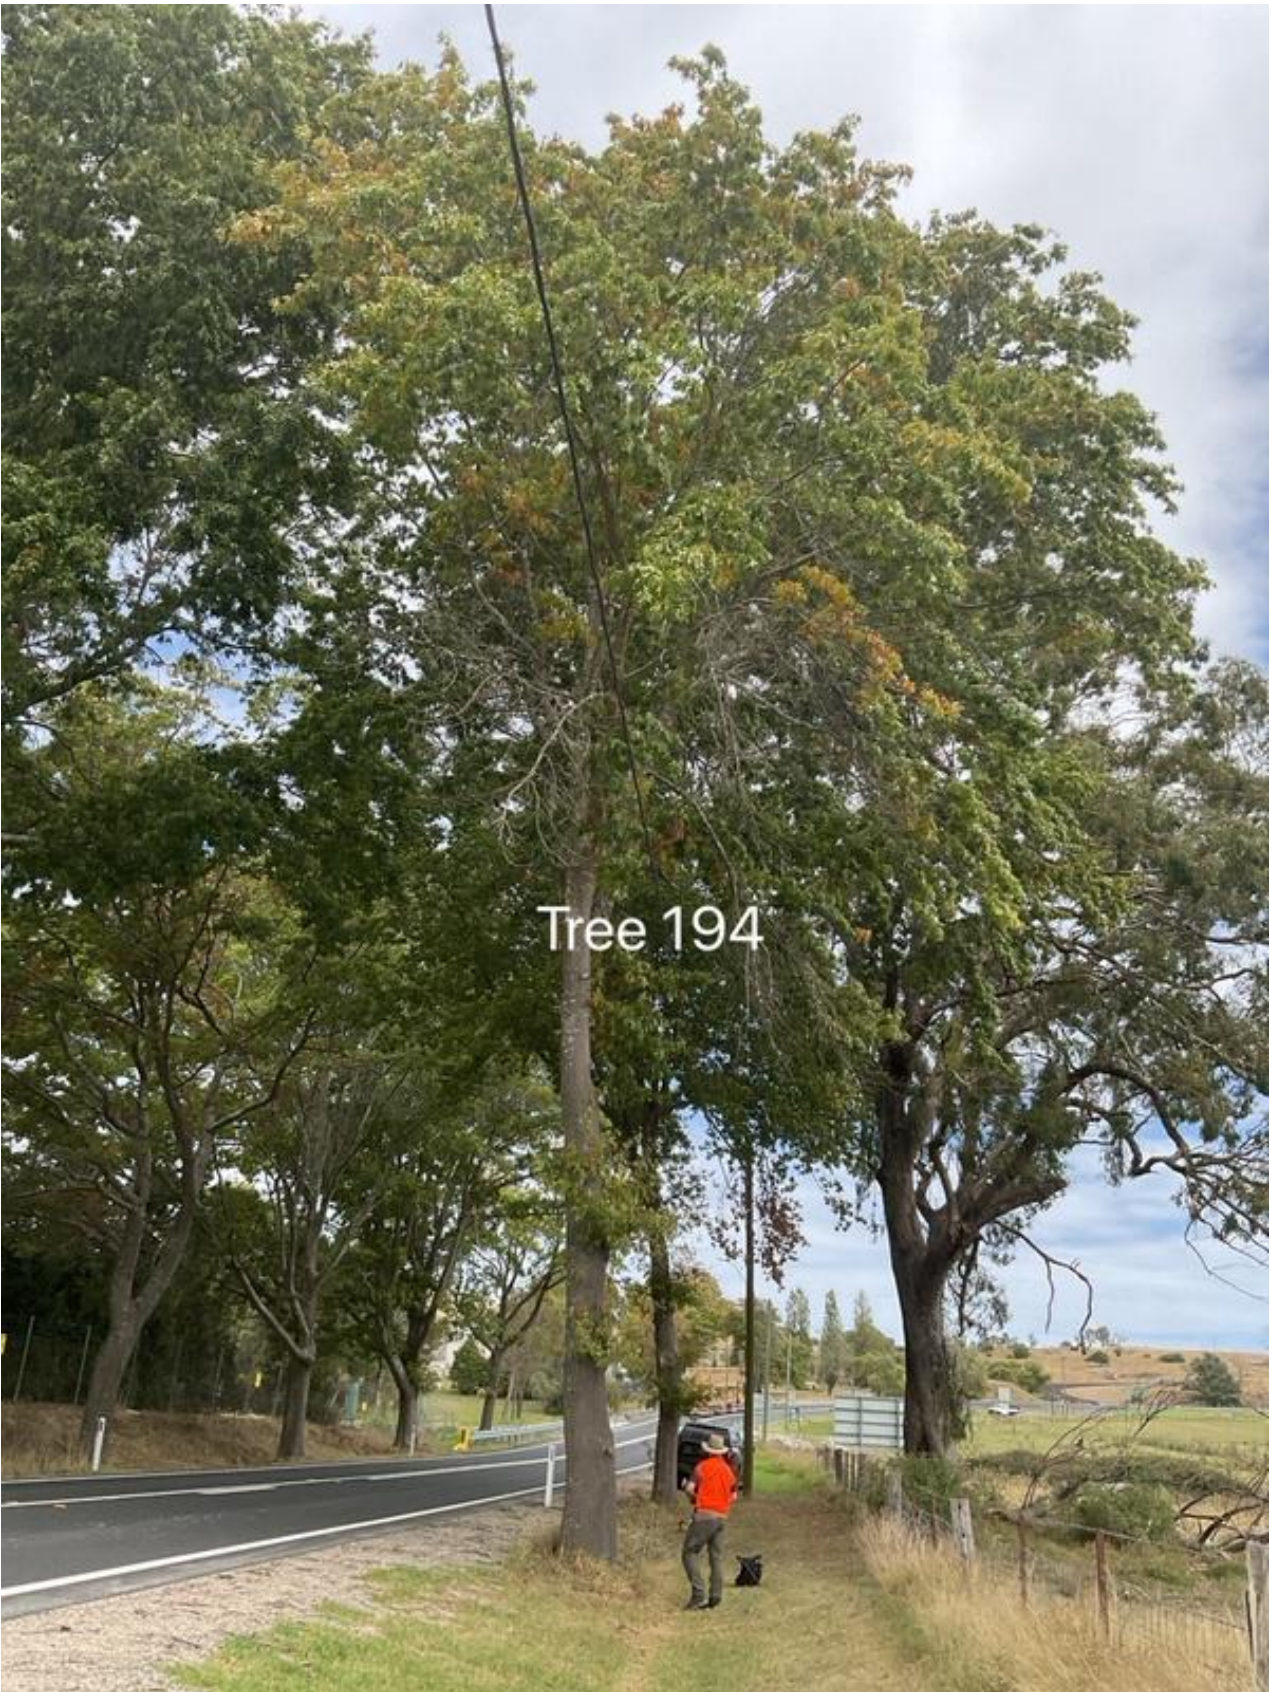
Photo 8

This tree appears to be in good condition. It has a small amount of epicormic growth present on the trunk and some deadwood present in the crown. There is a historic prune wound on the northern side of the tree approximately 1m from the ground that has decay present.

Remove the deadwood and epicormic growth. Monitor the tree for changes in health and structure.

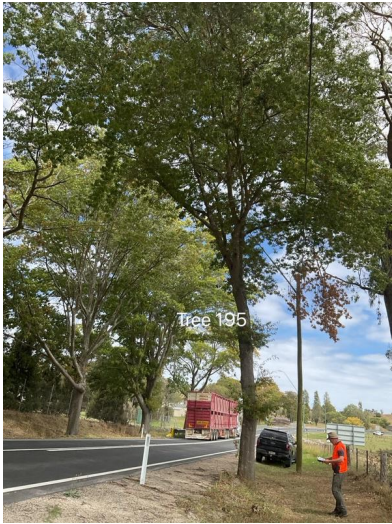
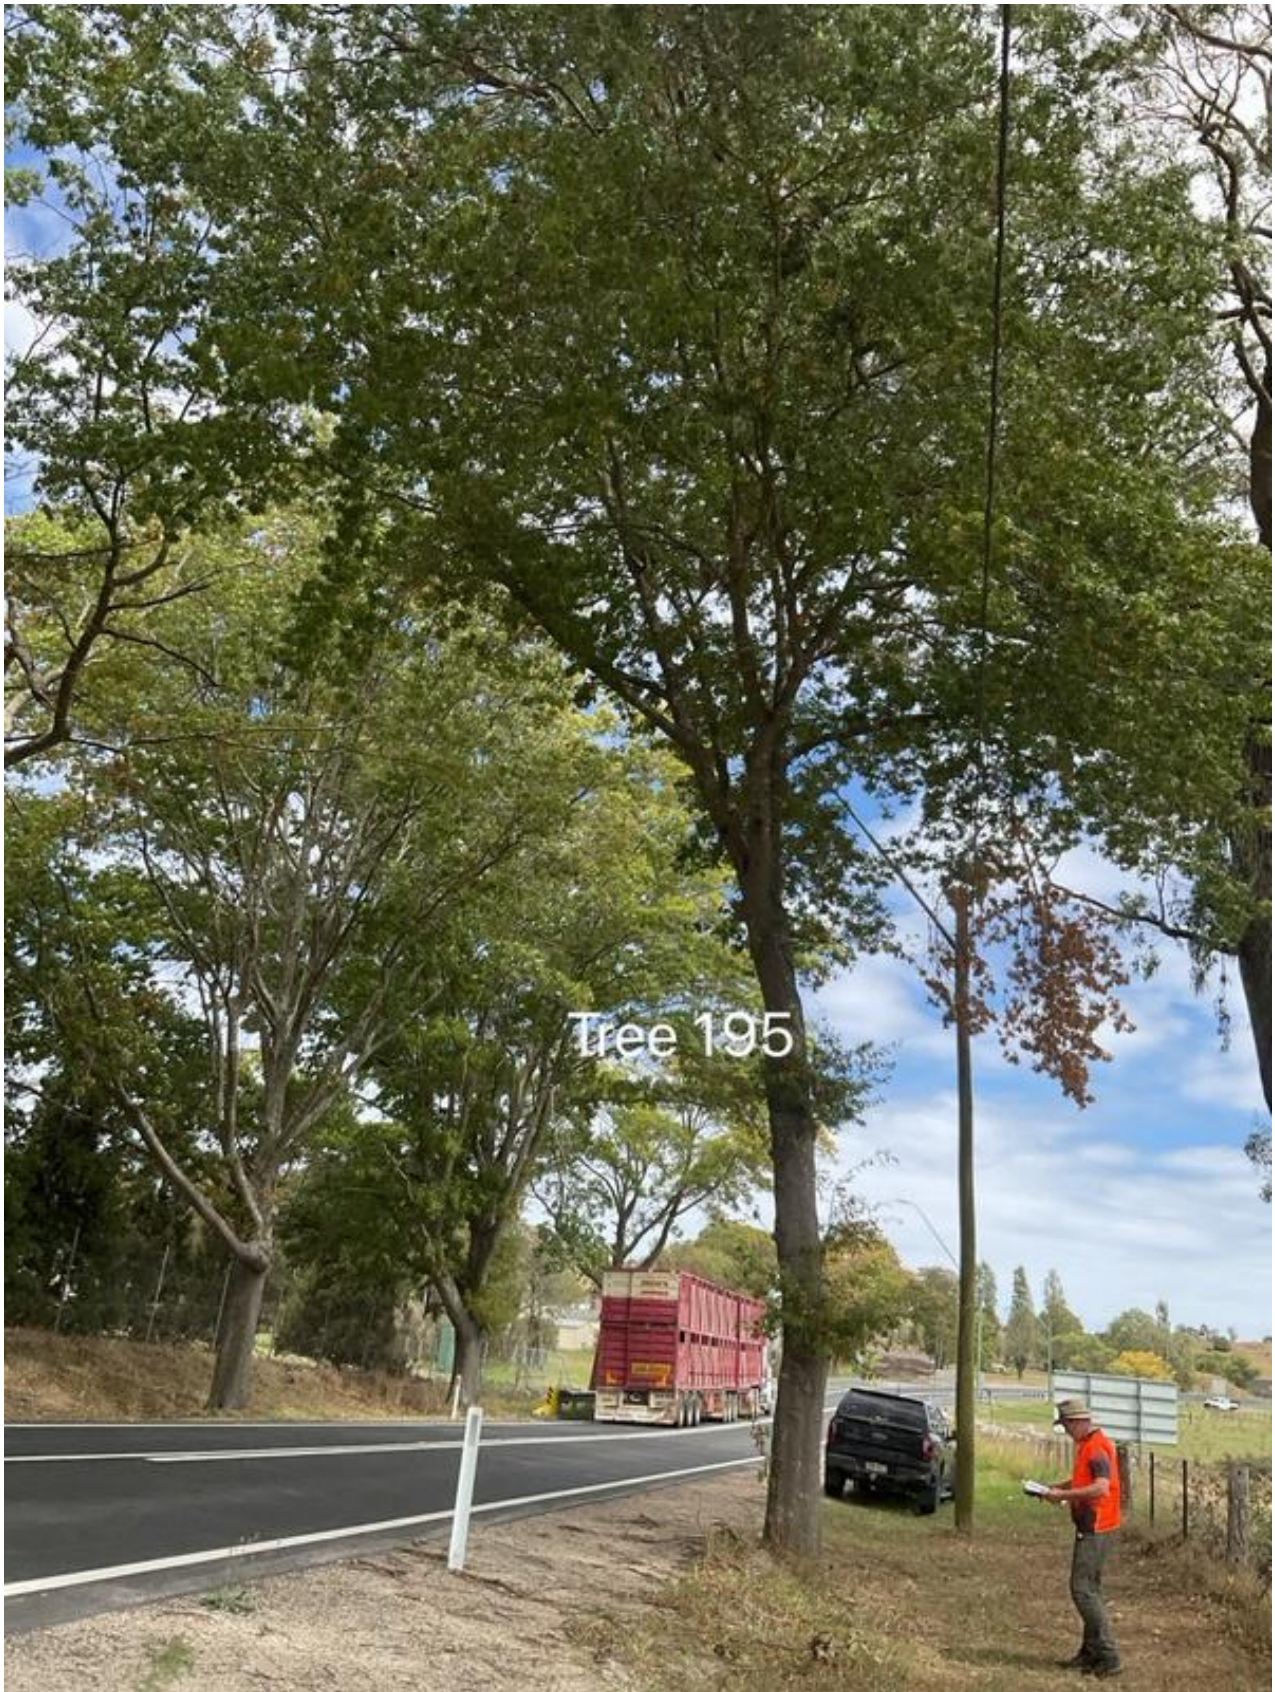
Photo 9

This tree appears to be in reasonable health. It has some epicormic growth present on the trunk. There are two historic prune points, approximately 2m from the ground, both of which have decay present. This will adversely affect the health of the tree in the future.

Remove the deadwood and epicormic growth. Monitor the tree for changes in health and structure.

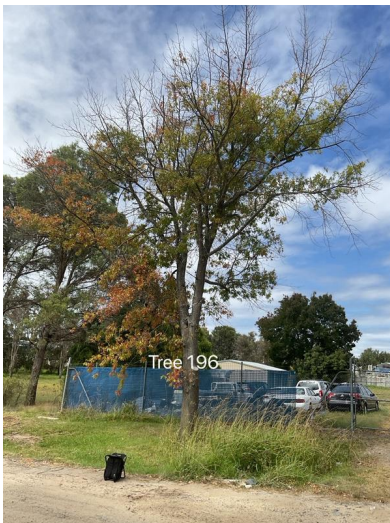
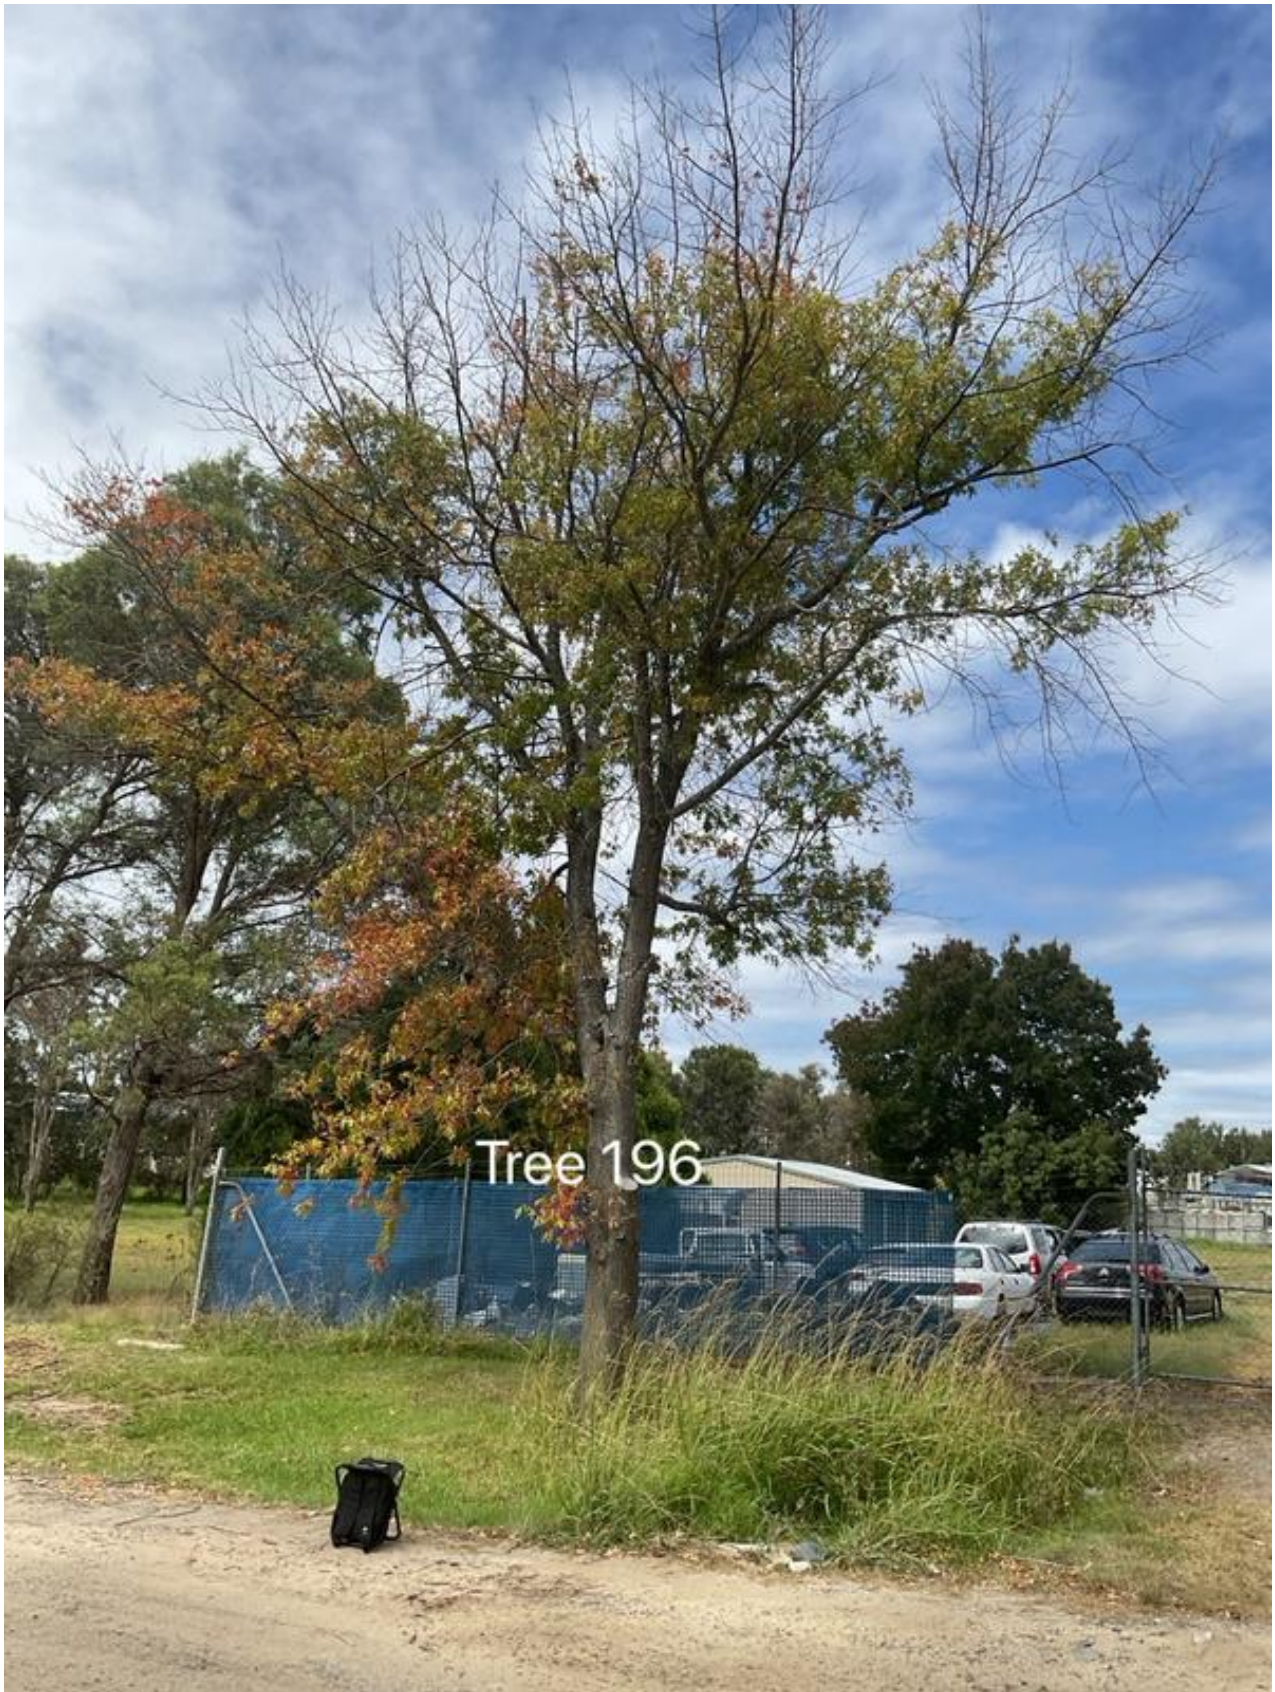
Photo 10

This tree is in poor condition. It is showing significant signs of decline due to fungal infection. The tree will not recover from its current state to be a viable specimen for the future.

Remove the tree and grind the stump.

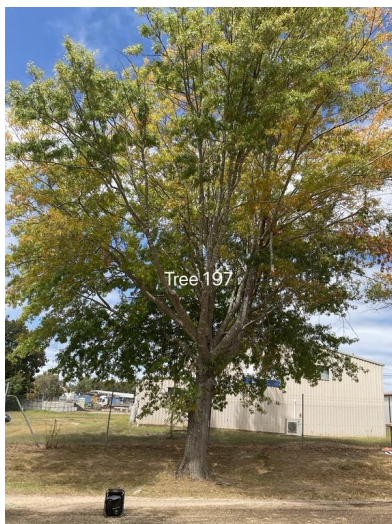
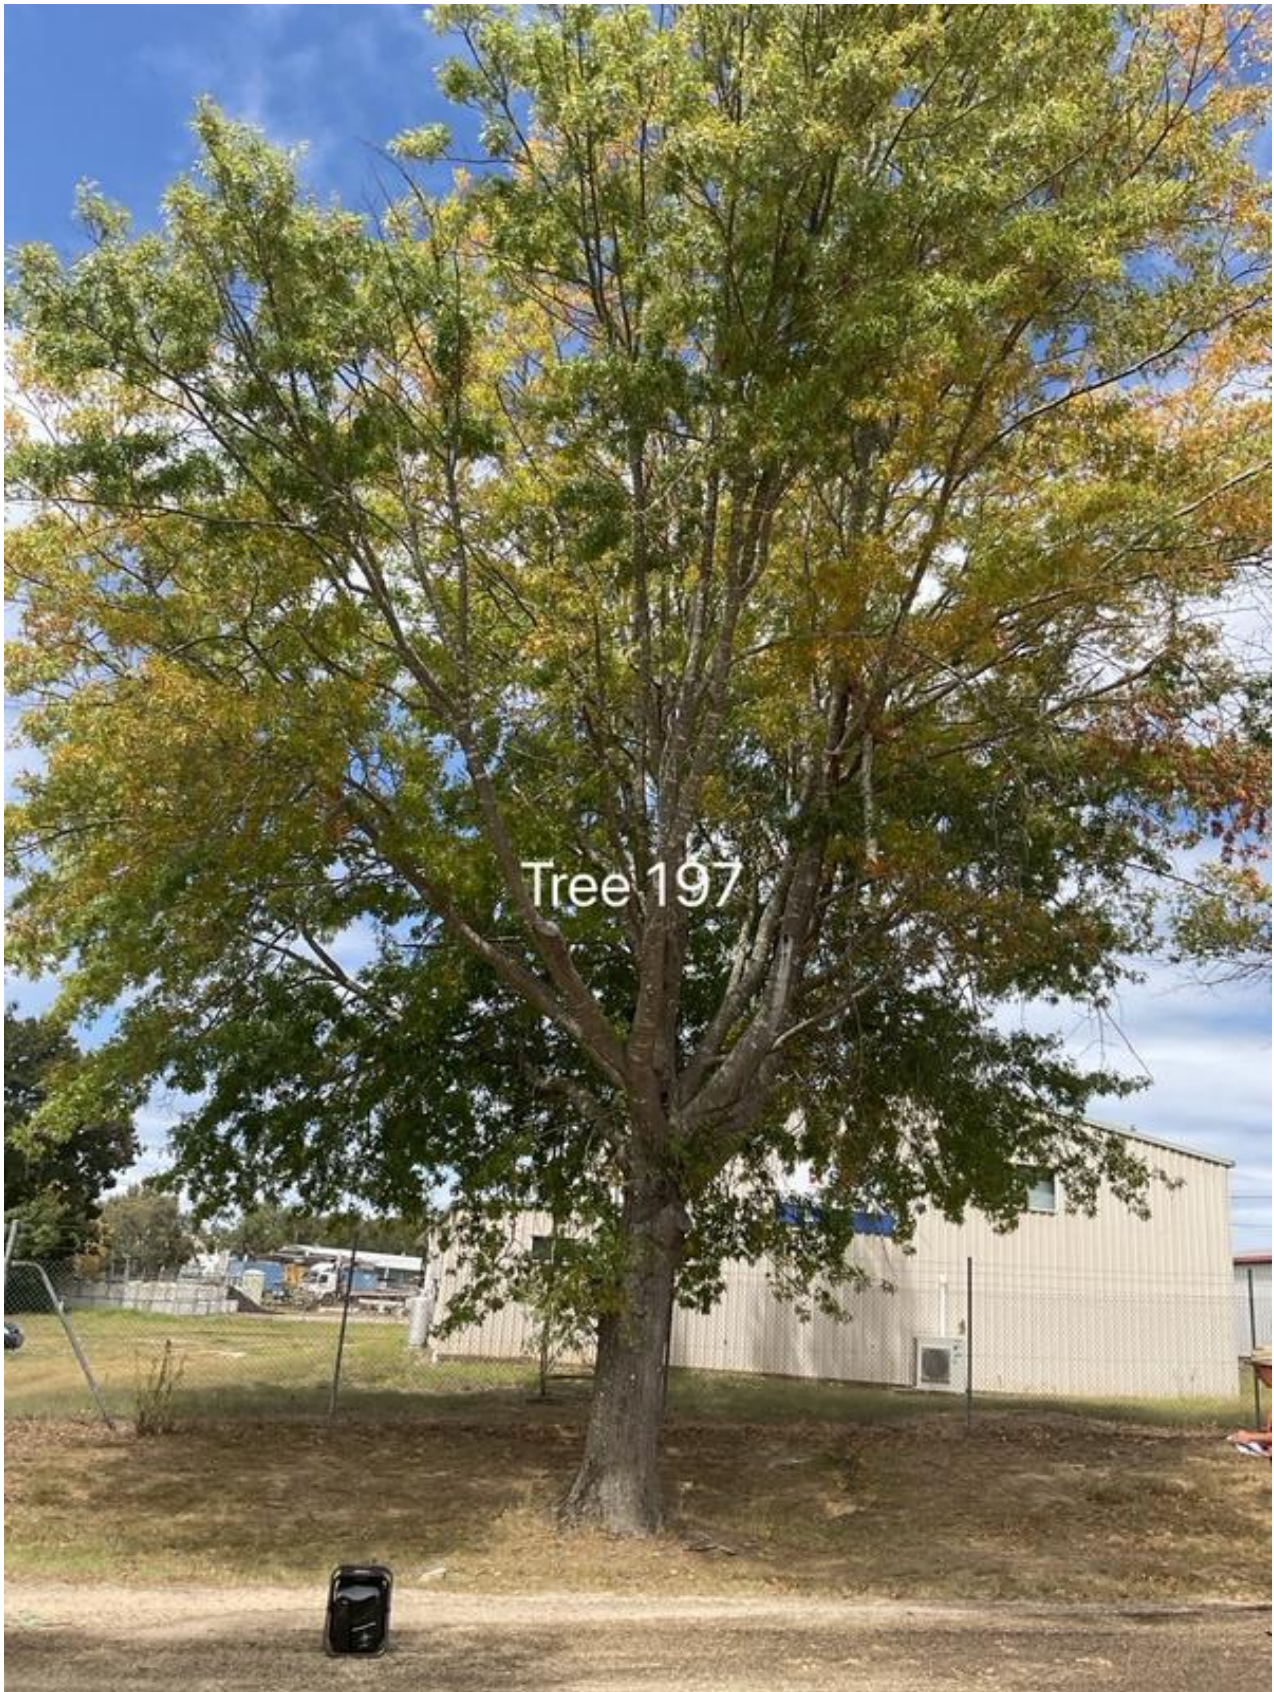
Photo 11

This tree has lost a significant limb in a recent severe weather event. The main part of the limb is still attached to the tree and hangs down low over the car park reserve area. The tree has significant decay present at a prior historical prune point approximately 3m from the ground on the eastern side of the tree just below the junction of the main leaders. The tree is showing significant signs of fungal infection with dieback in the crown and thinning of the canopy. The tree cannot be considered stable due to the amount of decay present at the main leader junction.

Remove the tree and grind the stump.
