Tree Assessment Report - Tree Protection Zones

3 Mar 2026

Cowper Street (between Pelham Street & New England Highway),
Tenterfield.

Report 10 of 10 - Tree ID 189-203

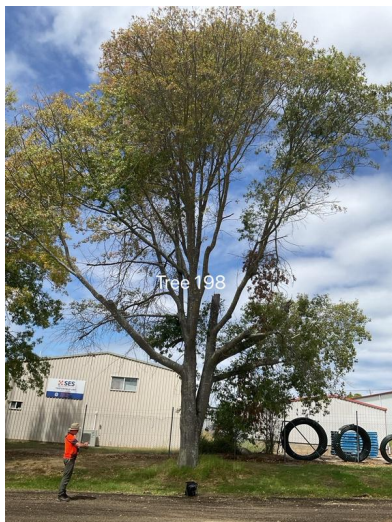
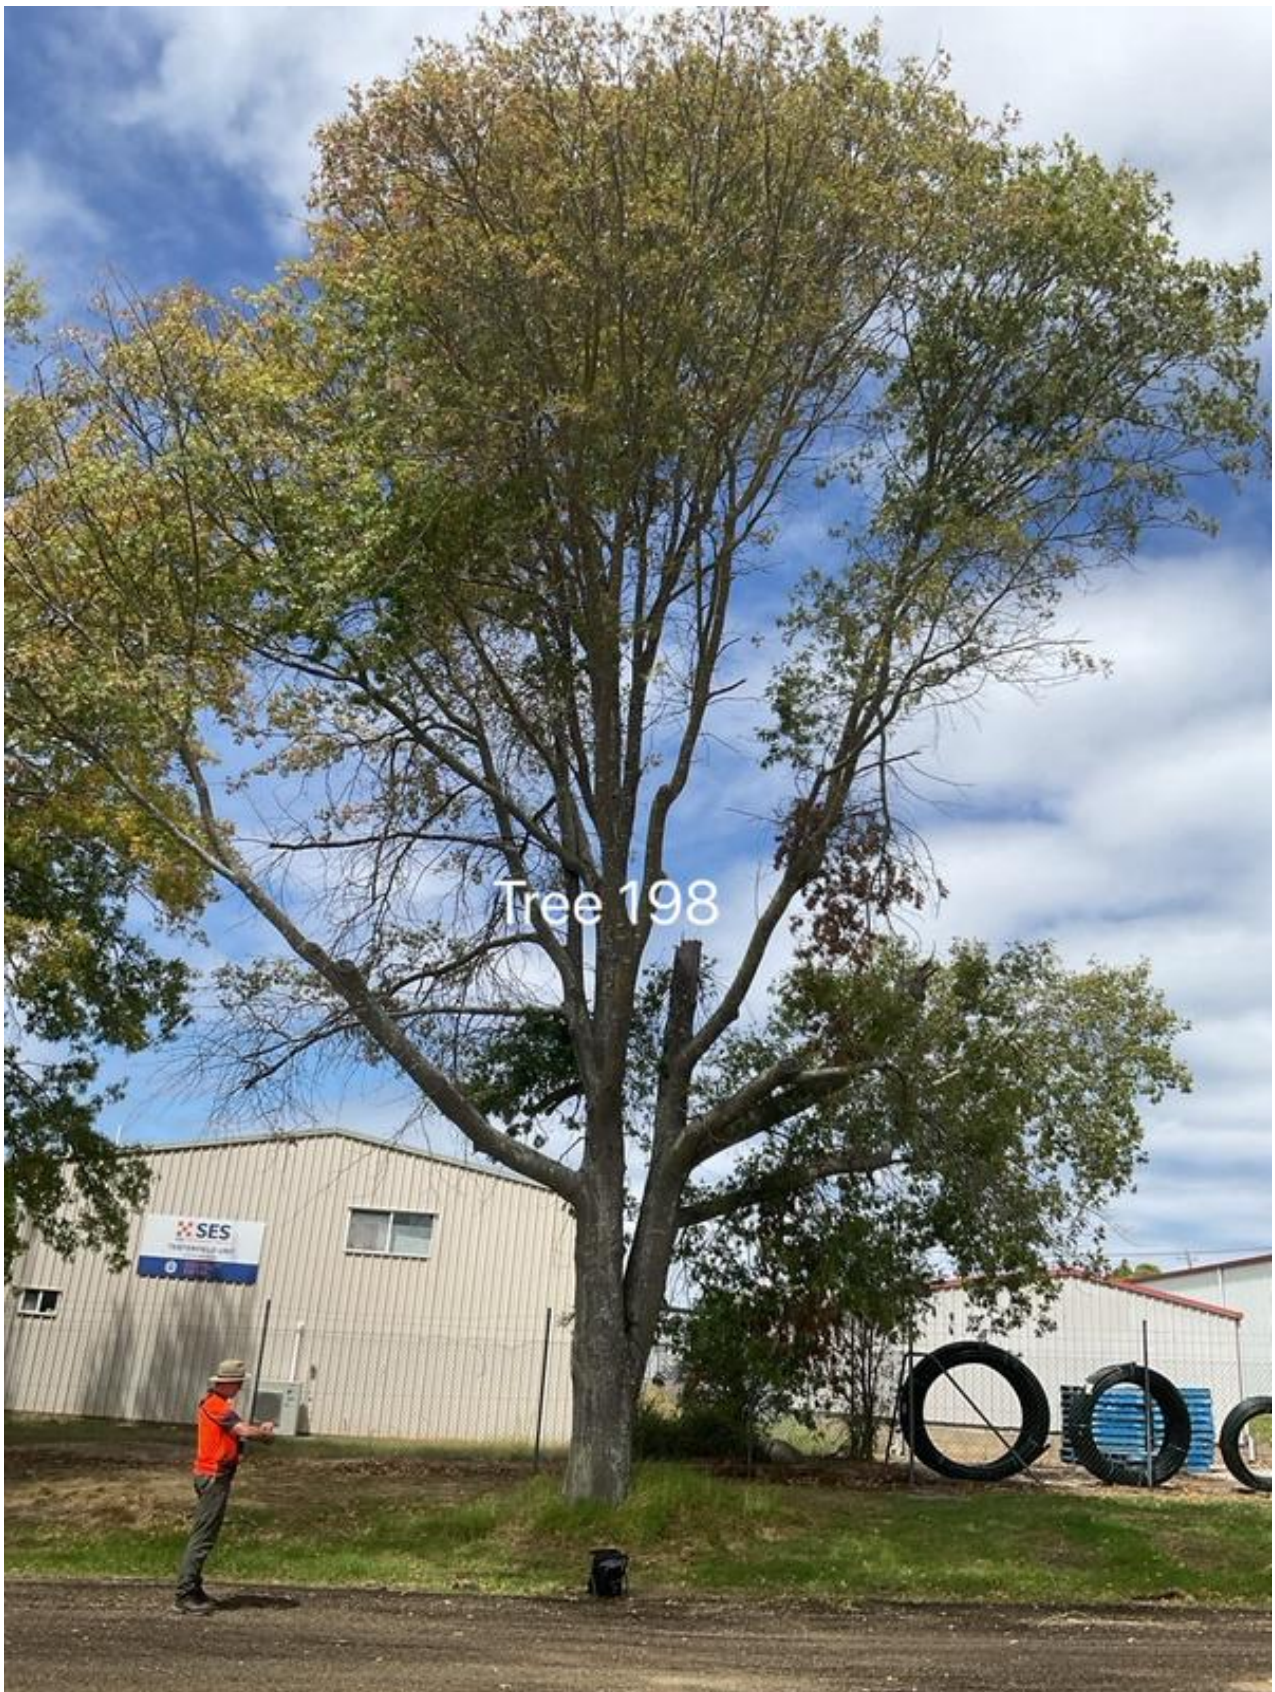
Photo 12

This tree has lost the majority of the western side of the canopy

during a recent storm event. The rest of the canopy will be left unbalanced and unstable. This tree is not suitable for retention due to the significance damage to the tree. It will not recover from its current state to be a viable specimen for retention.

Remove the tree and grind the stump.

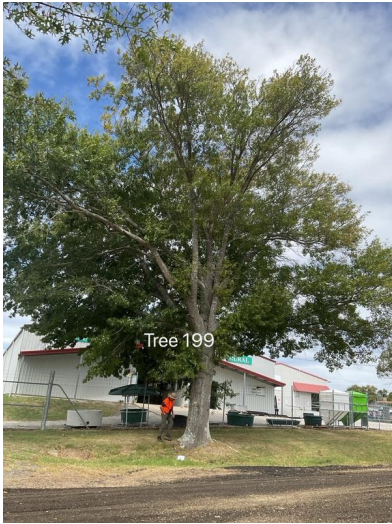
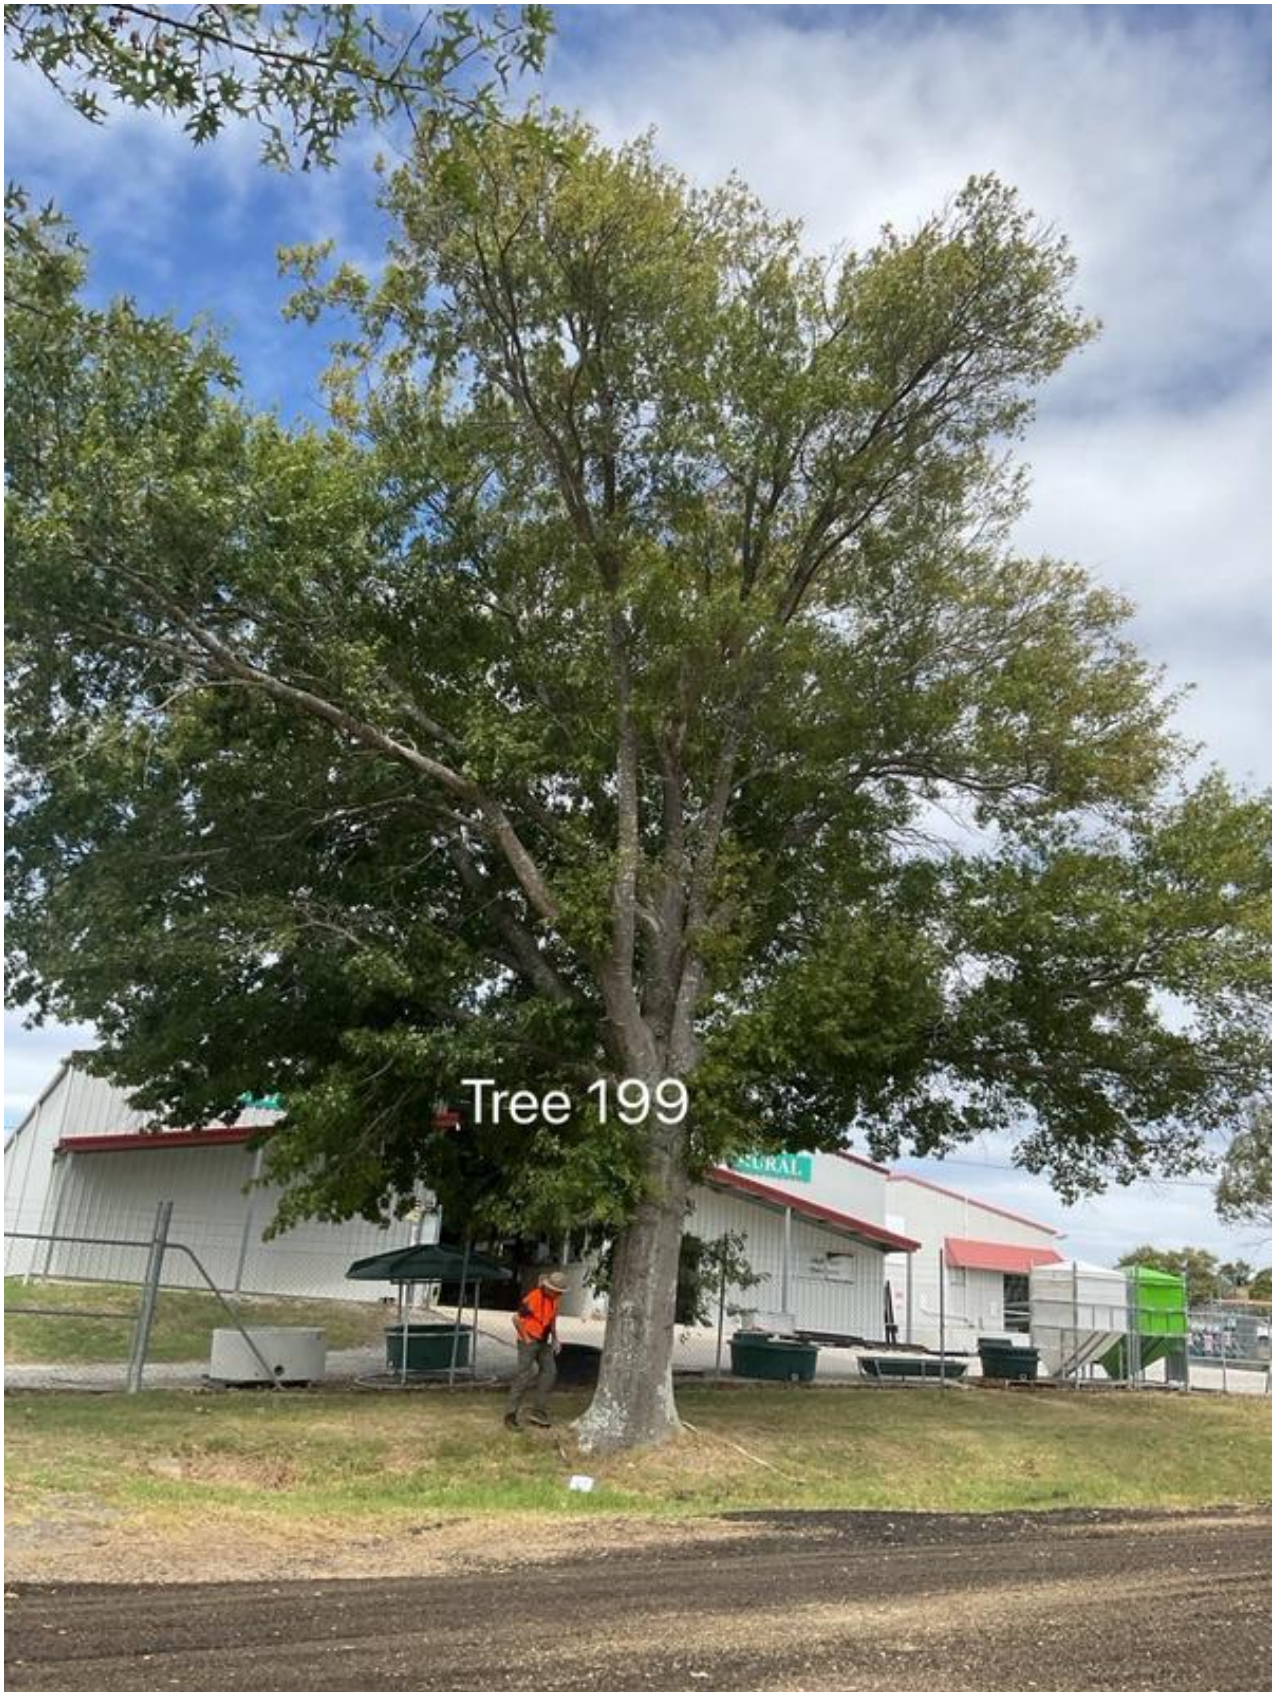
Photo 13

This tree appears to be in good condition. It has full foliage coverage in the canopy and a small amount of epicormic growth present on the trunk. The canopy is over-developed to the south and the west and it hangs heavily down over the neighbouring properties. The central leader of the tree has died and is badly decayed and still in the tree. The decay from this dead leader will have extended down into the trunk of the tree and will compromise its stability and health in the future.

Remove epicormic growth. Remove the lower leader. Apply a 20% weight reduction in the outer lower western and southern canopies. Monitor the tree for changes in health and structure.

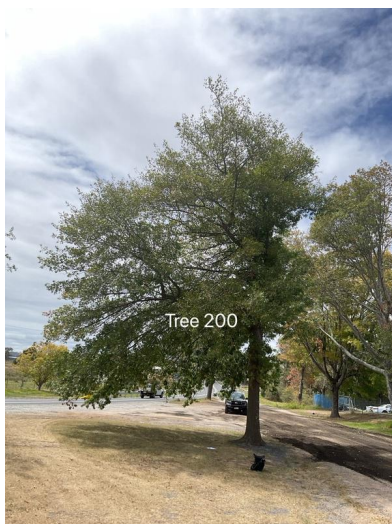
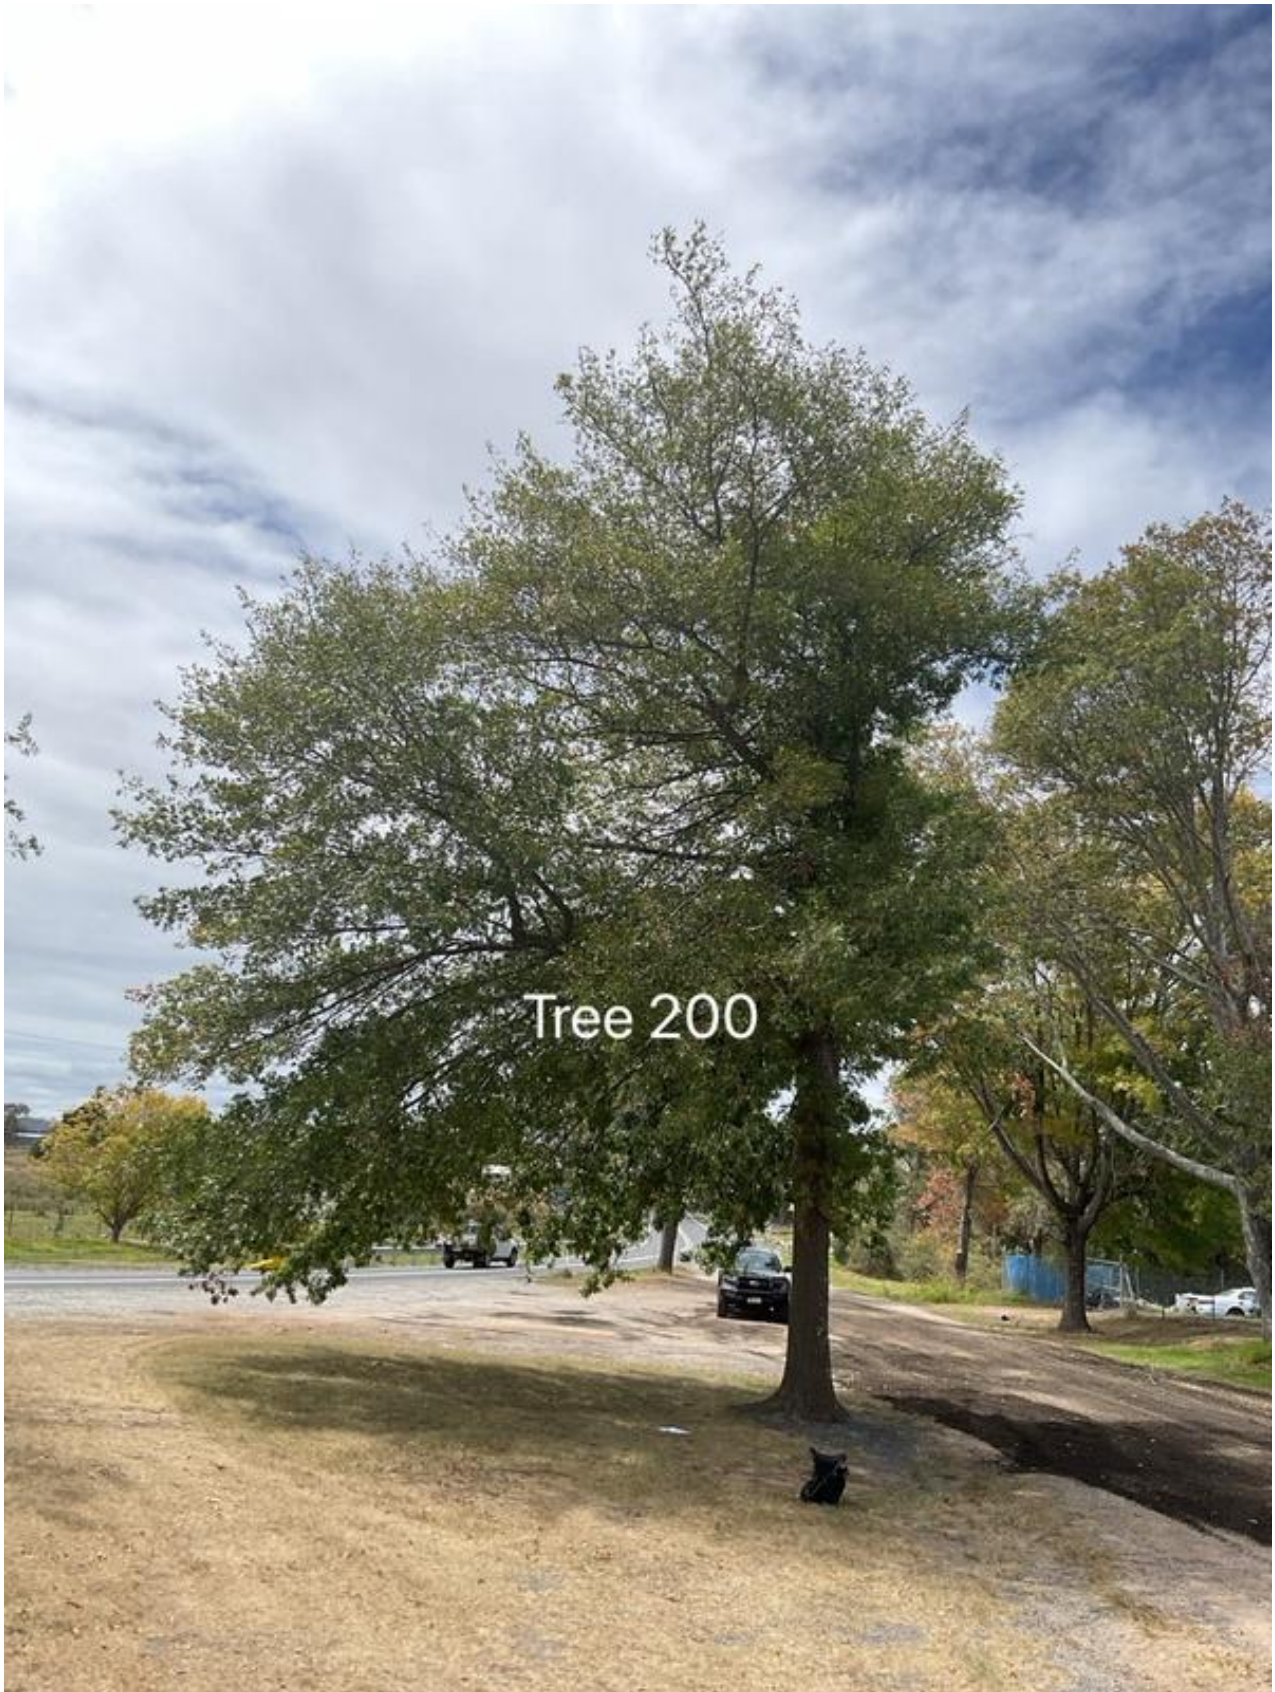
Photo 14

This tree appears to be in good condition. It has an over-developed canopy to the north and has been heavily pruned to the south. The northern canopy hangs low over the park. There is epicormic growth present on the trunk and inside lateral limbs.

Remove the deadwood and epicormic growth. Remove the lower limbs and lift the canopy to

the north to be a minimum of 3m above the ground. Apply a 20% weight reduction to the northern outer canopy. Monitor the tree for changes in health and structure.

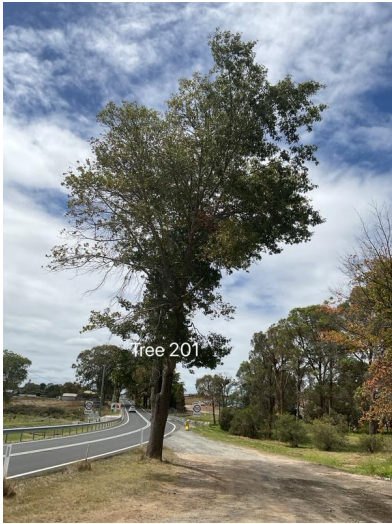
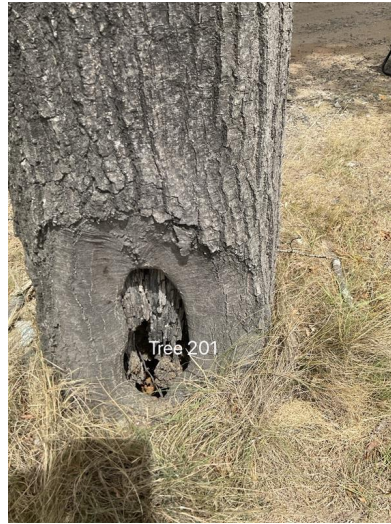
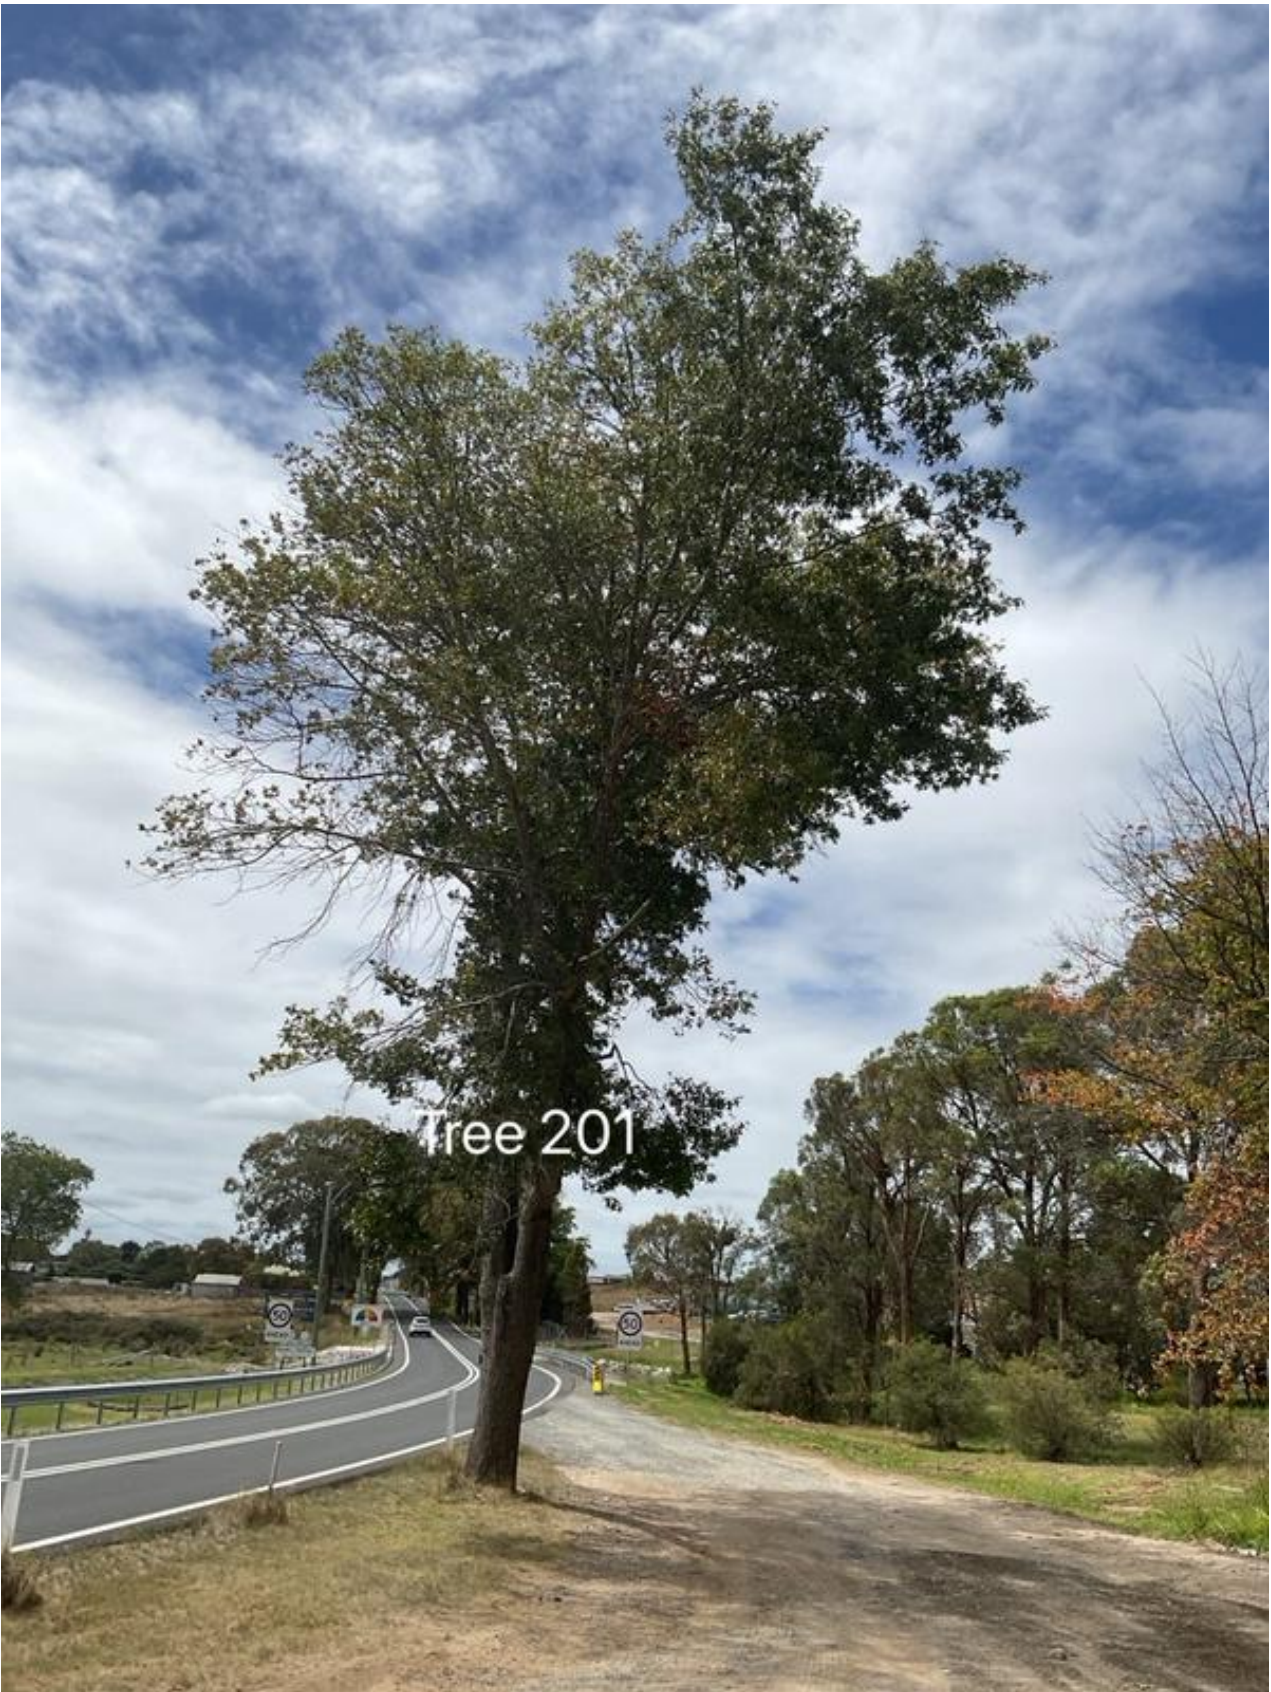
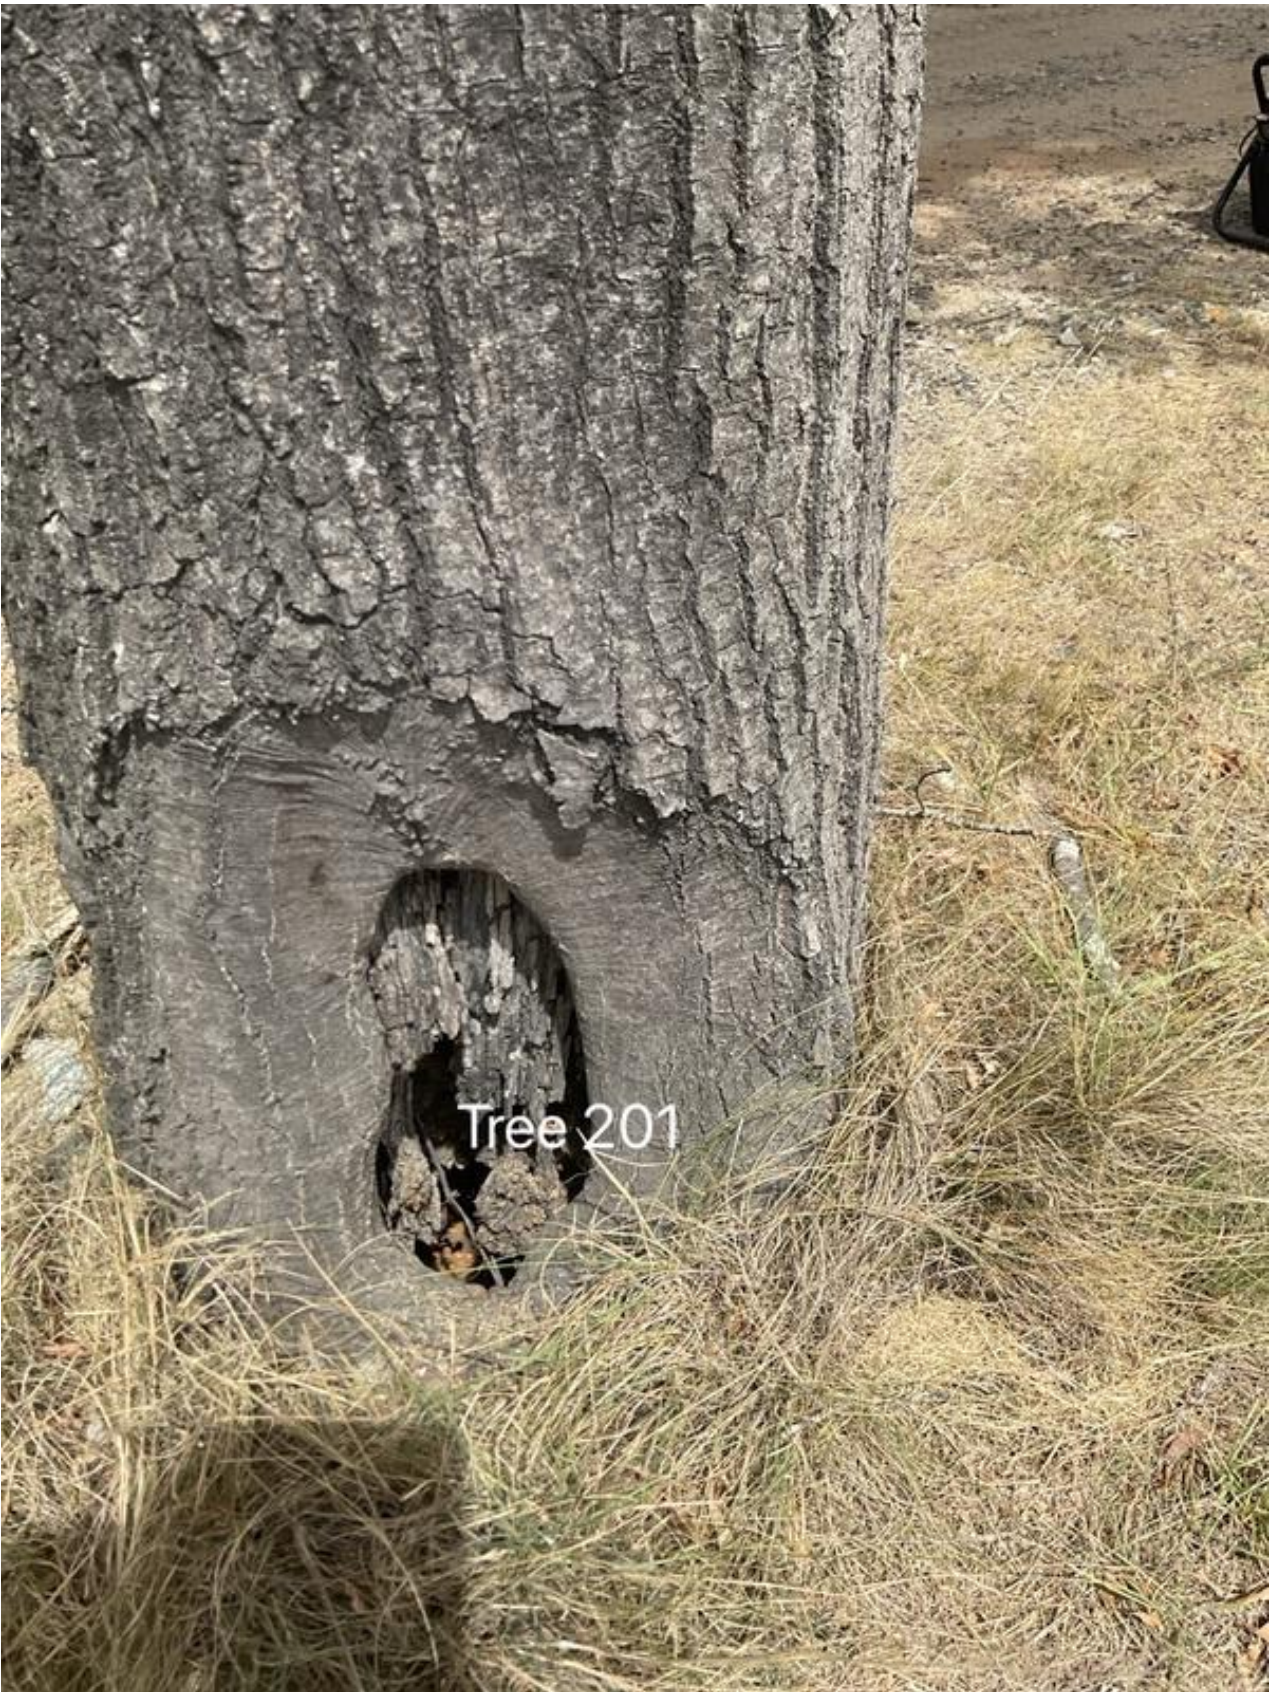
This tree has significant decay present at the base with a hollow on the northern side of the trunk at the root crown. The hollow extends down through the root crown. The tree will be unstable and is unsuitable for retention and should be removed as soon as possible.

Remove the tree and grind the stump.

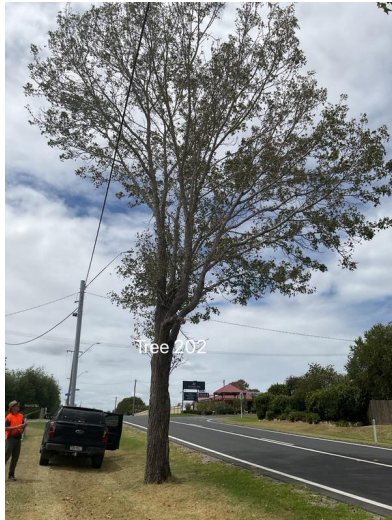
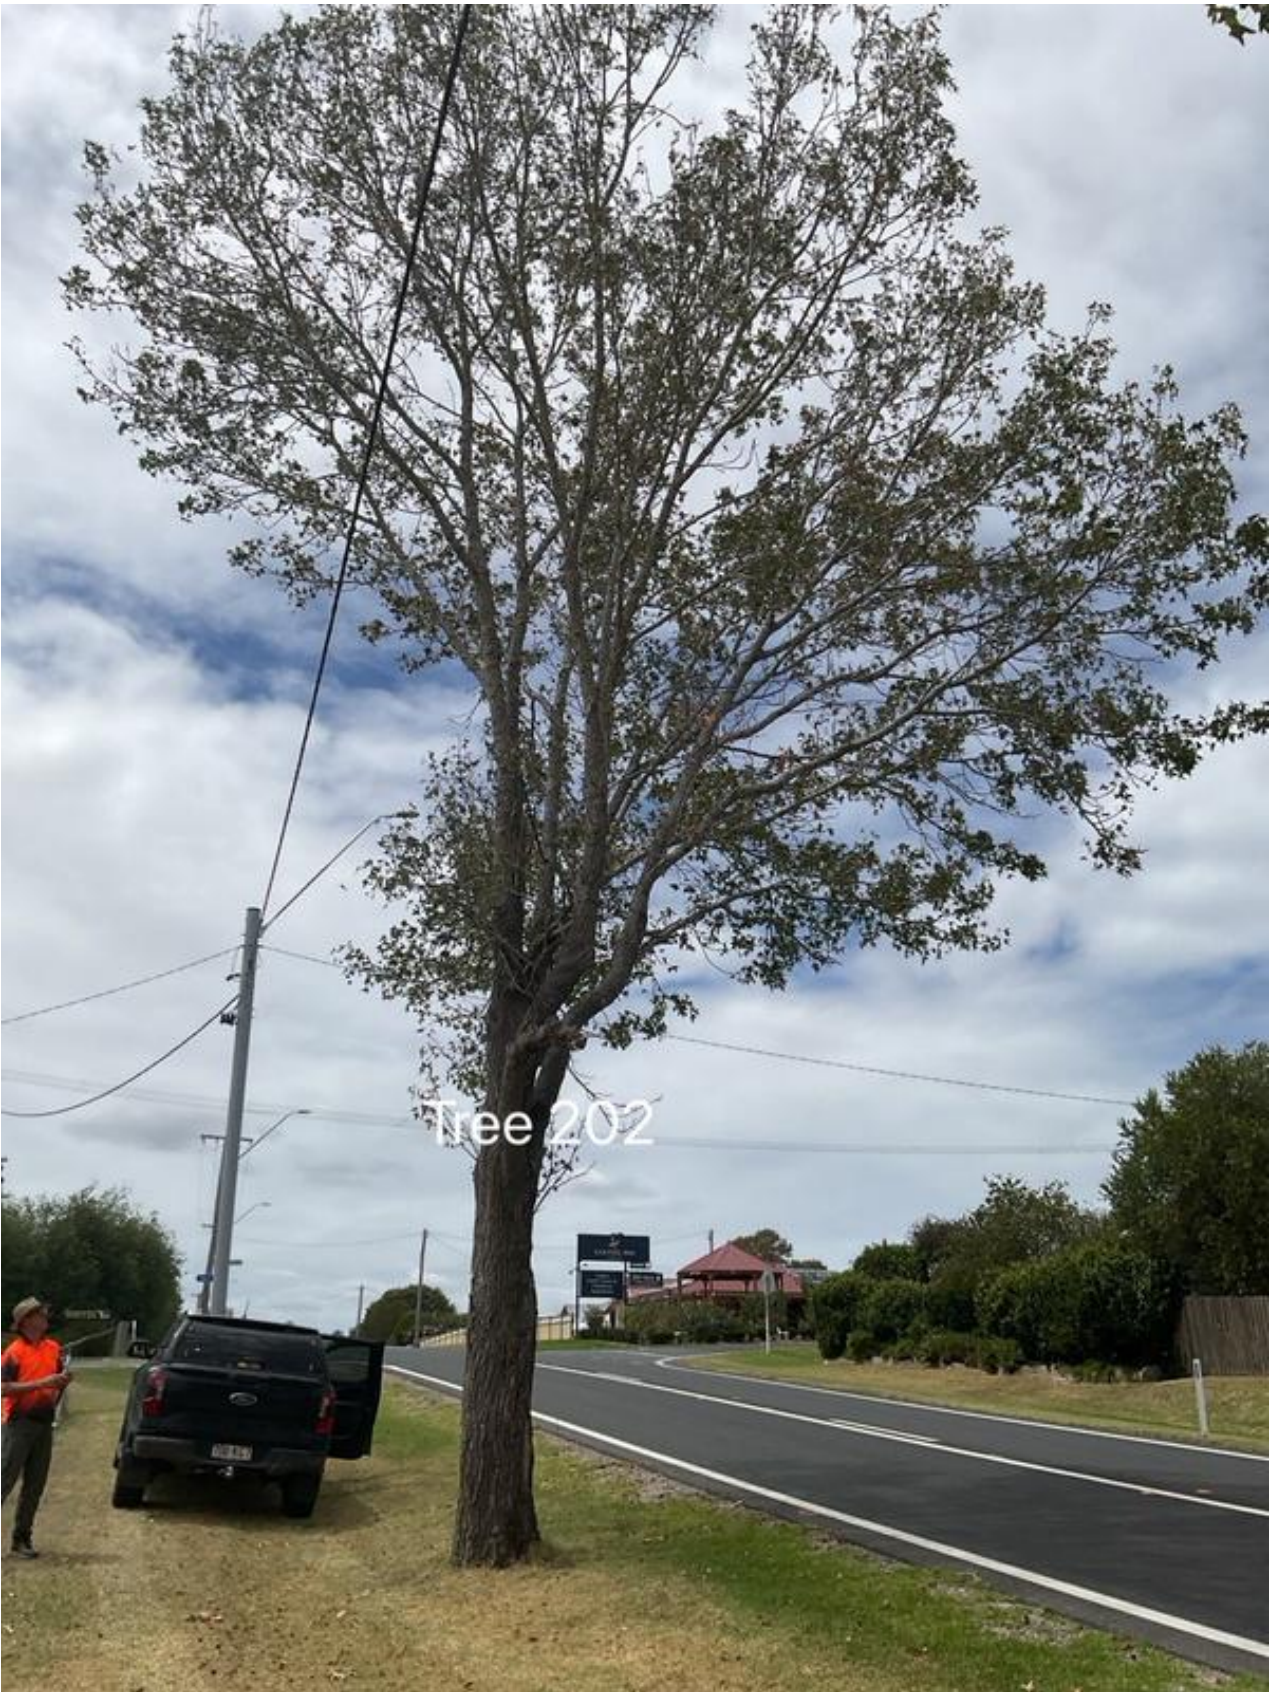
Photo 17

This tree has significant decay present at prior pruning points between 3m and 4m from the ground. This decay will extend into the main leader and make the tree unstable and unsuitable for retention.

Remove the tree and grind the stump.

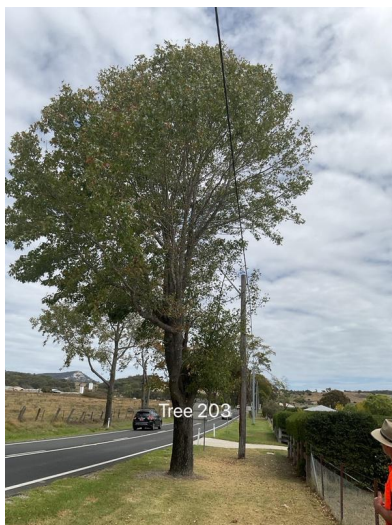
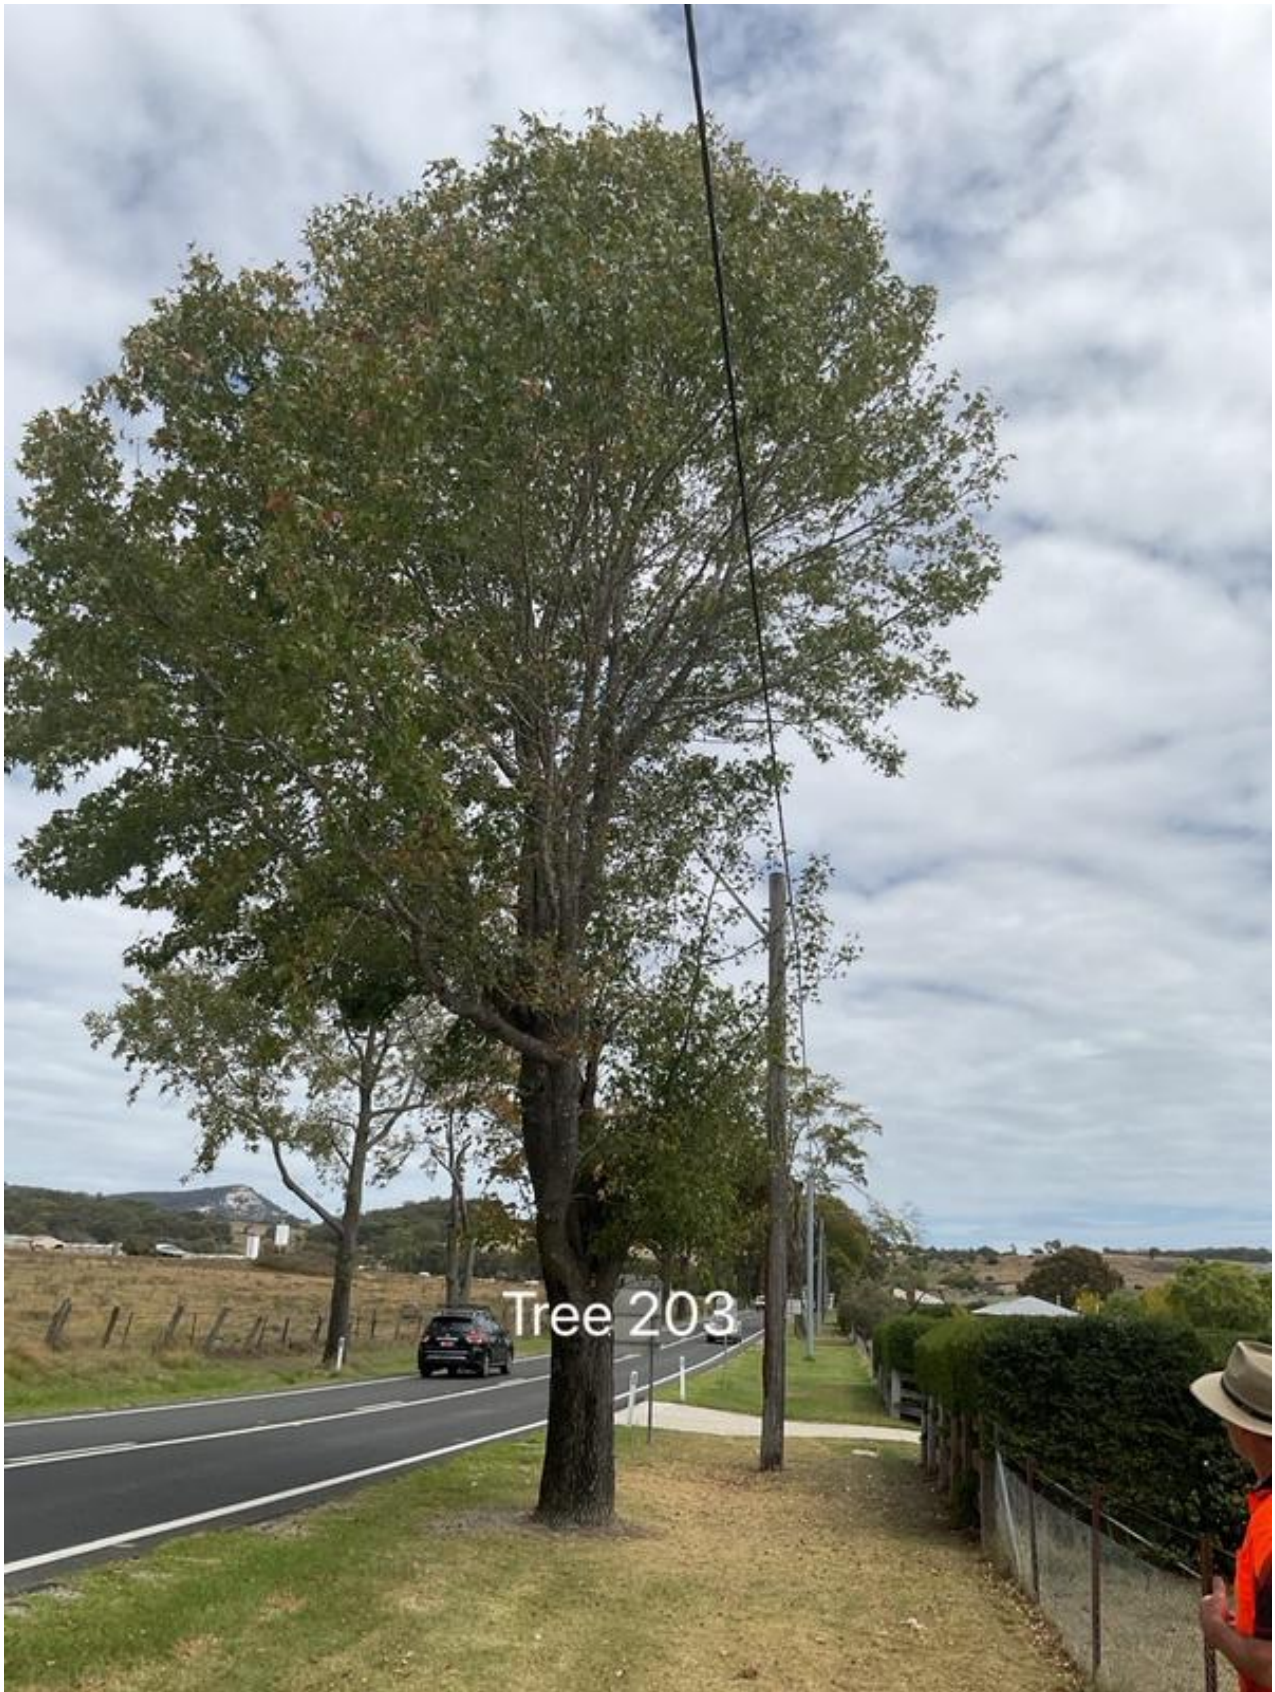
Photo 18

This tree is in decline. The canopy extends out over the highway to the south and it has some epicormic growth present underneath the powerlines to the north. There is decay present in a pruned leader on the northern side of the main trunk. The tree may be retainable for the short term with remedial works.

Lift the canopy to the south to be a minimum of 6m above the highway. Remove the epicormic growth on the northern side of the tree. Monitor the tree for changes in health and structure.
