Tree Assessment Report - Tree Protection Zones

Cowper Street (between Pelham Street & New England Highway),
Tenterfield

Report 9 of 10 - Tree ID 173-188

03.03.2026 08:00 AEST

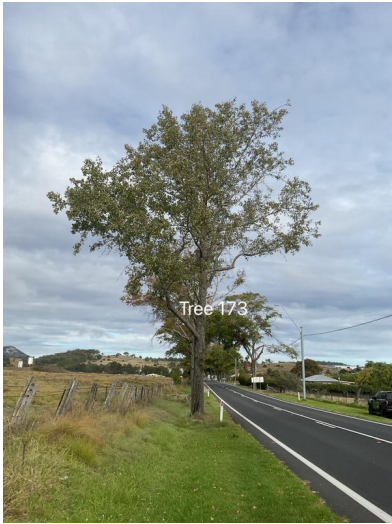
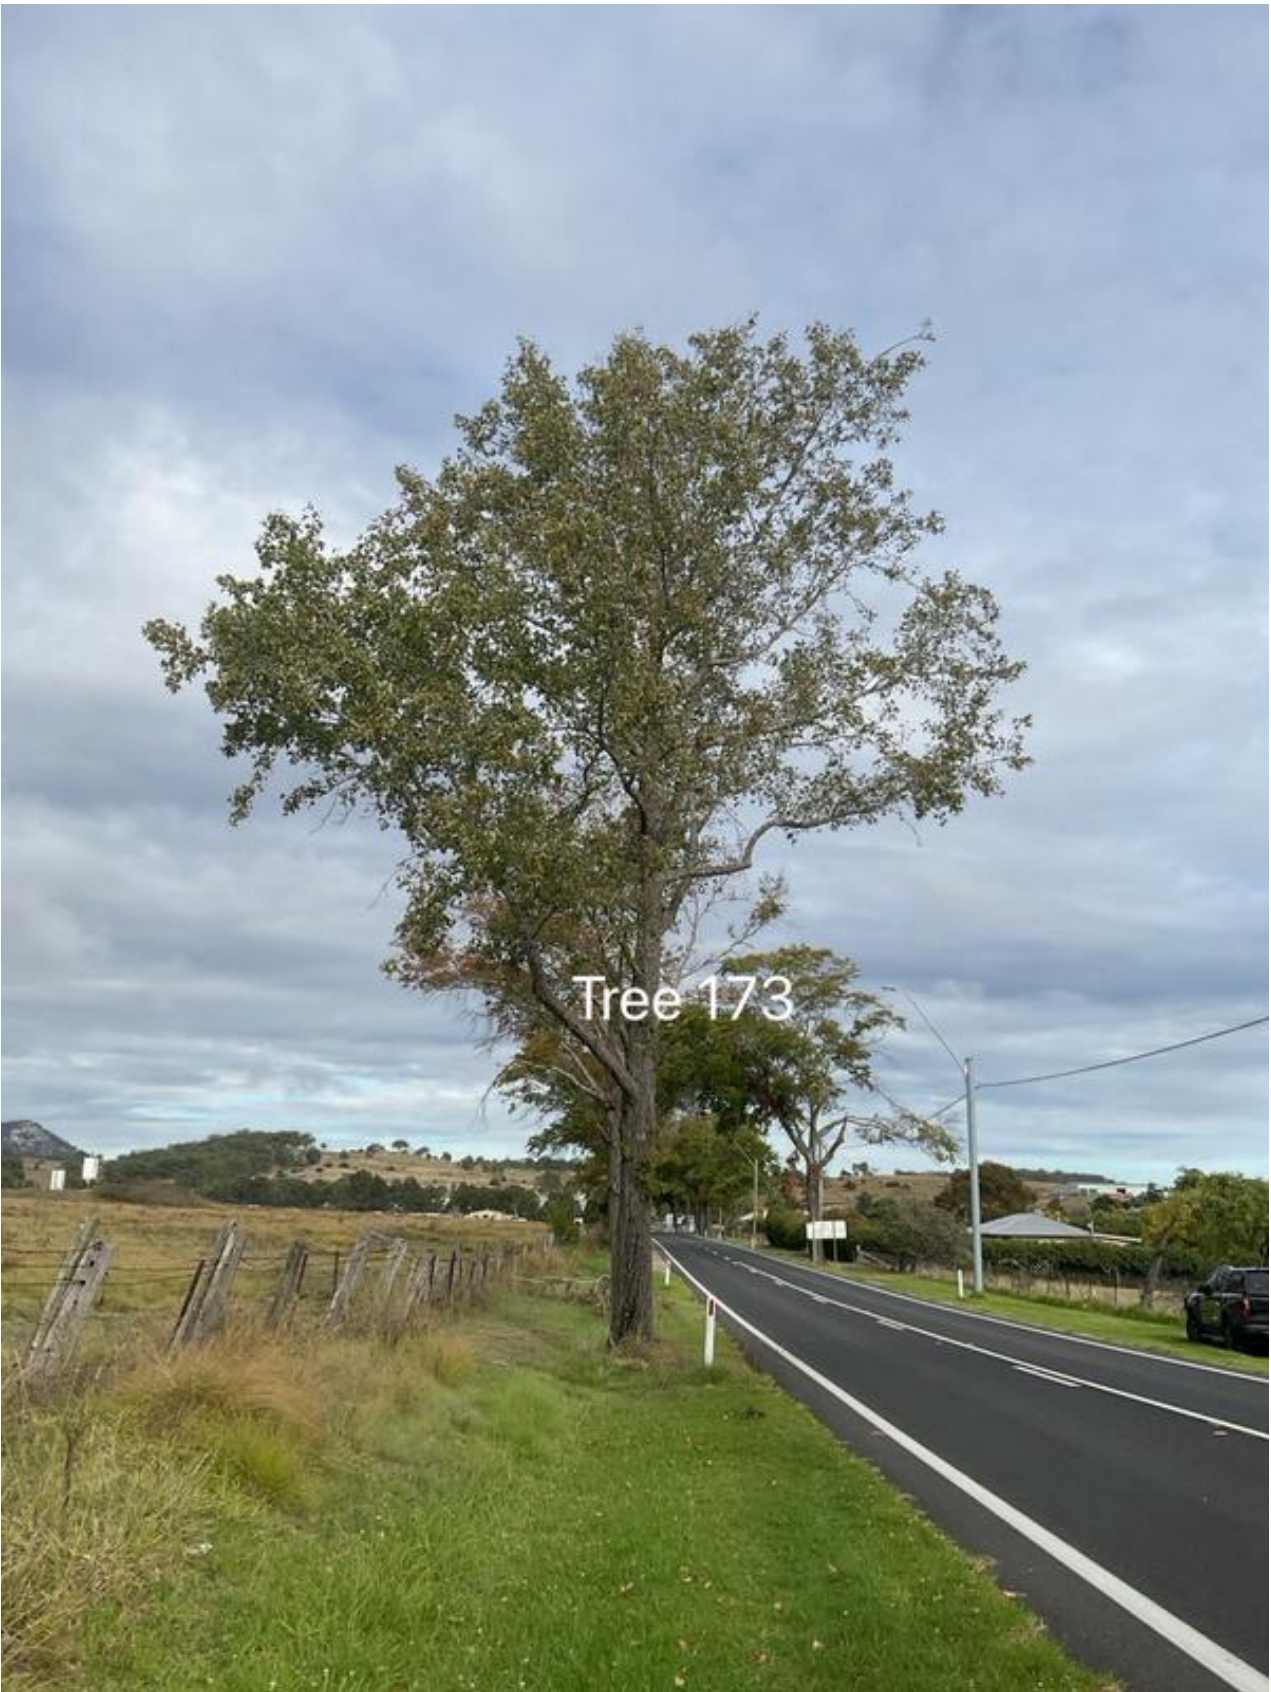
Photo 3

10 High - Failure likely especially during storms but low potential for injury/property damage

This tree is in a stressed condition. It has thinning in the canopy and has lost several limbs in a recent storm event. It has a large dead limb present that hangs over the highway making the tree dangerous. However, it may be suitable for retention in the short term with some remedial works.

Remove the dead limb from the crown. Prune the broken limb stubs. Remove the epicormic growth. Monitor the tree for changes in health and structure.

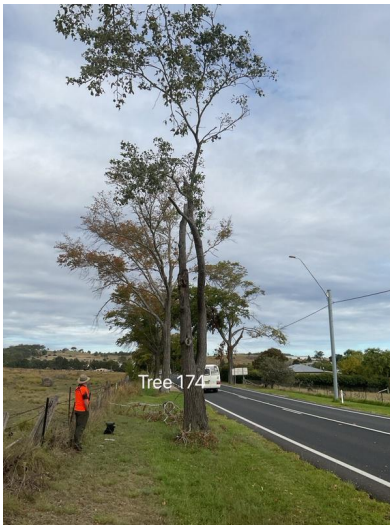
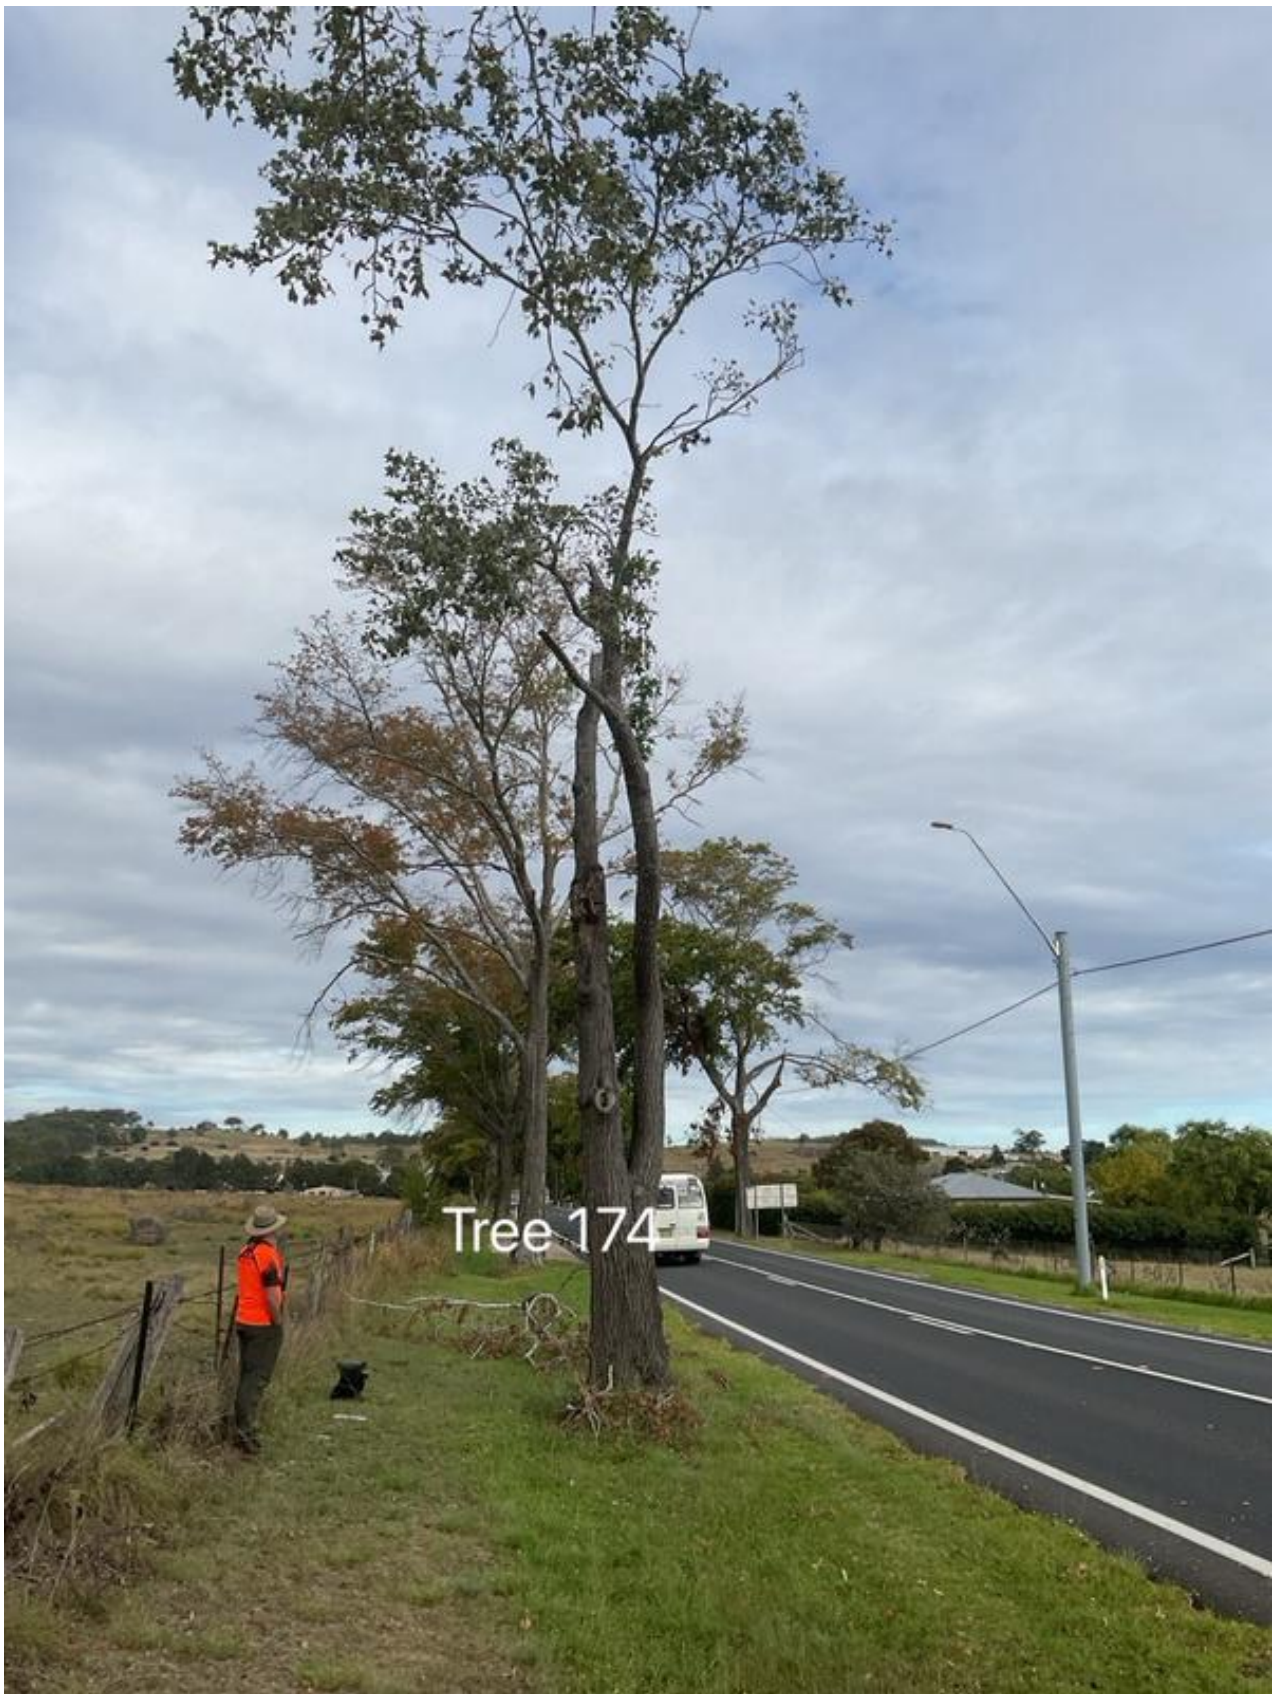
Photo 4

8 Moderate - Failure unlikely and/or high risk of failure but low risk of property damage/personal injury

This tree has been severely damaged in a recent storm event. The tree is no longer suitable for retention.

Remove the tree and grind the stump.

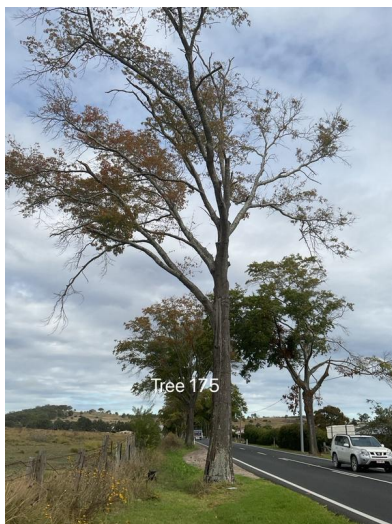
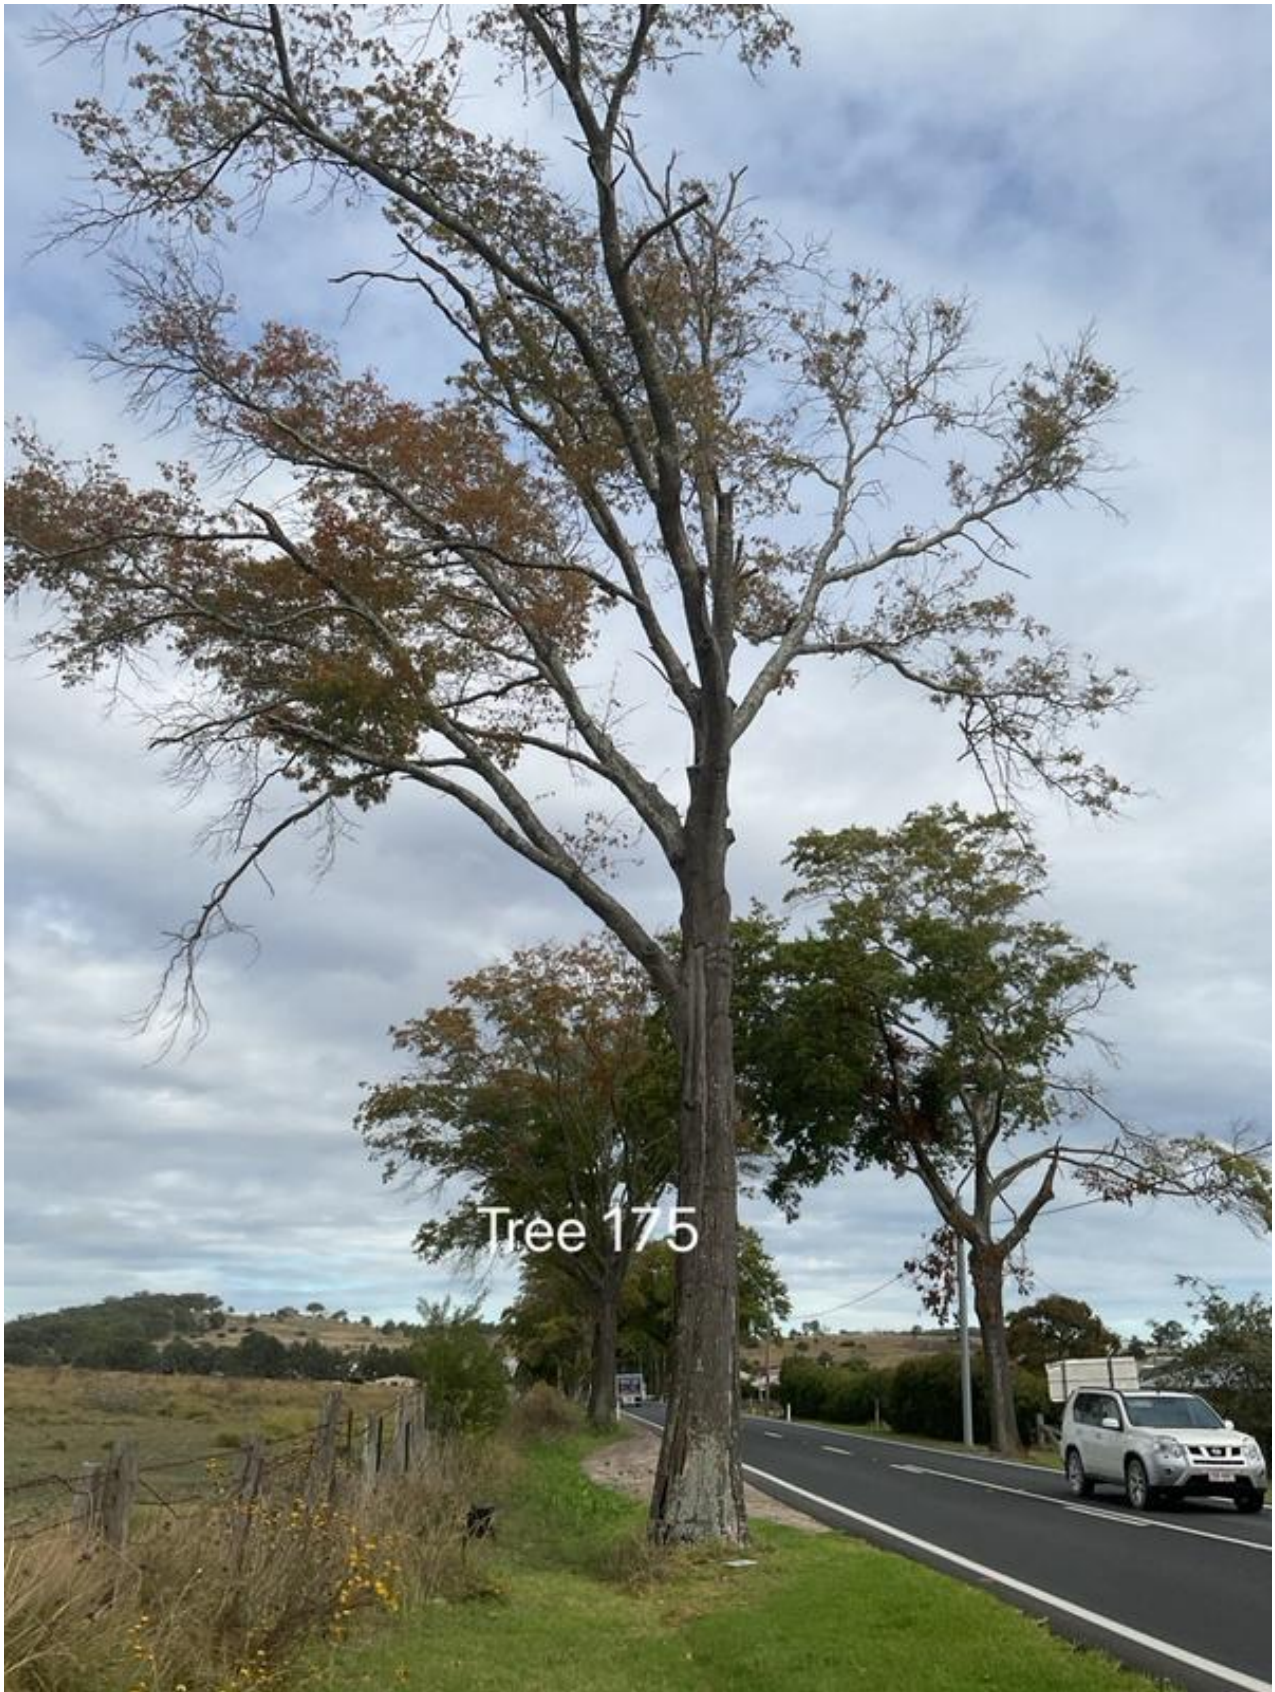
Photo 5

This tree is in severe decline. The tree is unstable and dangerous and should be removed as soon as possible.

Remove the tree and grind the stump.

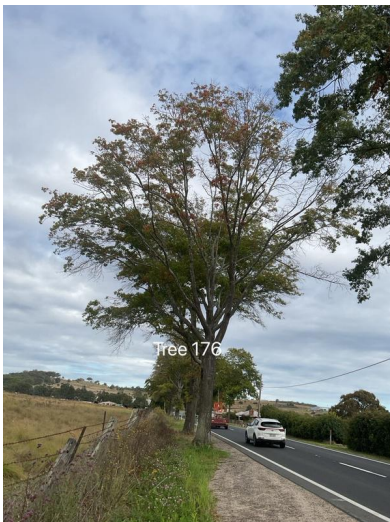
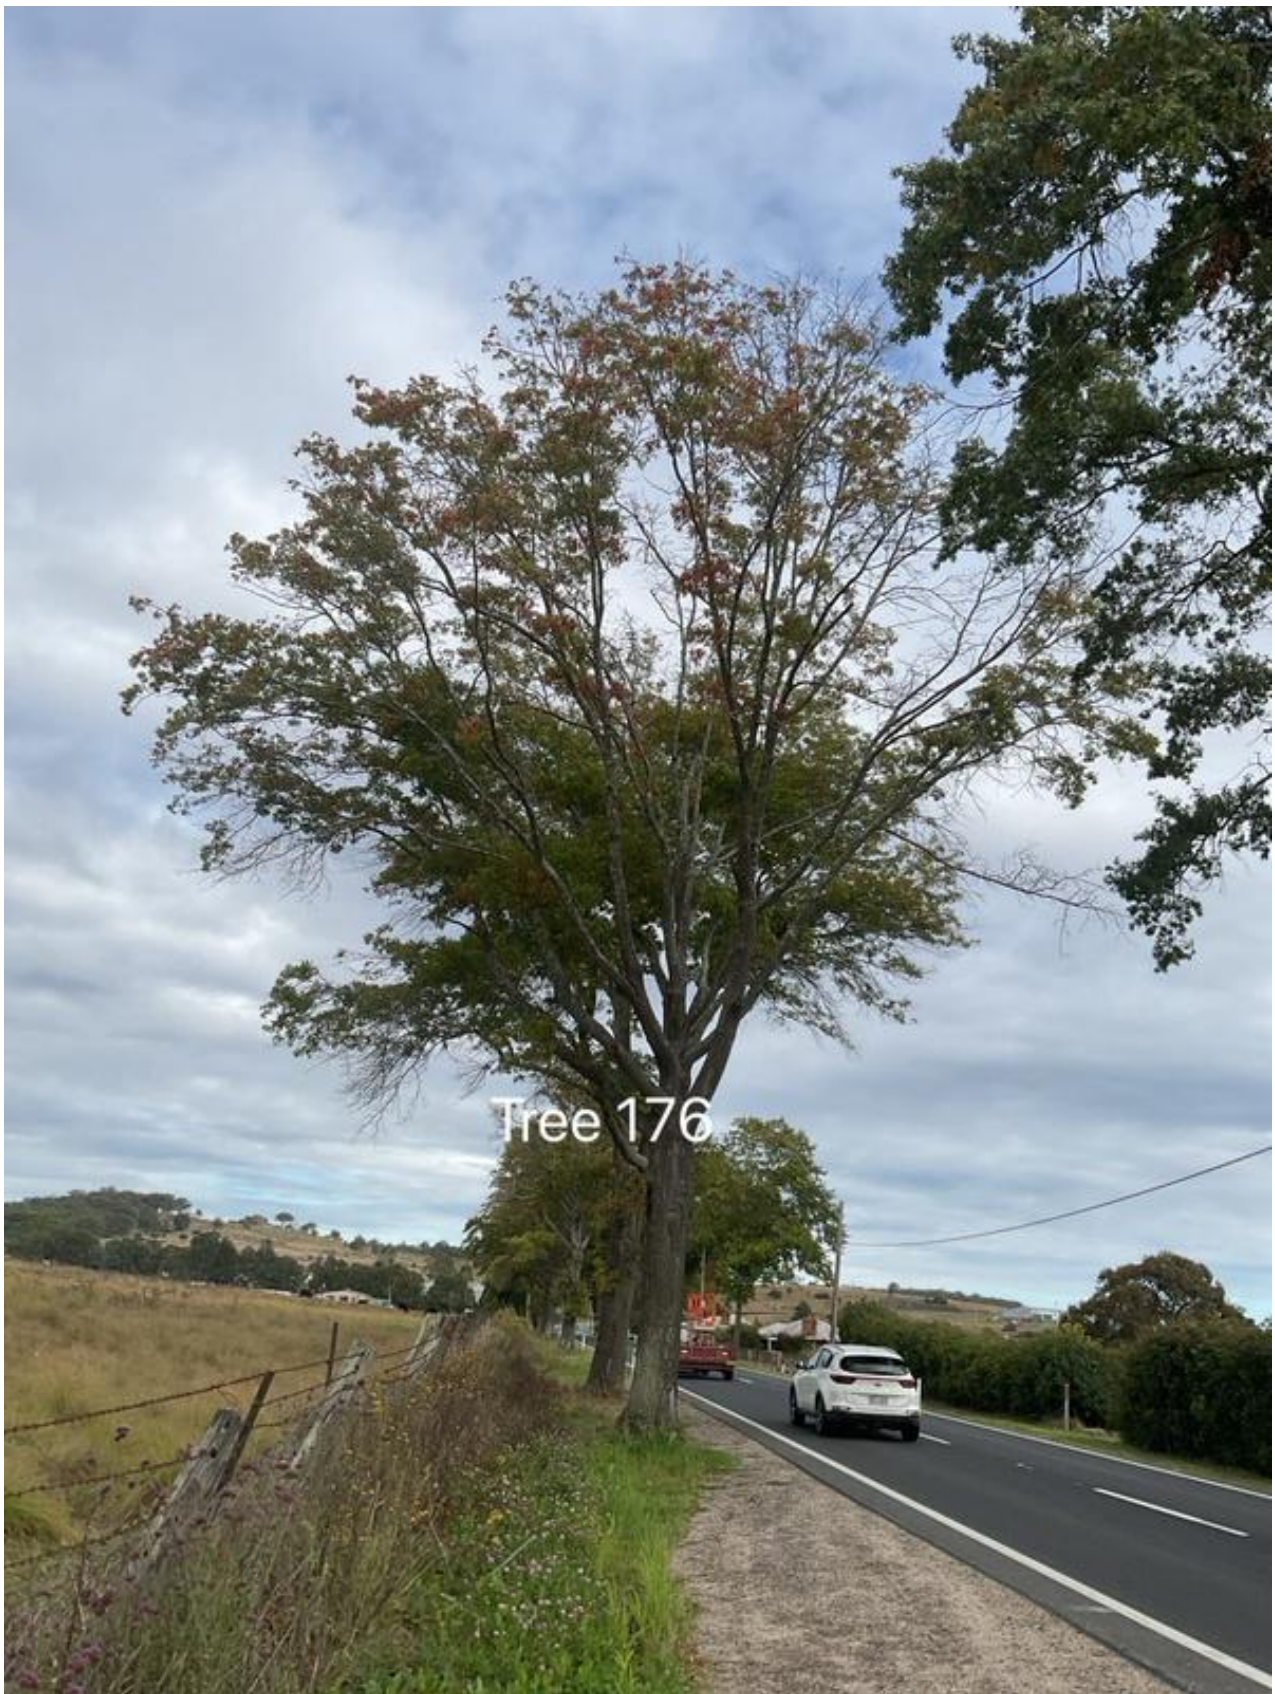
Photo 6

12 High - Failure likely especially during storms but high potential for injury/property damage

This tree is in serious decline. It has a large amount of deadwood present in the crown. The tree has very low foliage coverage and is significantly infected with

Armillaria and/or Phytophthora.
The tree is dangerous and unstable and should be removed as soon as possible.

Remove the tree and grind the stump.

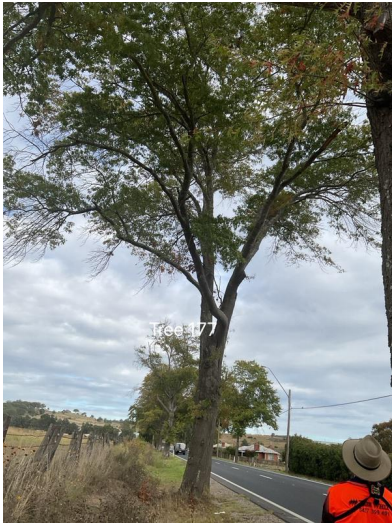
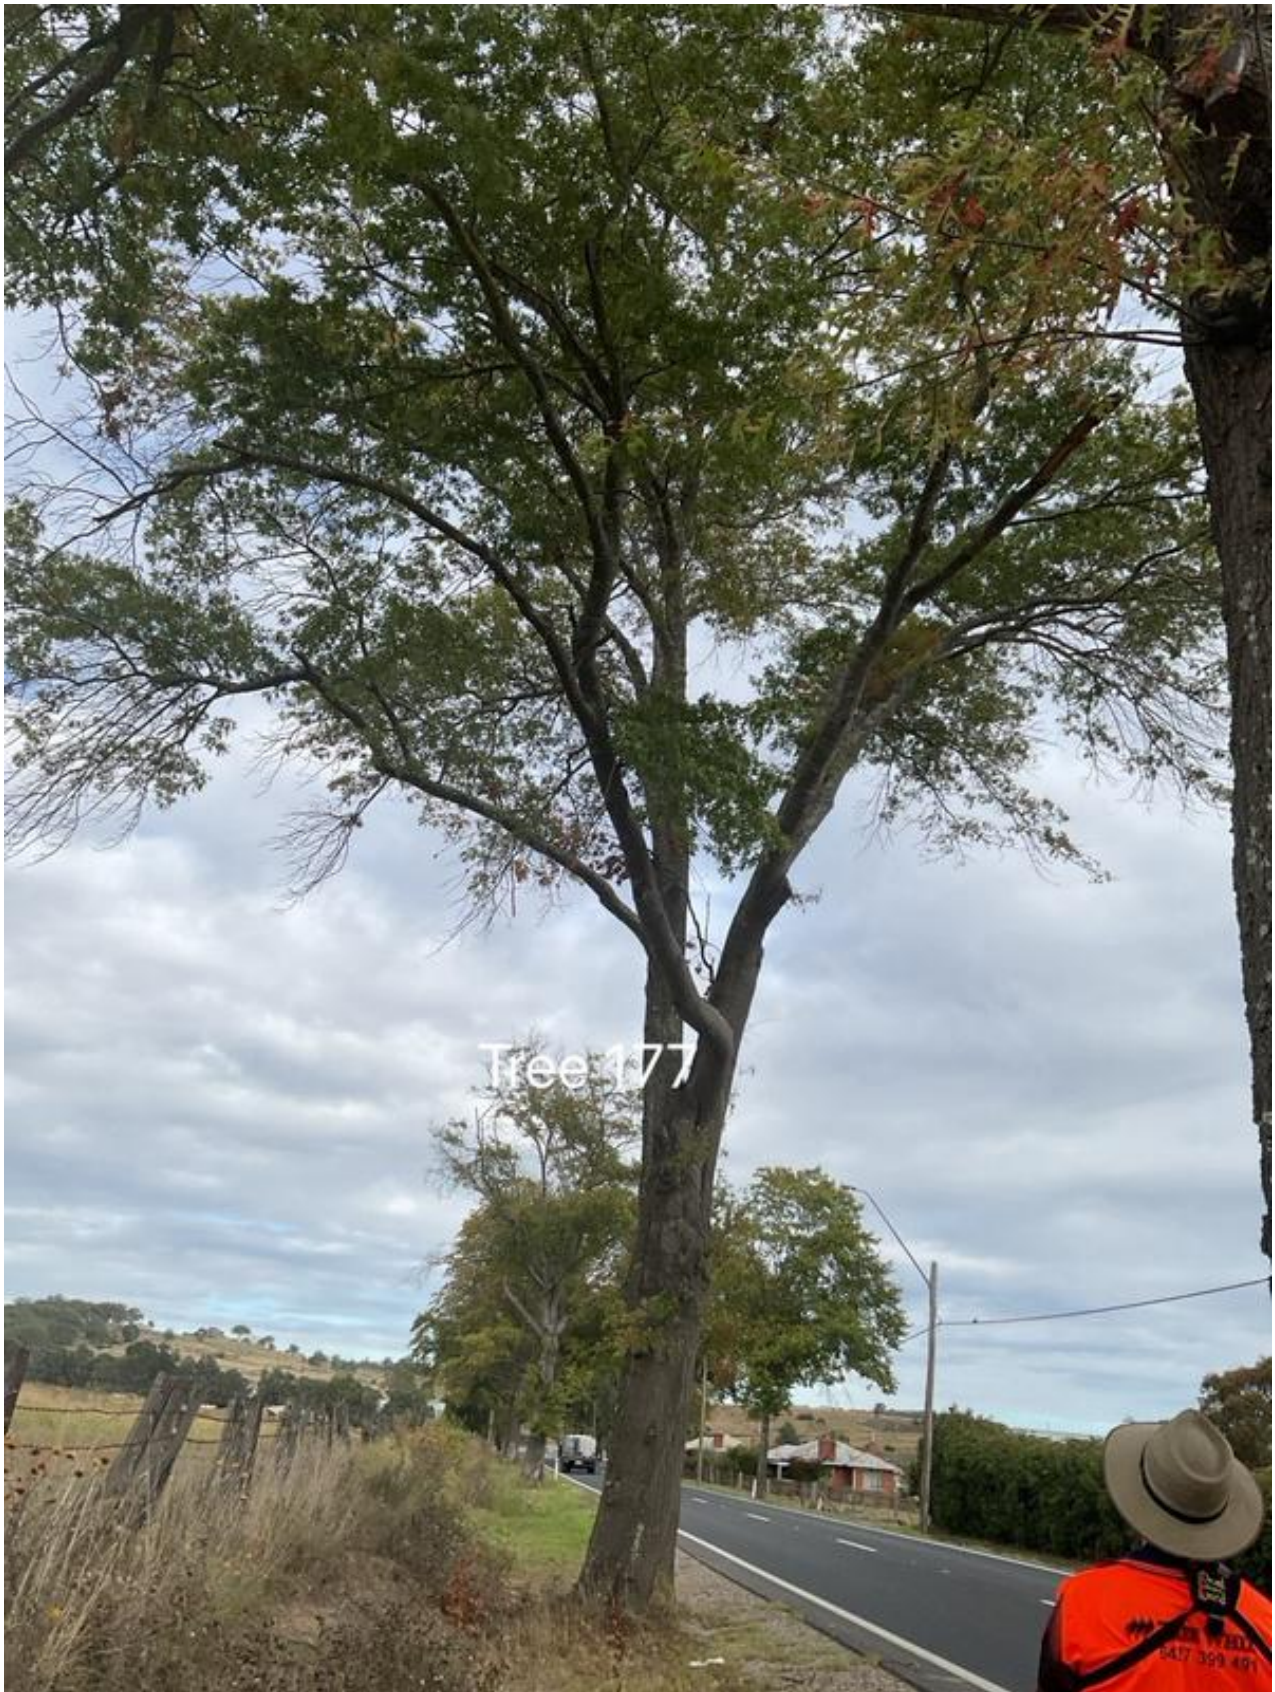
Photo 7

10 High - Failure likely especially during storms but low potential for injury/property damage

This tree is in a stressed condition. It has a thinning canopy with dieback present and significant deadwood throughout the canopy. The tree has lost large limbs in recent storm events. There is a hanging limb present in the crown and there is some epicormic growth present on the trunk. There are two holes that have been drilled in the tree, one approximately 30 cm from the ground and one approximately 80cm from the ground. The holes are about 19mm in diameter. They should not have been drilled in the tree and may have contributed to the decline. However, with remedial work this tree may be retainable in the short term.

Remove the deadwood and the hanging limb. Monitor the tree for changes in health and structure.

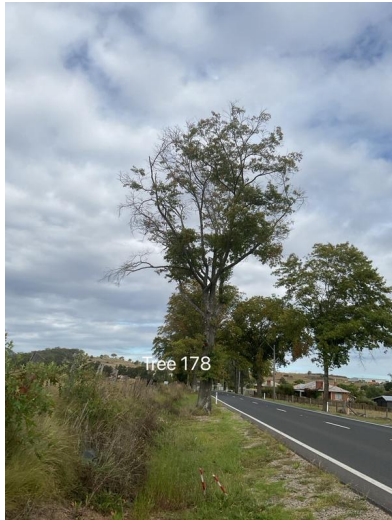
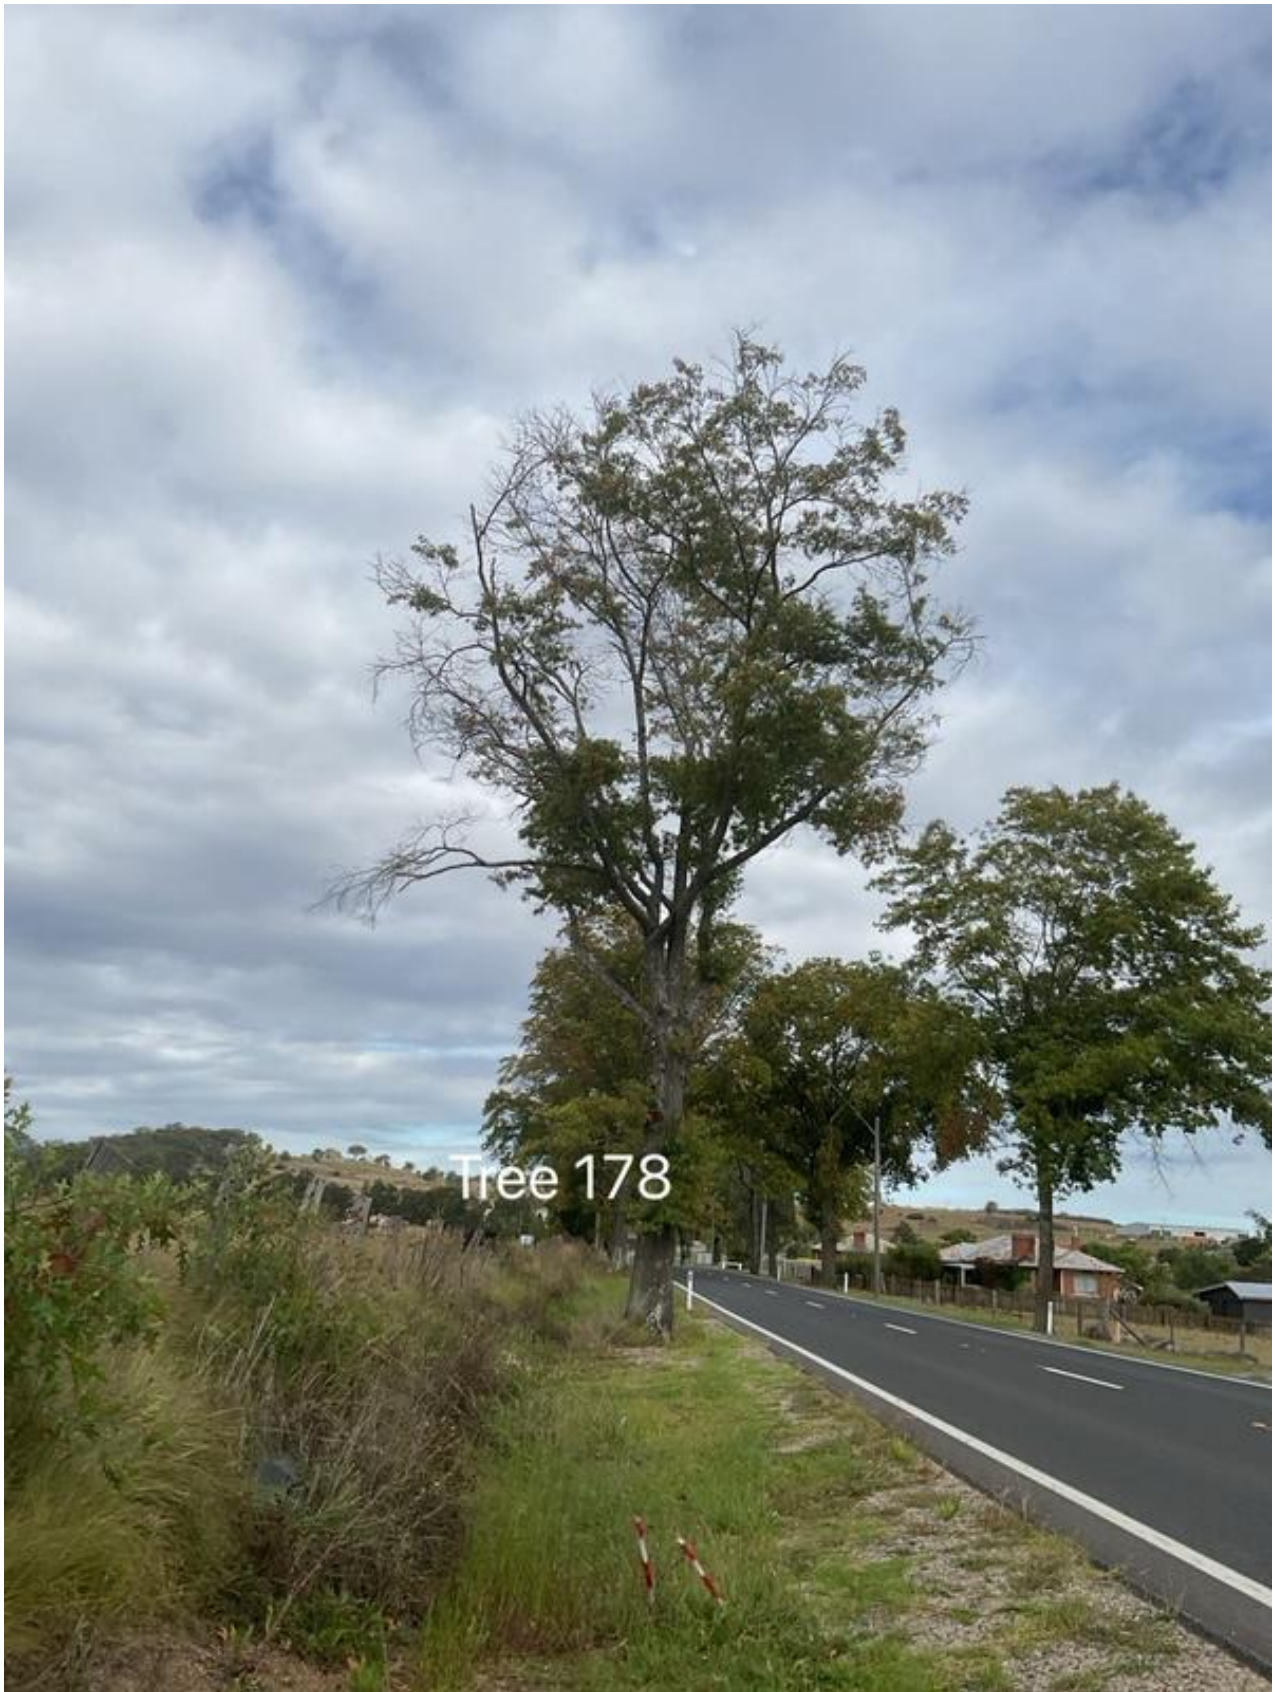
Photo 8

12 High - Failure likely especially during storms but high potential for injury/property damage

This tree is in significant decline. It is in the late stages of Armillaria and/or Phytophthora infection. It also has significant root crown rot and a large amount of deadwood in the crown. The tree will be unstable and is unsuitable for retention.

Remove the tree and grind the stump.

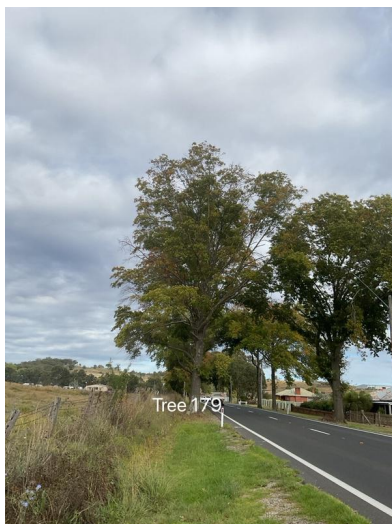
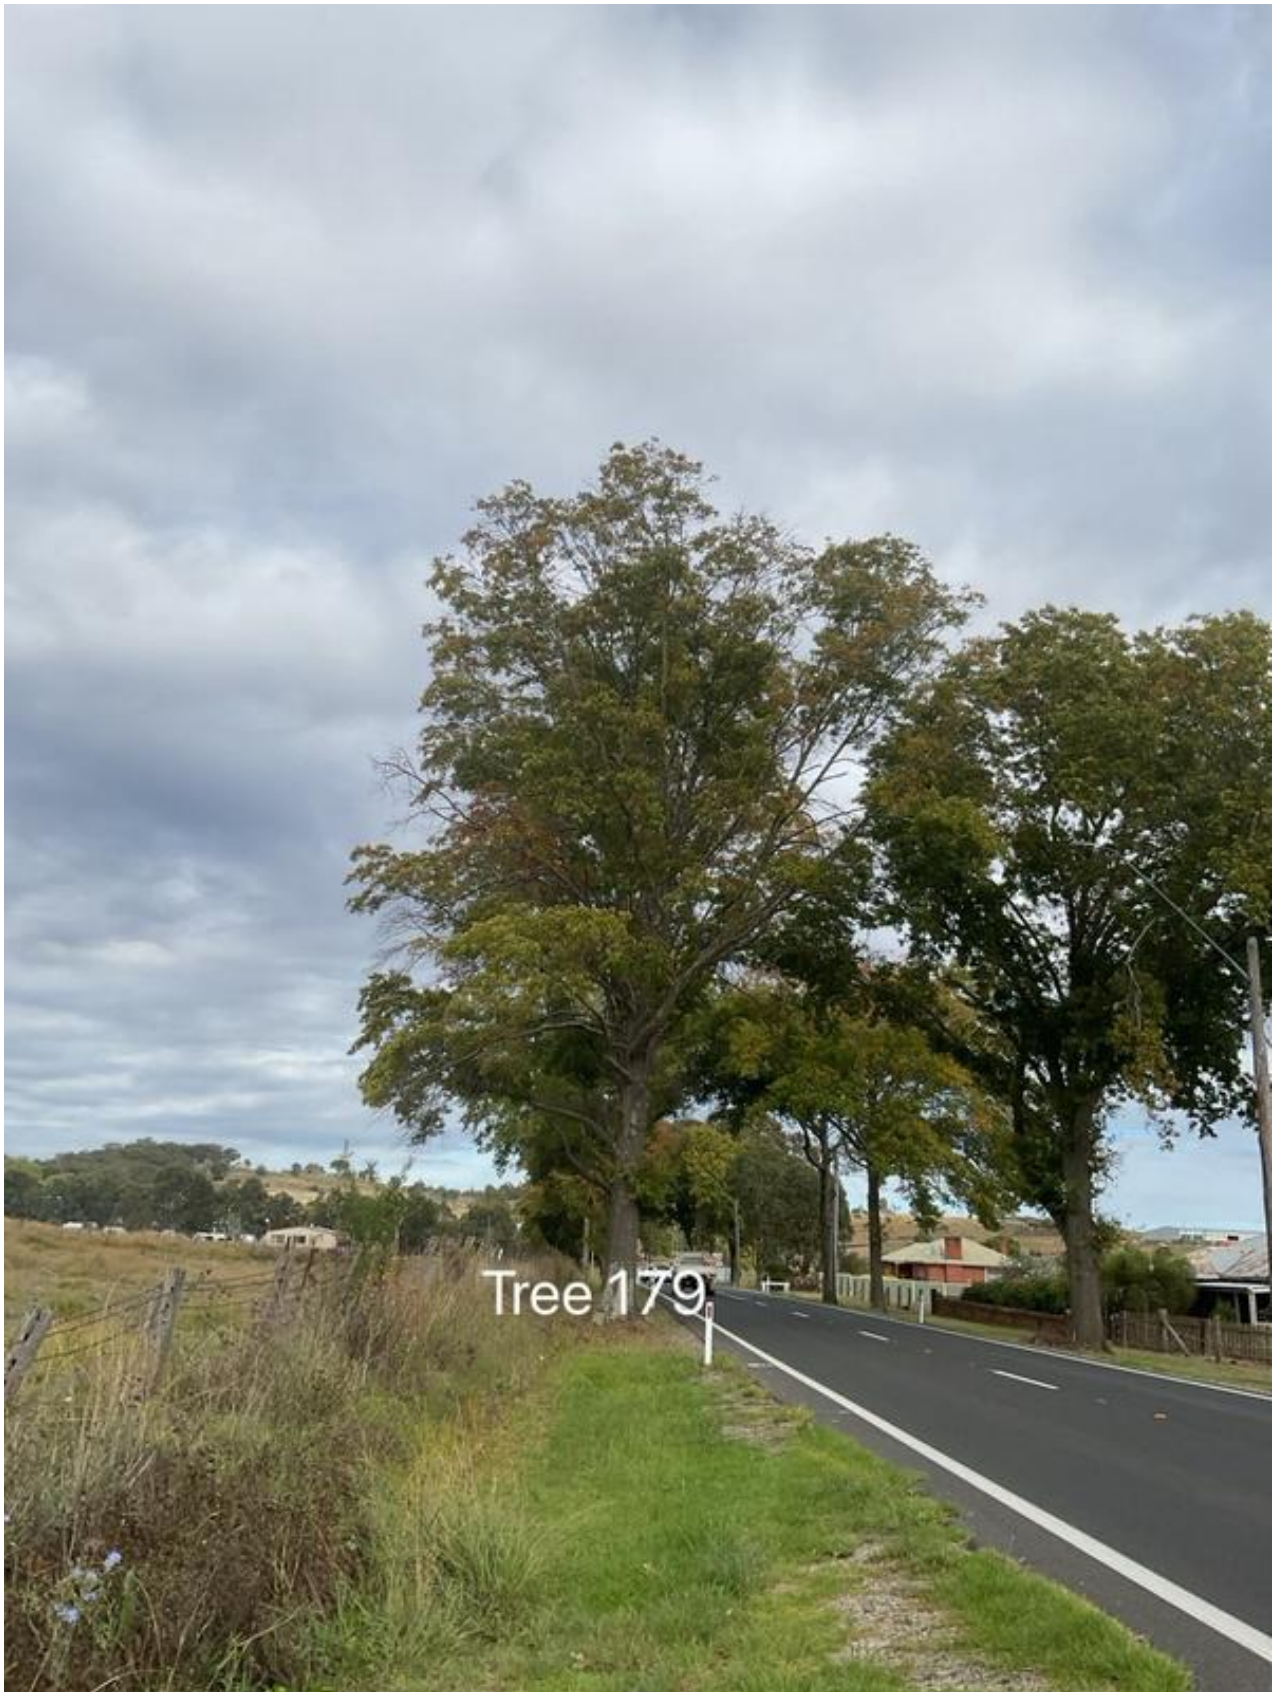
Photo 9

This tree has a very large number of large dead limbs present in the crown. The tree is in significant decline. It is unstable and unsuitable for attention.

Remove the tree and grind stump.

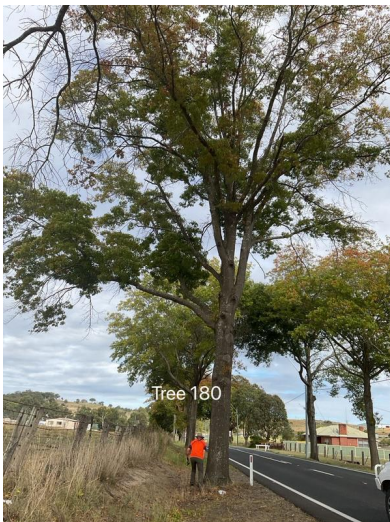
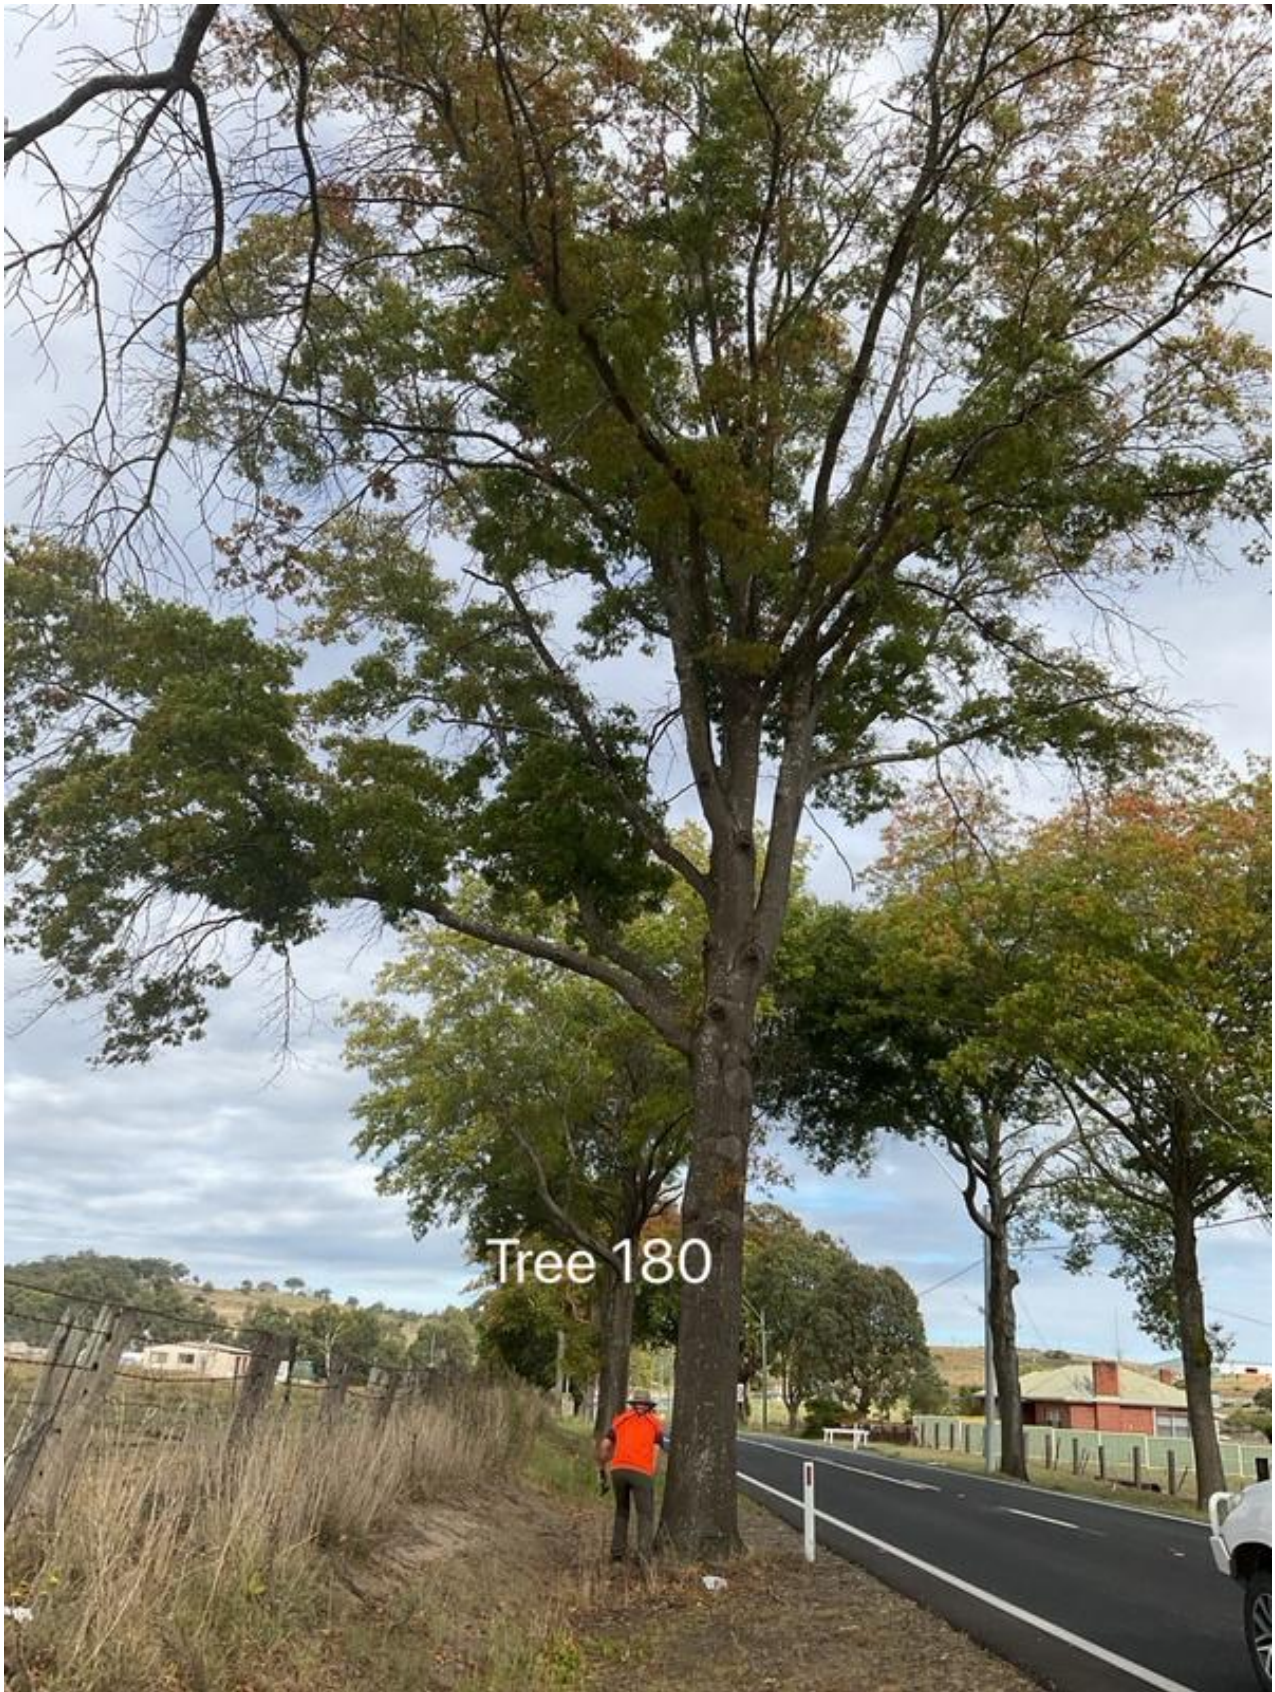
Photo 10

12 High - Failure likely especially during storms but high potential for injury/property damage

This tree is in decline. It has a thinning canopy with dieback and significant deadwood present in the crown. The tree is showing signs of Armillaria and/or

Phytophthora infection. There is also root crown rot present. Given the history of this species in this area, the tree cannot be considered safe for retention in this high traffic area.

Remove the tree and grind the stump.

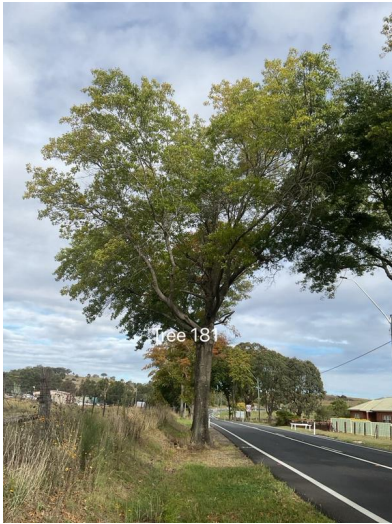
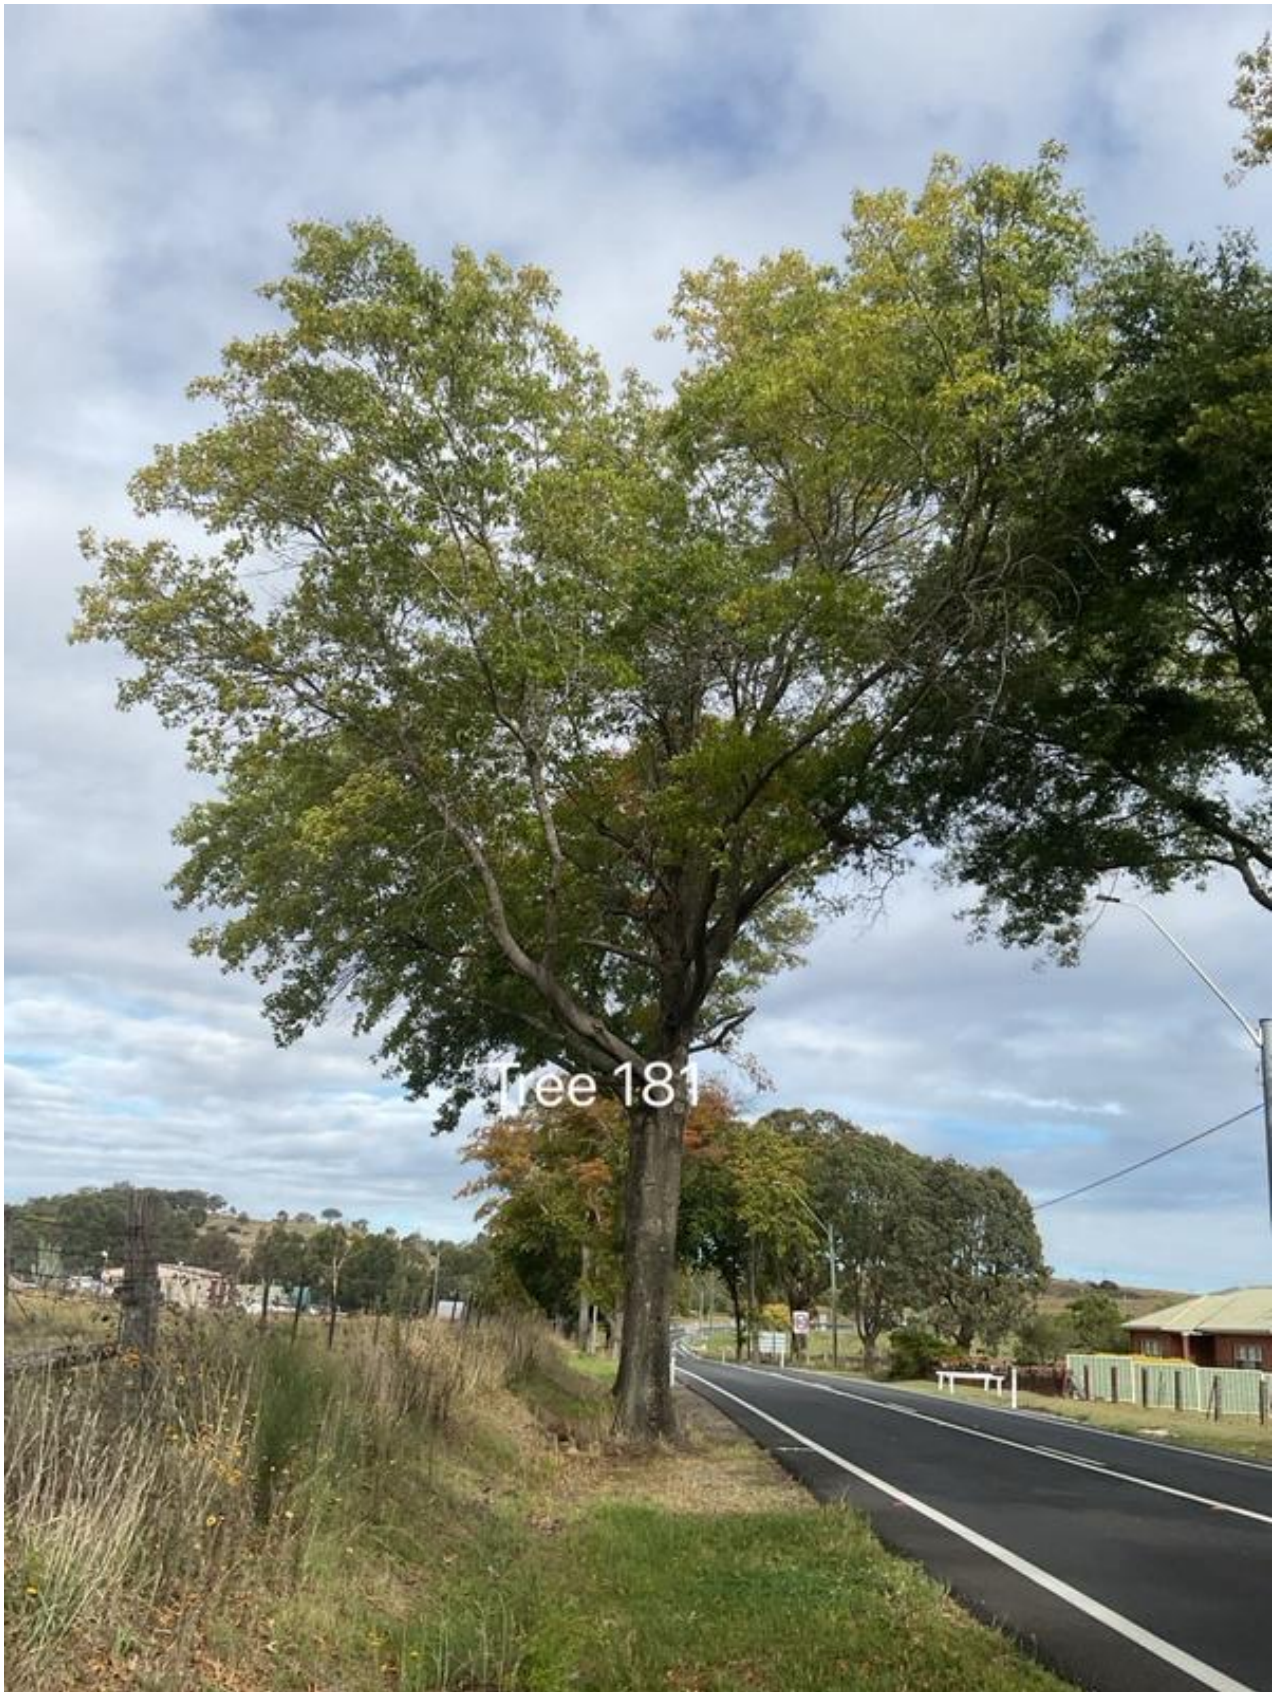
Photo 11

12 High - Failure likely especially during storms but high potential for injury/property damage

This tree is in fair condition. It has some deadwood present in the crown and yellowing in the foliage. There is dieback present in the upper canopy. There is significant decay present in the main leader approximately halfway up the tree. This will make the tree unstable and unsuitable for retention in this high traffic area.

Remove the tree and grind the stump.
