Tree Assessment Report - Tree Protection Zones

Cowper Street (between Pelham Street & New England Highway),
Tenterfield

Report 9 of 10 - Tree ID 173-188

03.03.2026 08:00 AEST

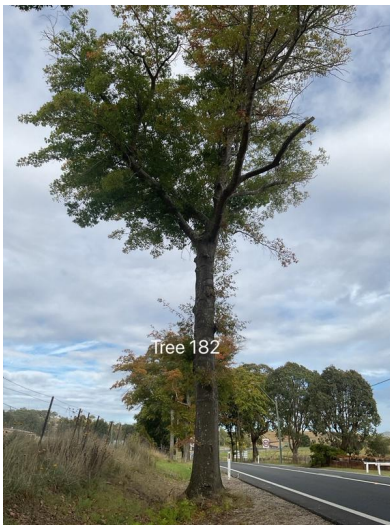
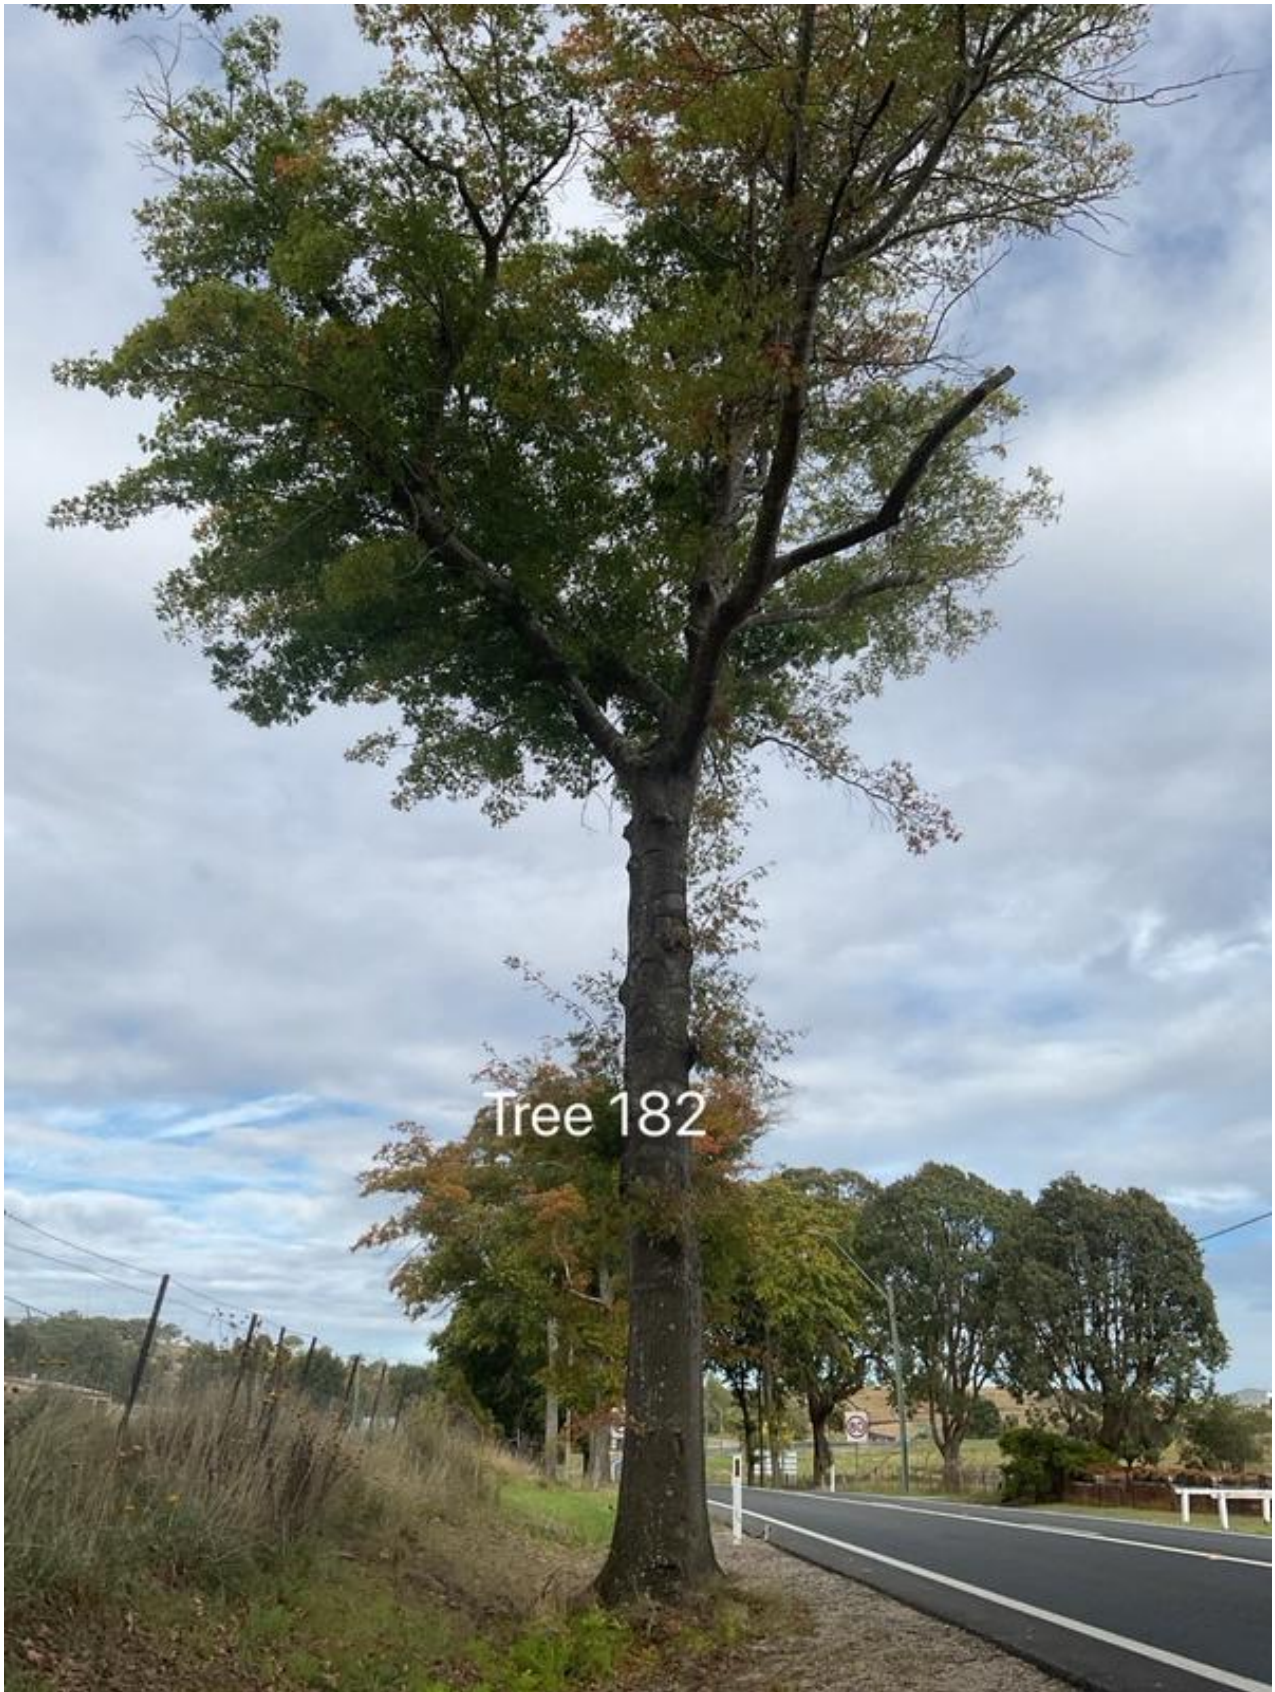
Photo 12

12 High - Failure likely especially during storms but high potential for injury/property damage

This tree is in poor condition. It has significant deadwood present in the crown, yellowing in the foliage in the upper canopy and dieback present in the crown. There is epicormic growth present on the trunk. The tree has several damaged dead limbs in the crown. If the the dead limbs and the deadwood are removed it will leave the tree with very poor form. This tree is not suitable for retention in a high traffic area.

Remove the tree and grind the stump.

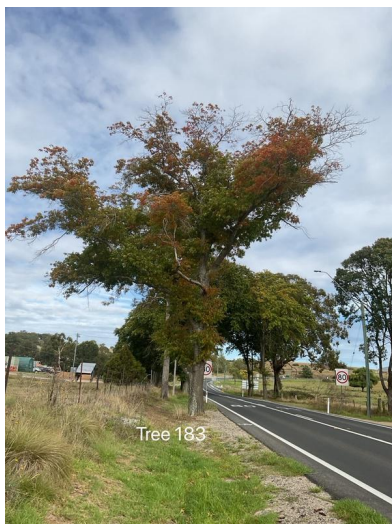
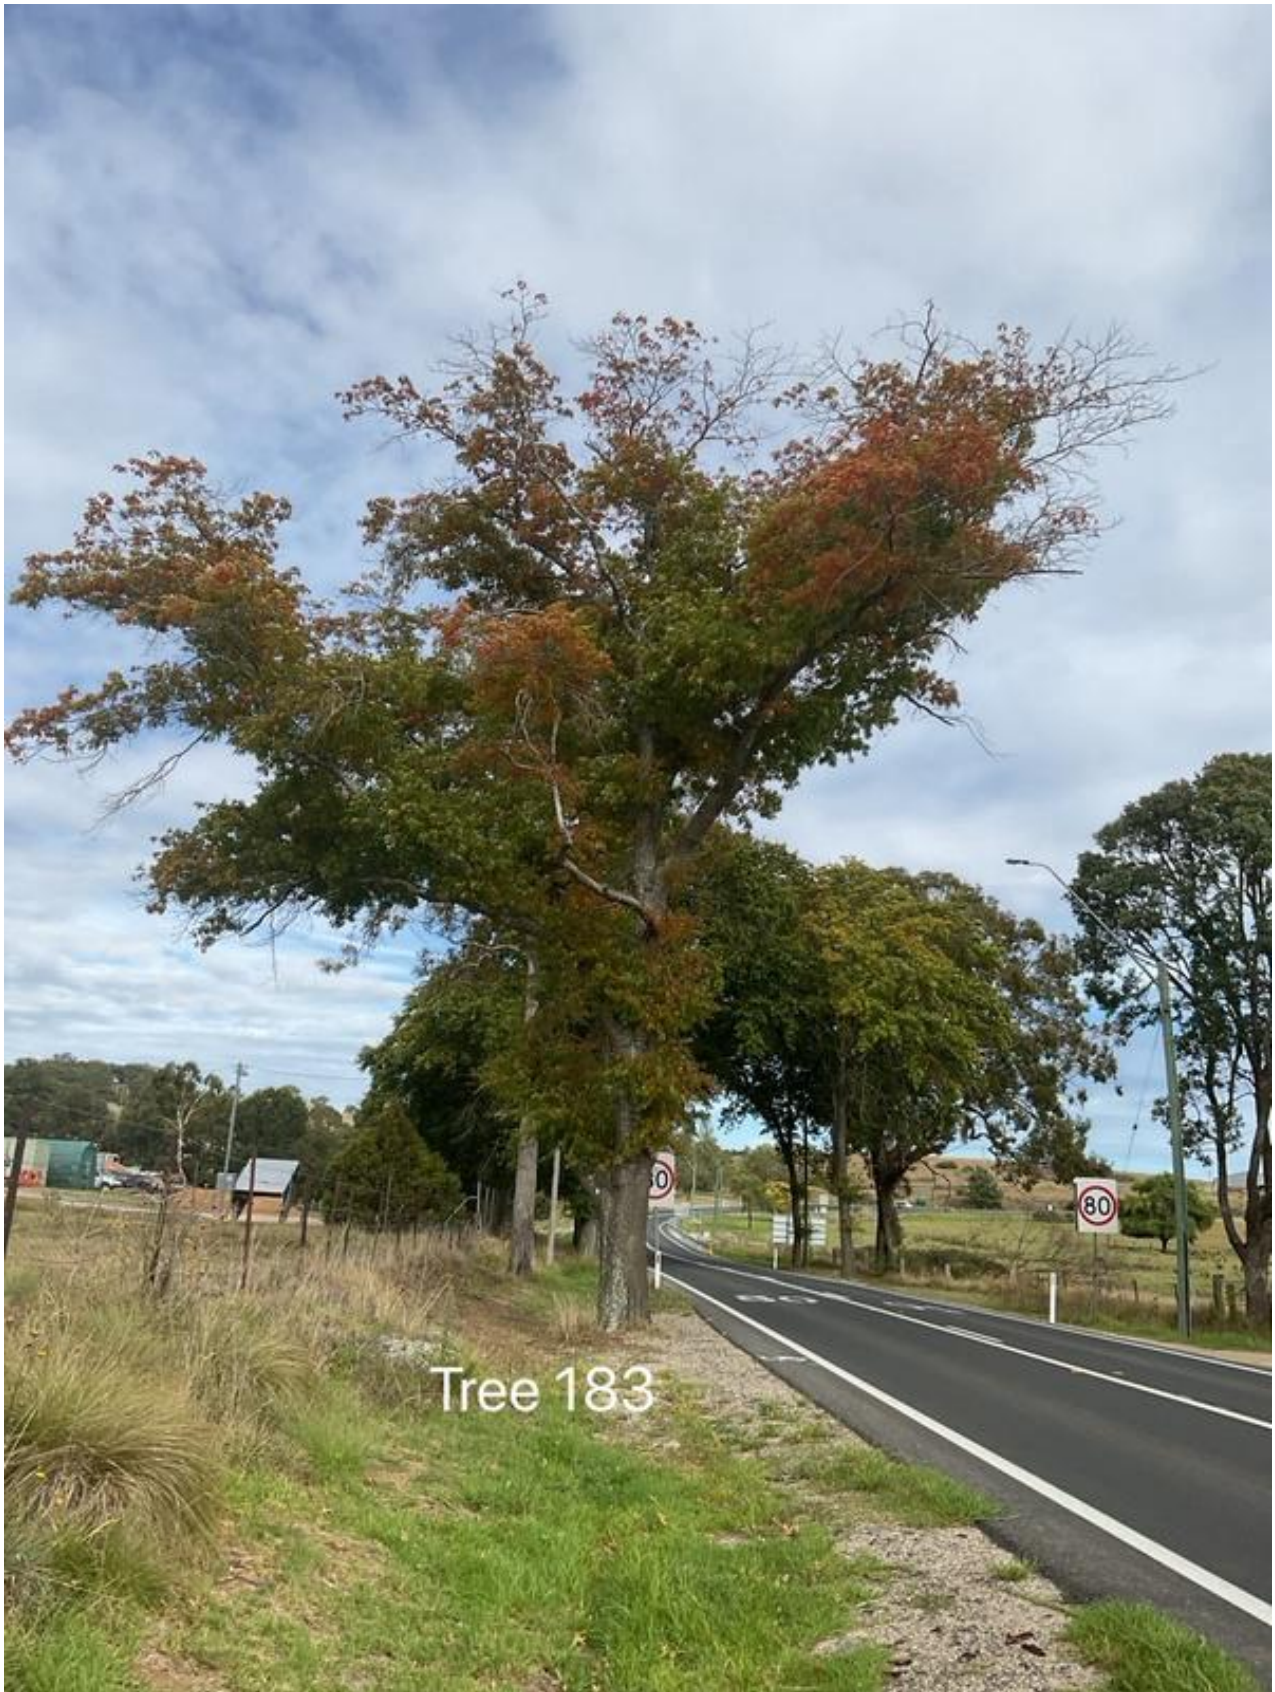
Photo 13

This tree is in fair condition. There is a significant amount of epicormic growth present on the trunk and on the leaders. This is a sure sign of vascular decline. The tree has a large amount of dieback in the outer canopy with

large dead limbs present. There is thinning of the foliage in the upper canopy and there is significant fungal infection present. This tree cannot be considered stable and safe for retention in such a high traffic area.

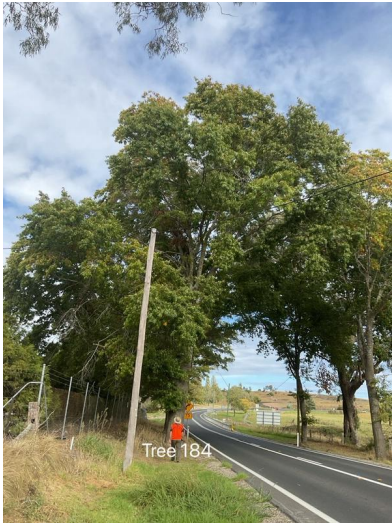
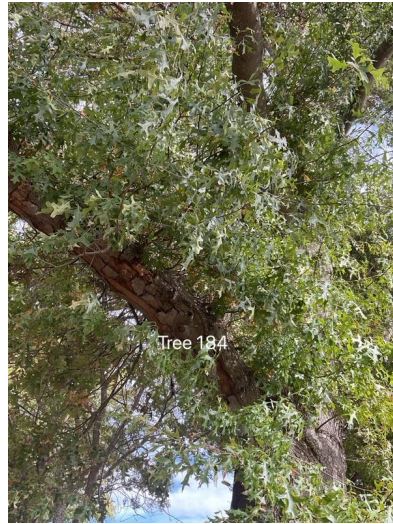
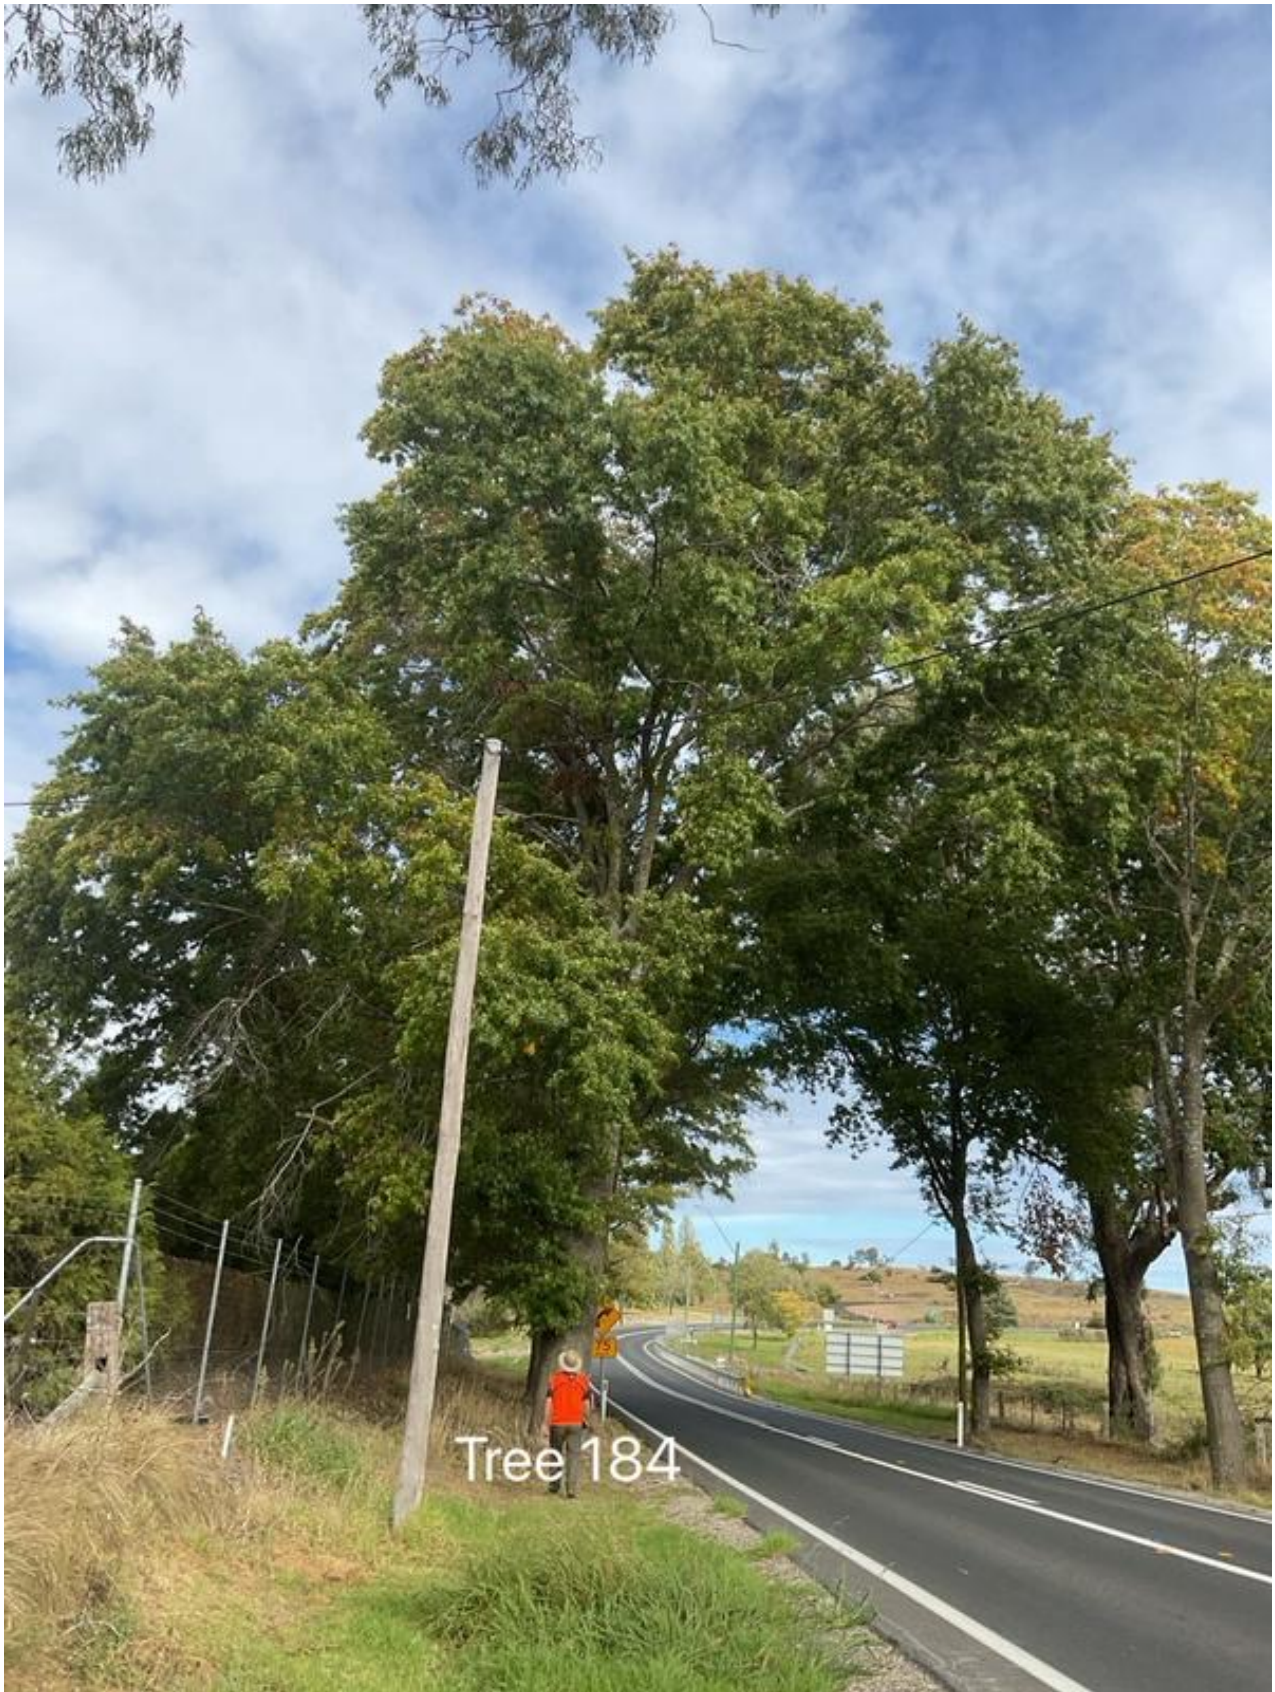
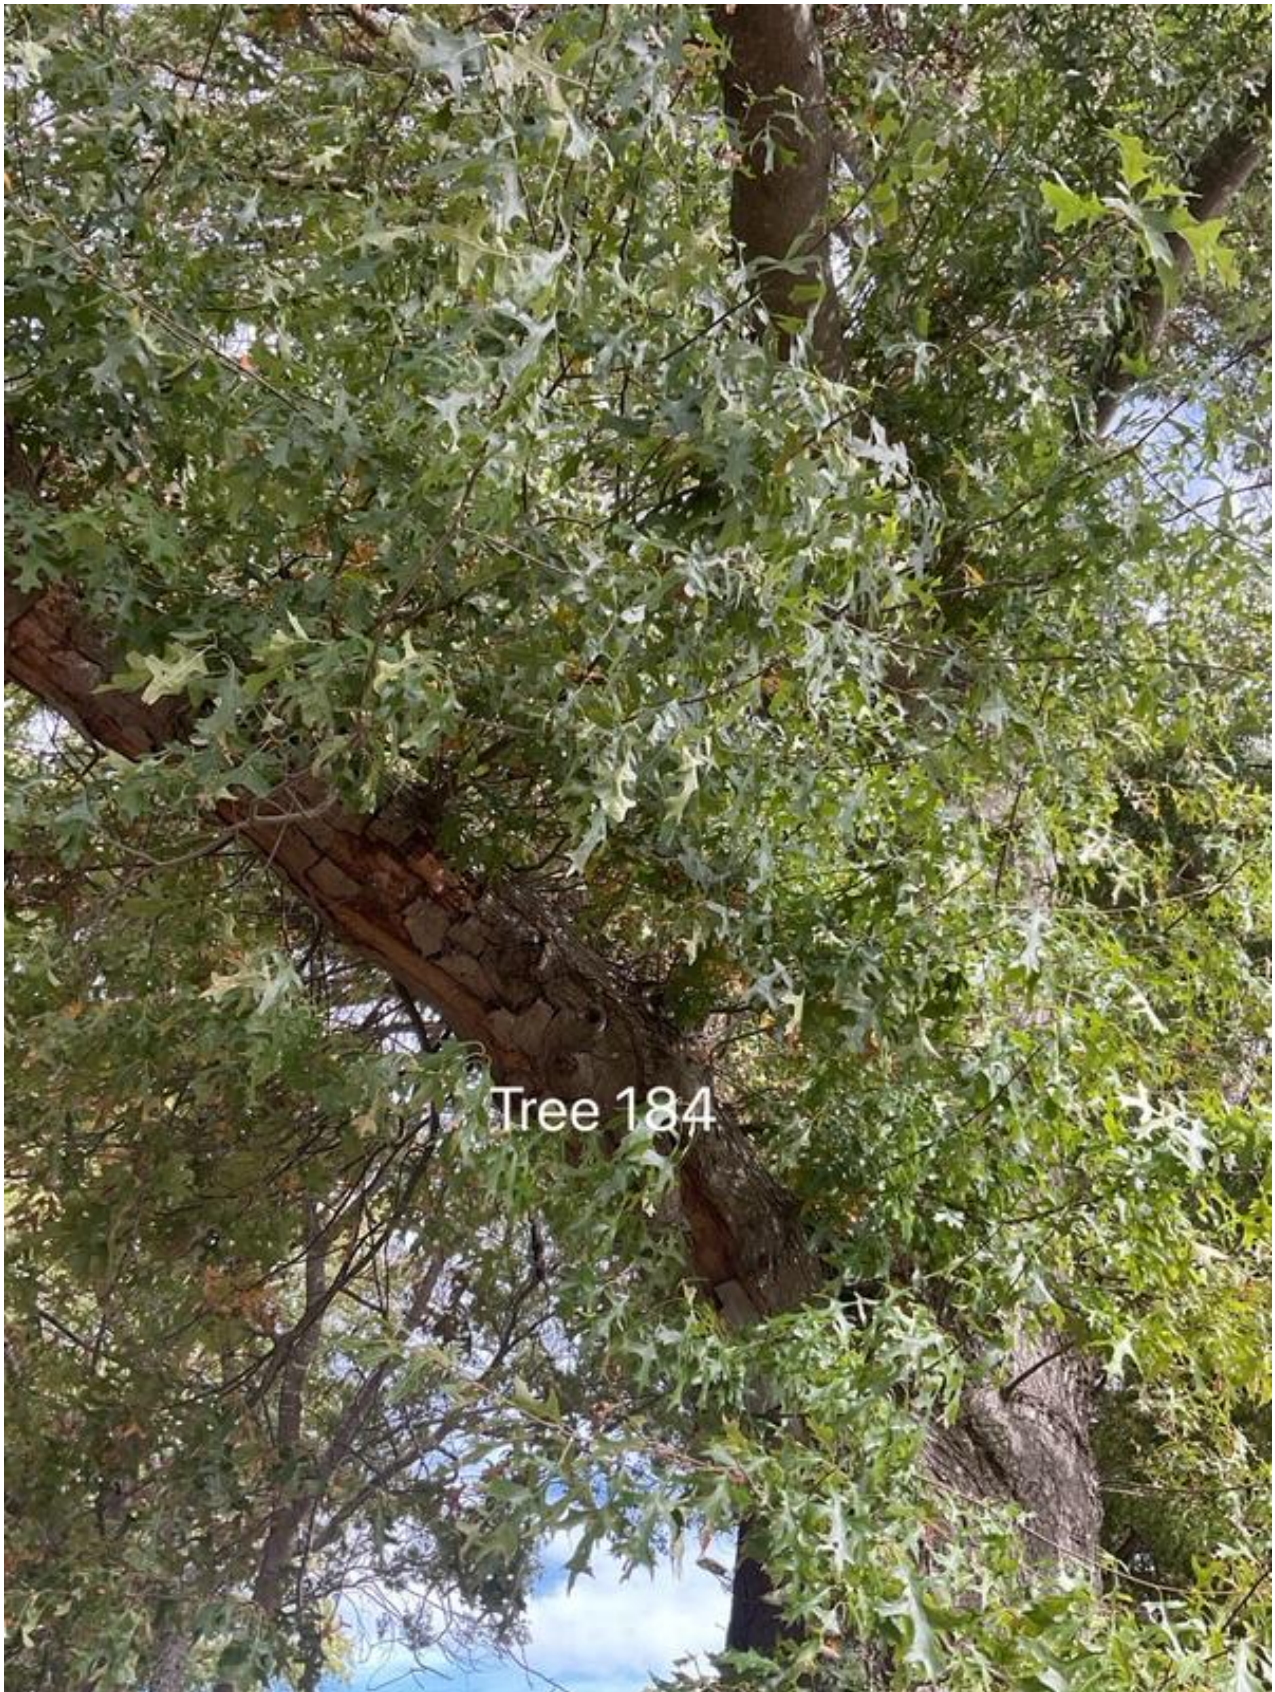
12 High - Failure likely especially during storms but high potential for injury/property damage

Despite the apparent healthy appearance, this tree has significant structural problems. There is large deadwood present throughout the crown. The tree has significant signs of fungal infection. The large lower lateral leader that grows over the property to the south has significant decay present and will need to be removed for safety reasons. If this limb is removed, along with many of the large limbs, back to the trunk of the tree - this would contribute further to the decline of the tree and allow fungal access to the interior of the tree. The tree has several broken limbs present from the recent storm event. Due to the damage and condition of the tree, it is not suitable for retention in such a high traffic area.

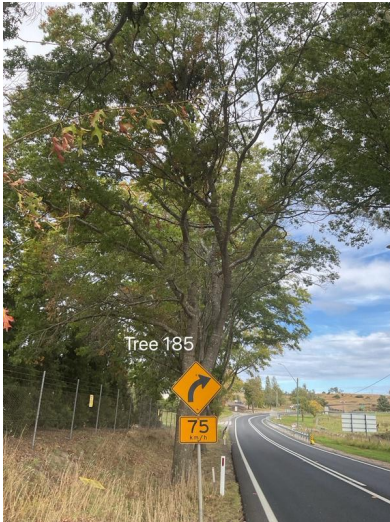
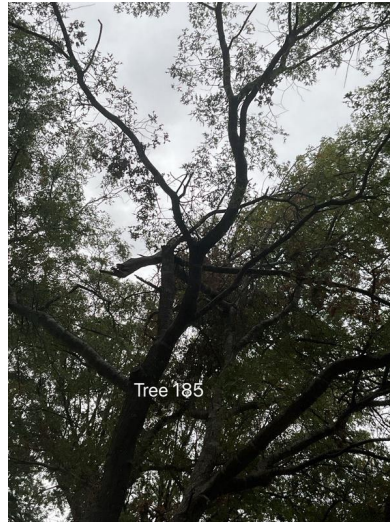
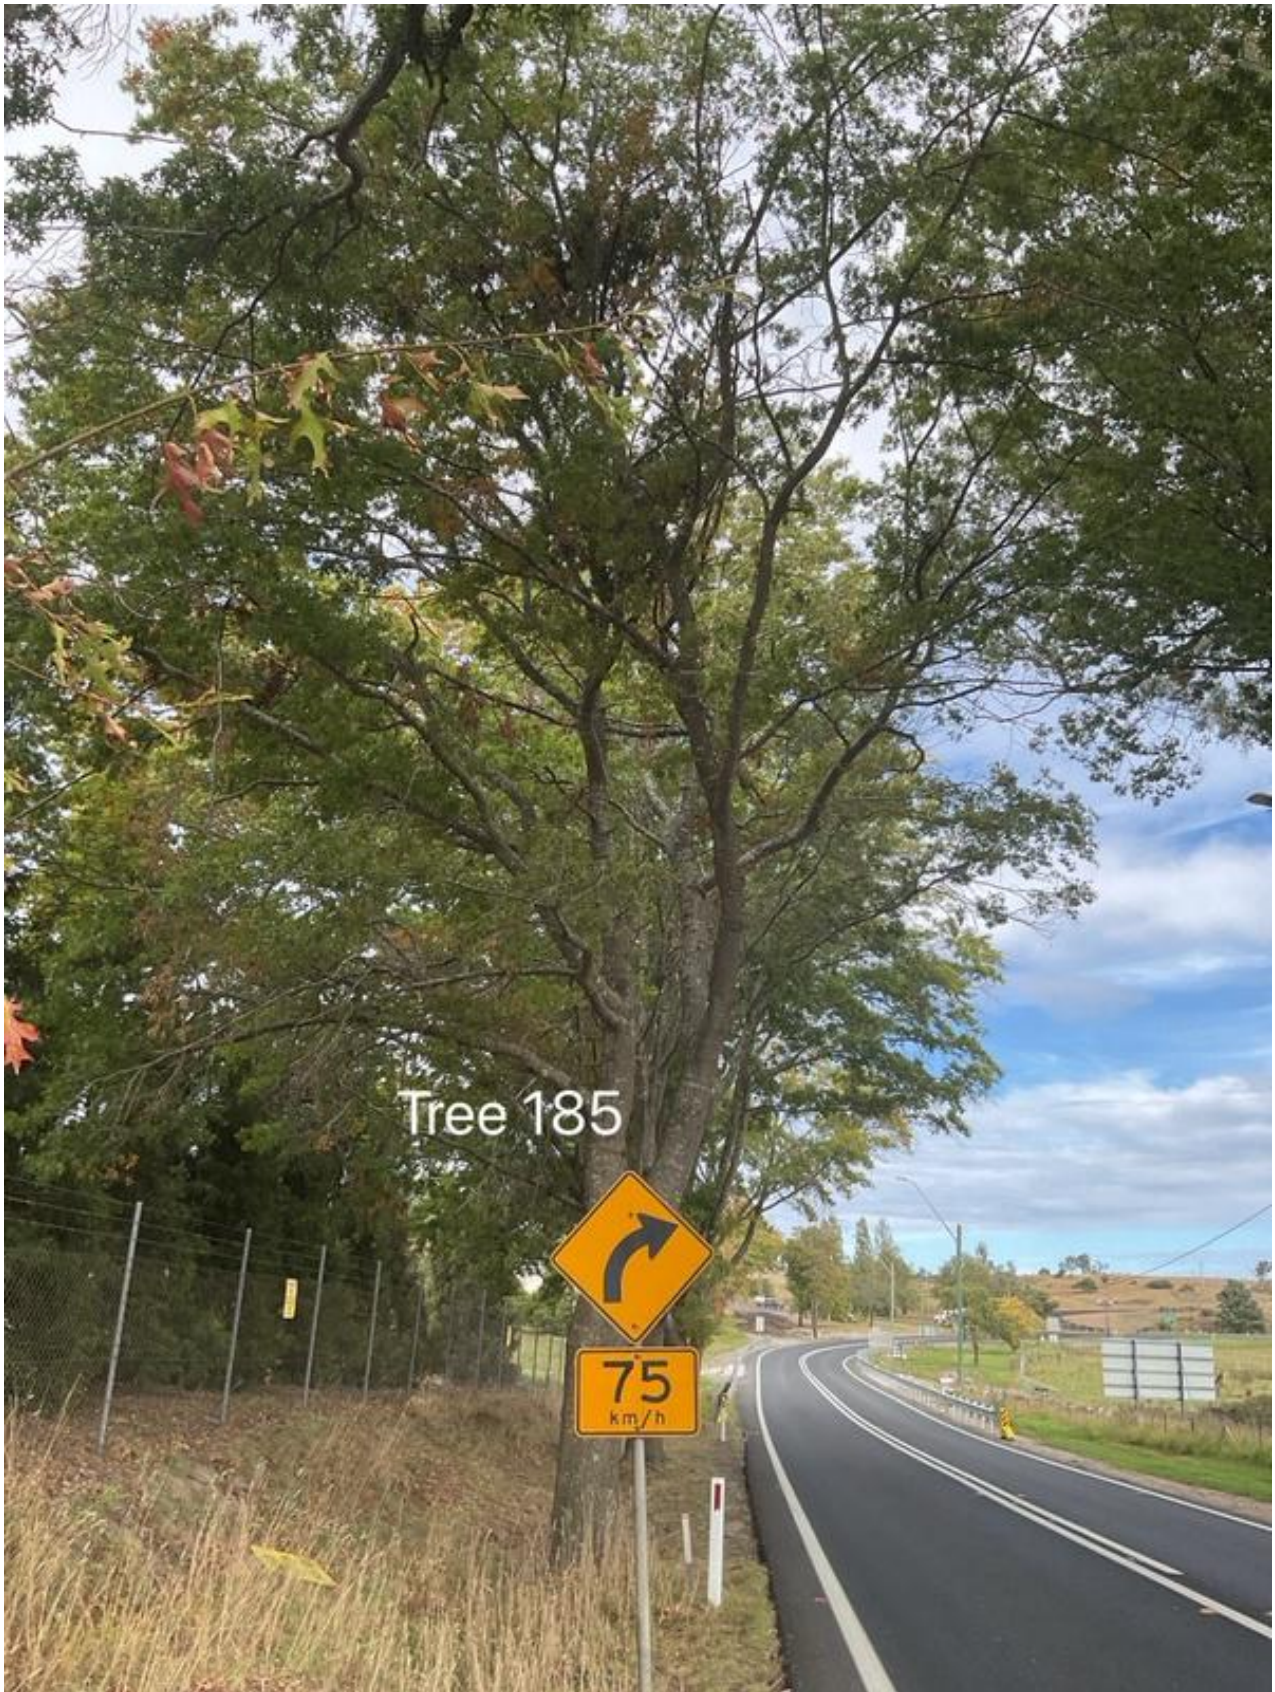
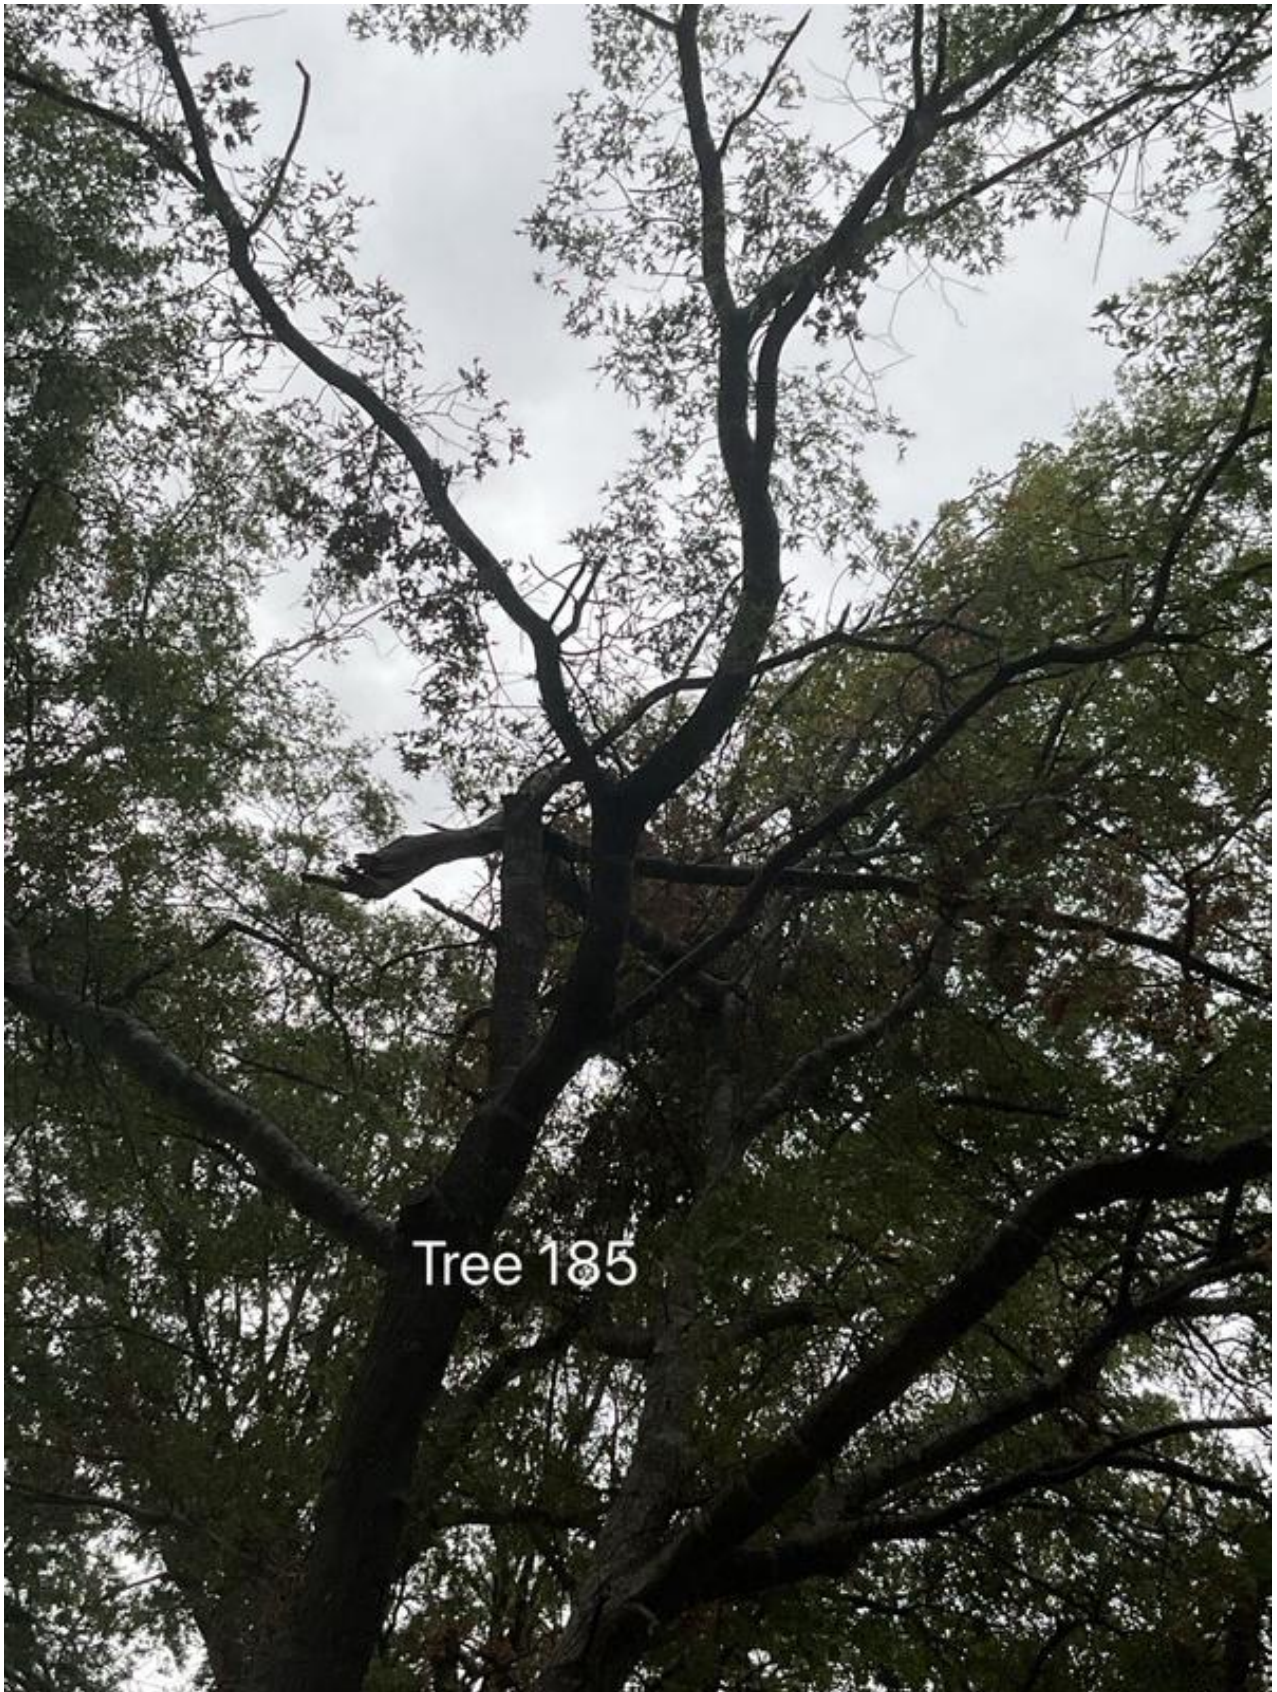
13 Critical - Failure imminent but low potential for injury/property damage

This tree has been significantly damaged in a recent storm event. It has lost the western top of the canopy and two large broken limbs hang dangerously in the tree over the highway. The tree has significant deadwood present in the crown and thinning in the canopy. The tree has poor form and obvious signs of fungal infection. It is unlikely to recover to be a viable retainable specimen. The tree is not suitable for attention in such a high traffic area.

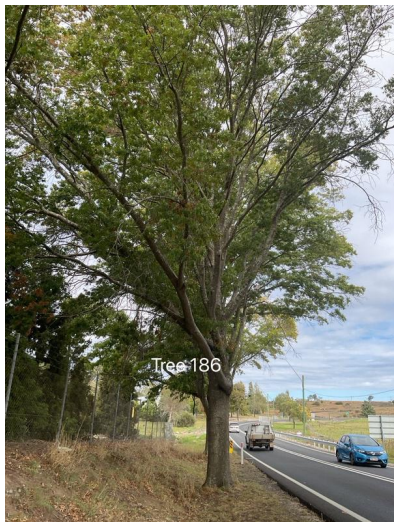
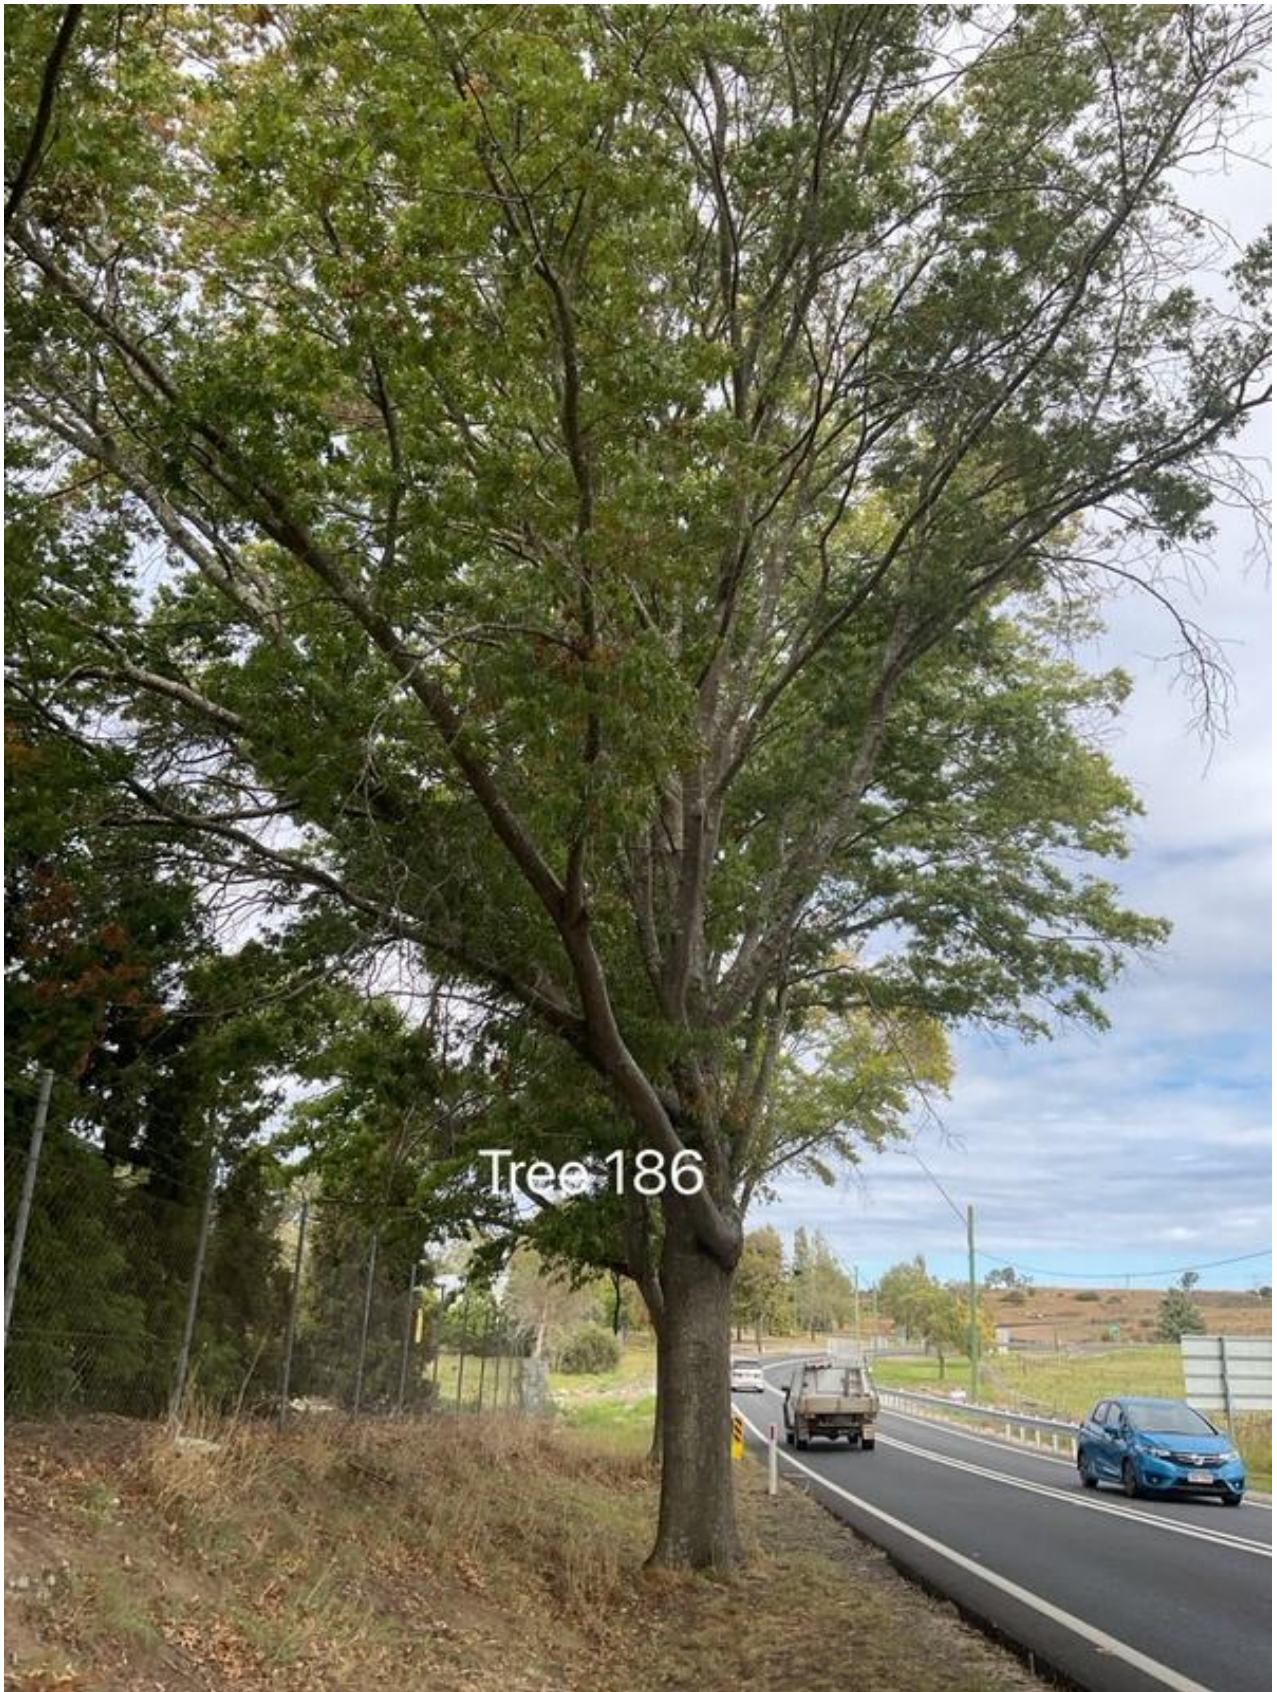
Photo 18

This tree is in fair condition. It has a large amount of deadwood present in the crown with many large dead limbs present. The tree has an over-developed southern canopy that extends out and over the Council Depot. There is a small amount of epicormic growth present on the tree. The tree

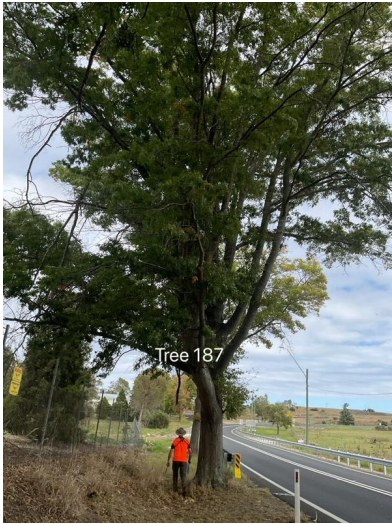
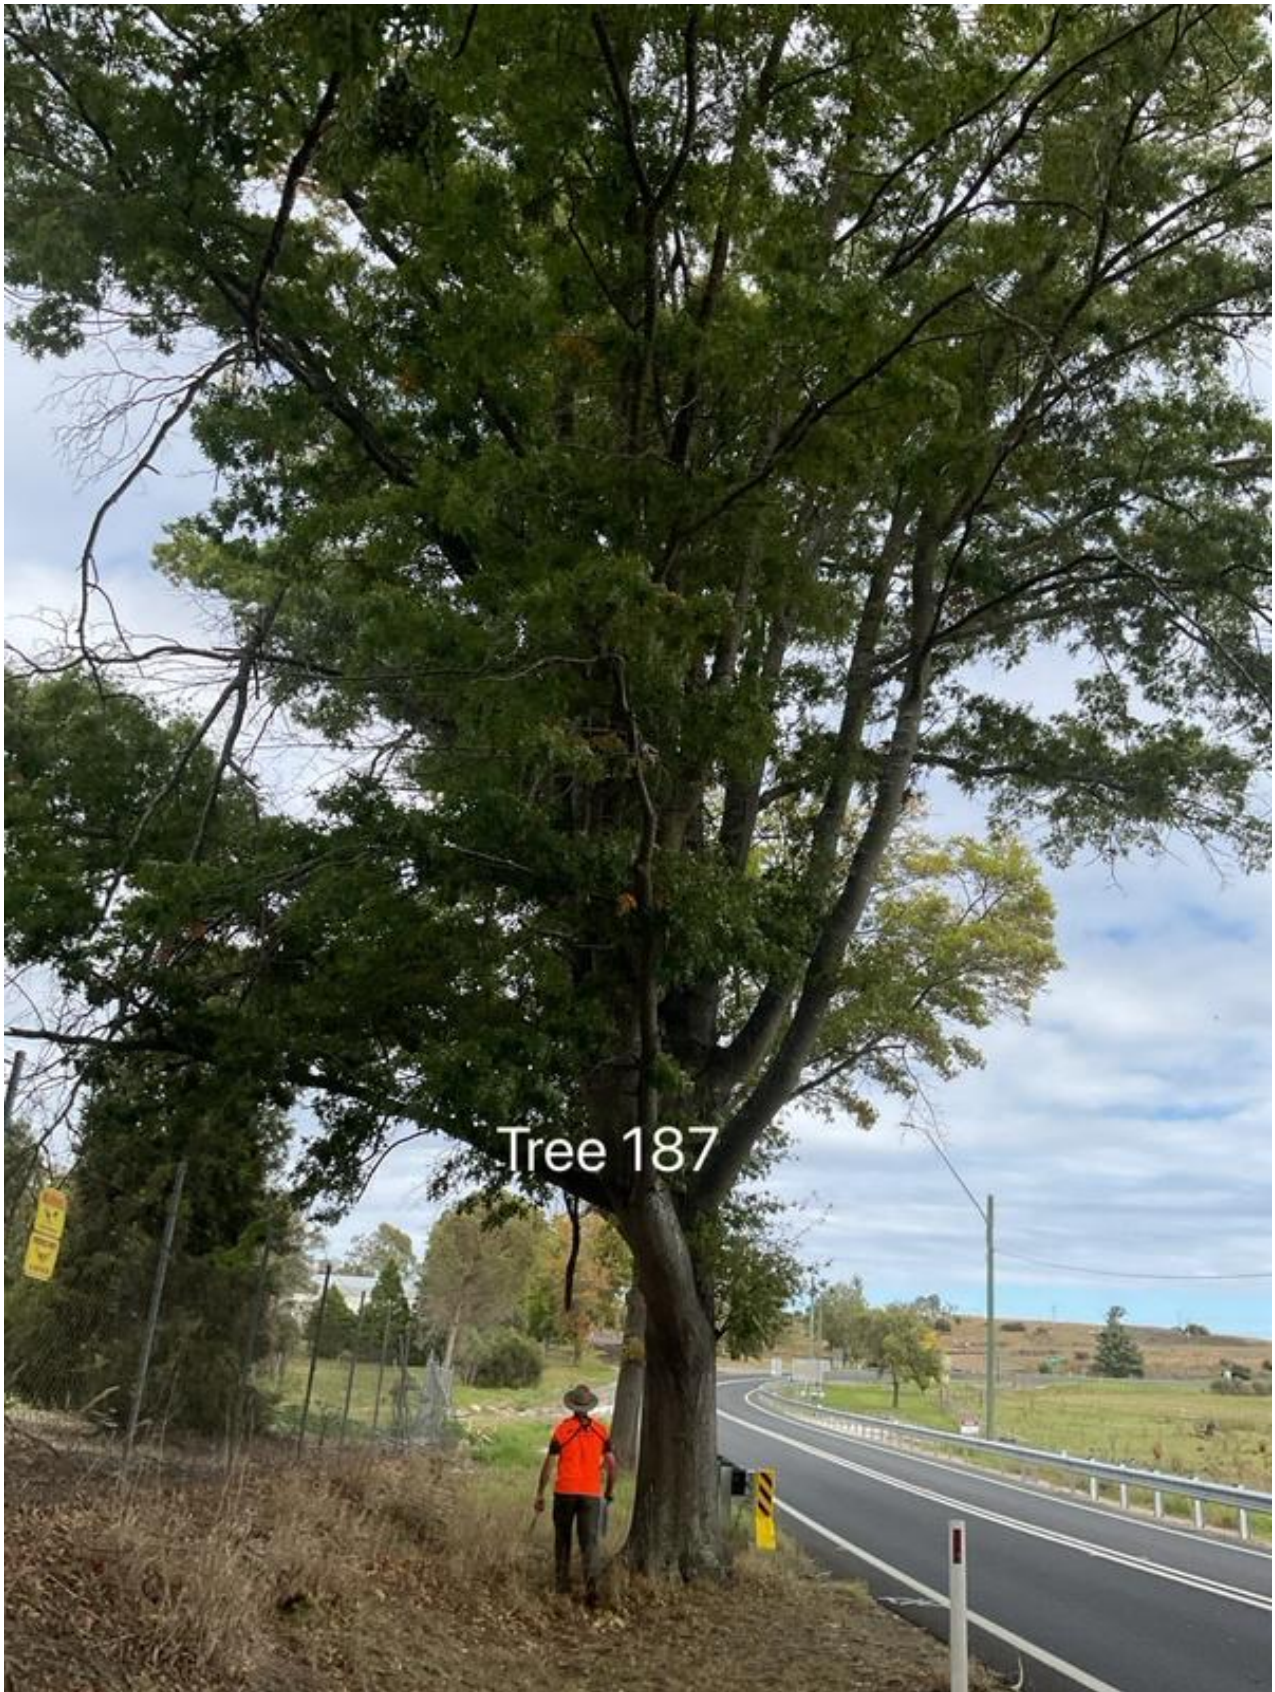
Photo 19

10 High - Failure likely especially during storms but low potential for injury/property damage

This tree appears to be in reasonable condition. The tree has several large dead limbs present and large, dangerous hanging limbs in the crown. There is some dieback present in the crown and epicormic growth present on the trunk. The canopy extends to the south over the Council Depot. Resistograph testing of the root crown has shown that there is decay present on the southern side of the of the root crown and the eastern root crown. The tree may be suitable for retention in the short term with remedial works.

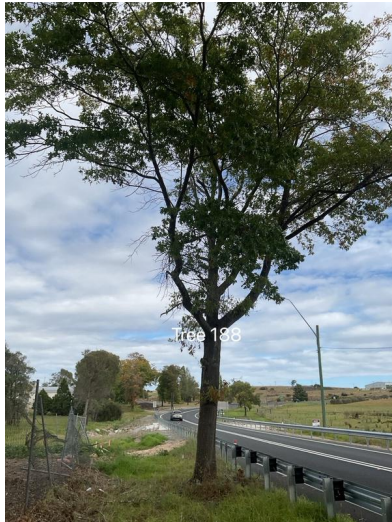
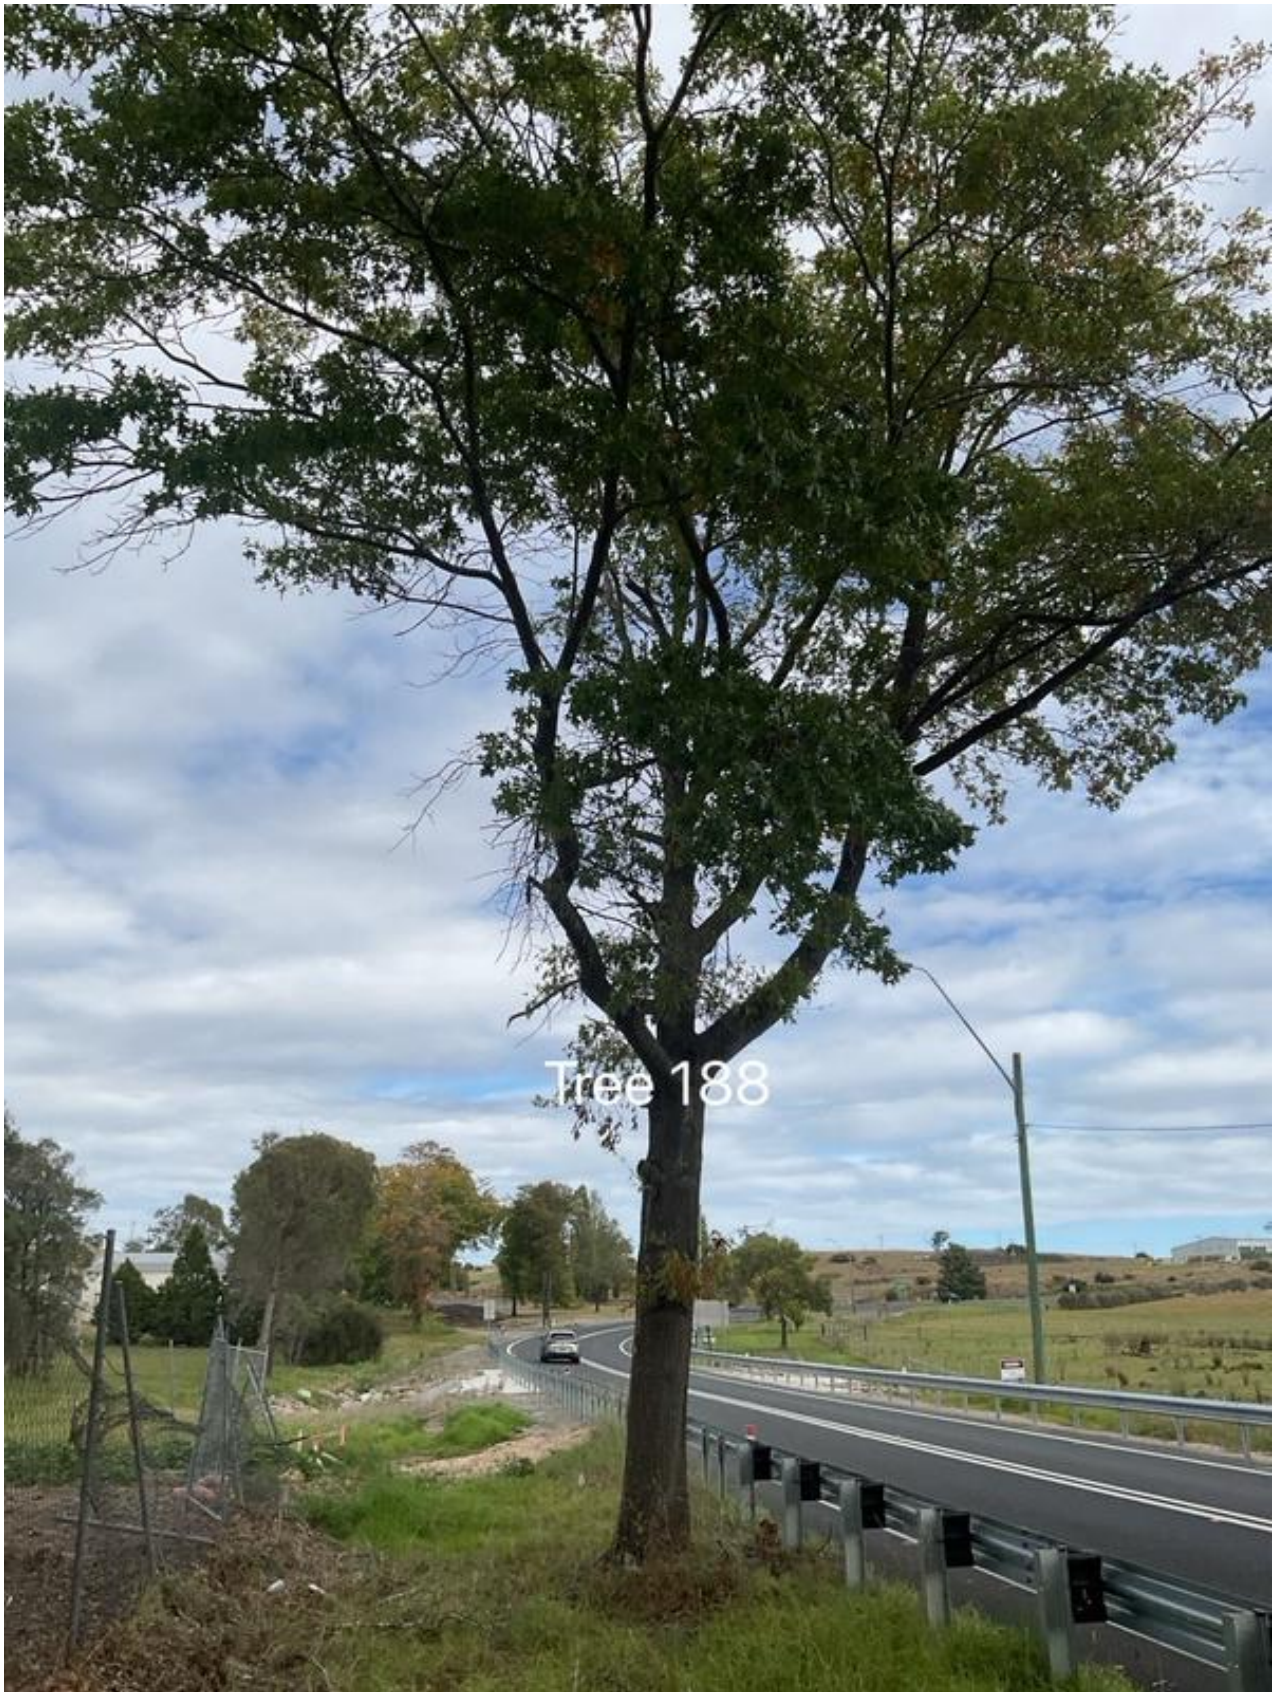
Photo 20

8 Moderate - Failure unlikely and/or high risk of failure but low risk of property damage/personal injury

This tree has been so badly damaged in a recent storm event that is no longer suitable for retention. It has lost the whole of the western canopy and will not recover to be a reasonable viable specimen for retention.
