Conditions of Consent

1 4 8 R O U S E S T R E E T , T E N T E R F I E L D

CONCEPT DEVELOPMENT APPLICATION 2021.132
LOT 3, DP 1138201, LOT 1, DP 516621 AND LOTS A & B, DP 150057
REDEVELOPMENT OF 148 ROUSE STREET, TENTERFIELD

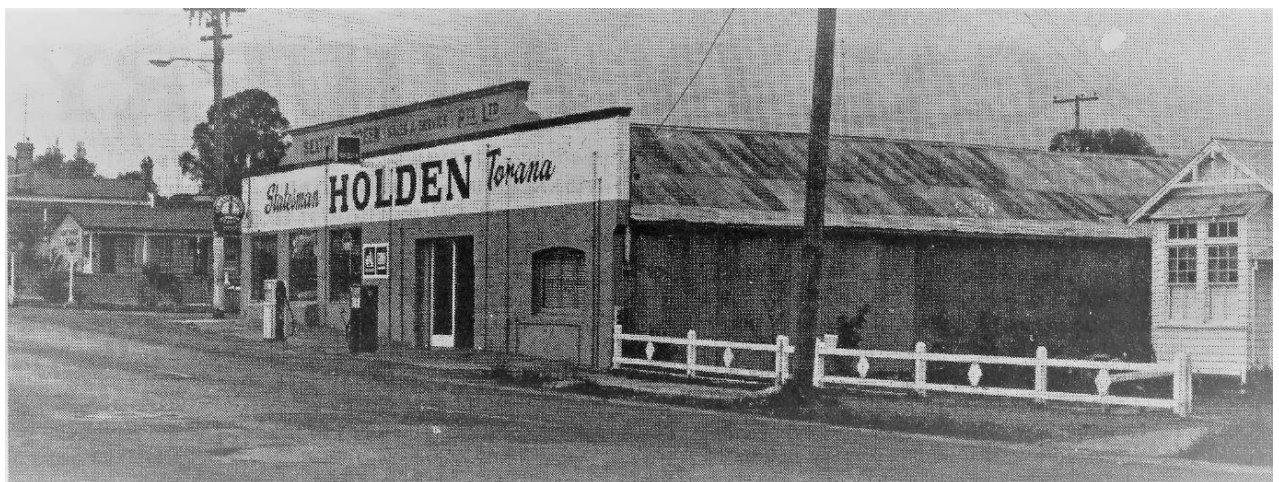
Figure 6 Undated photo possibly late 1920s. showing addition of brick parapet to the gabled building. Bricks are unpainted other than signage band. This photo also shows the projecting element forward of the southernmost window on the pavement. Source K. Halliday.

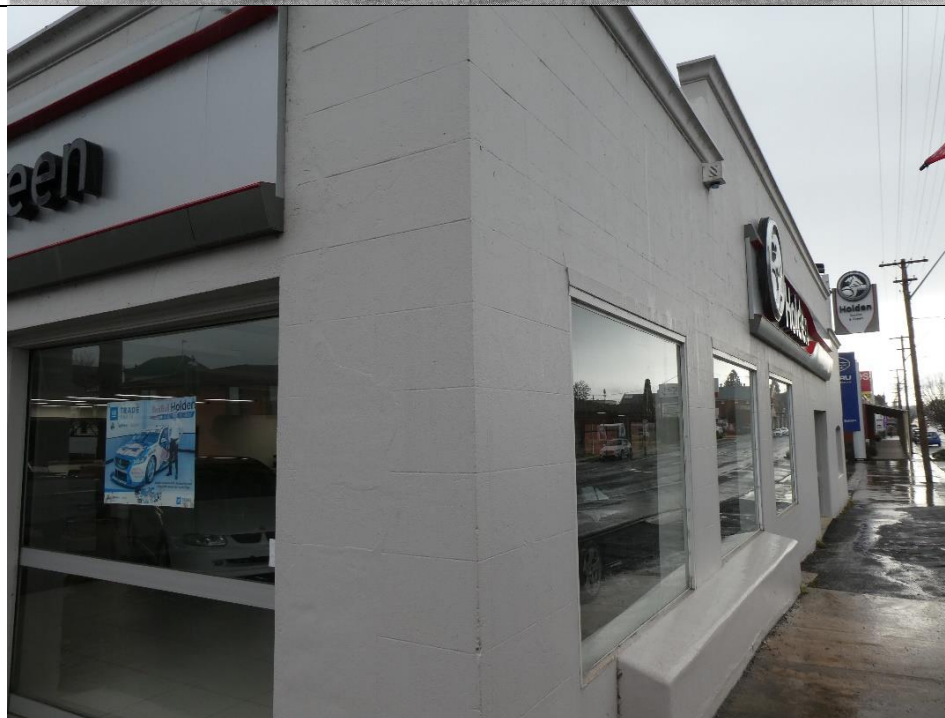
Projecting structure on pavement. Further investigation is required.

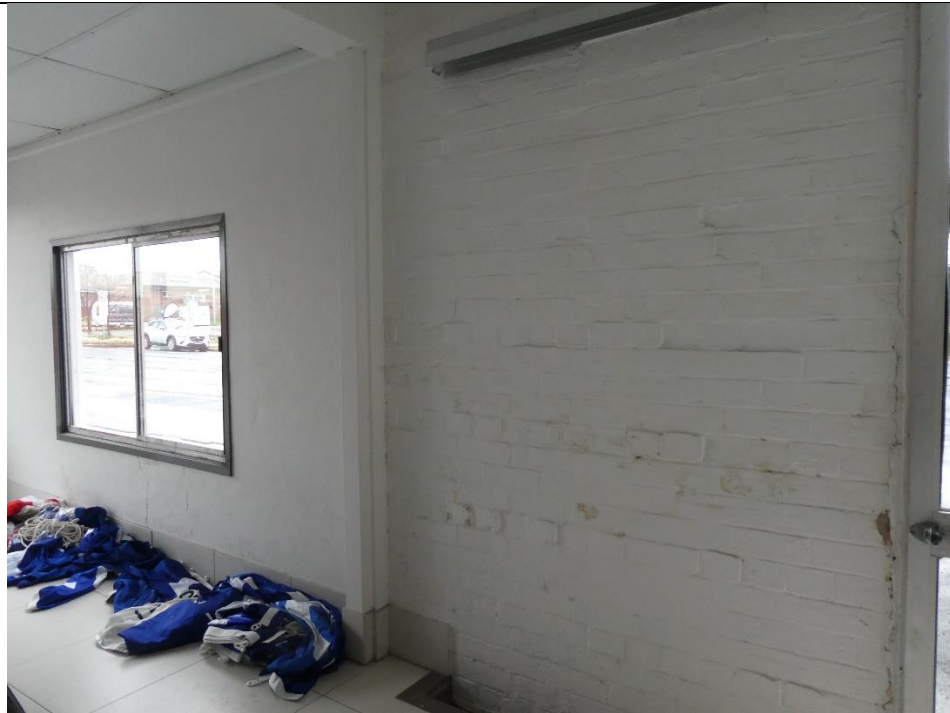
Delaminating paint layers possible rising damp issues in areas of the painted brickwork.

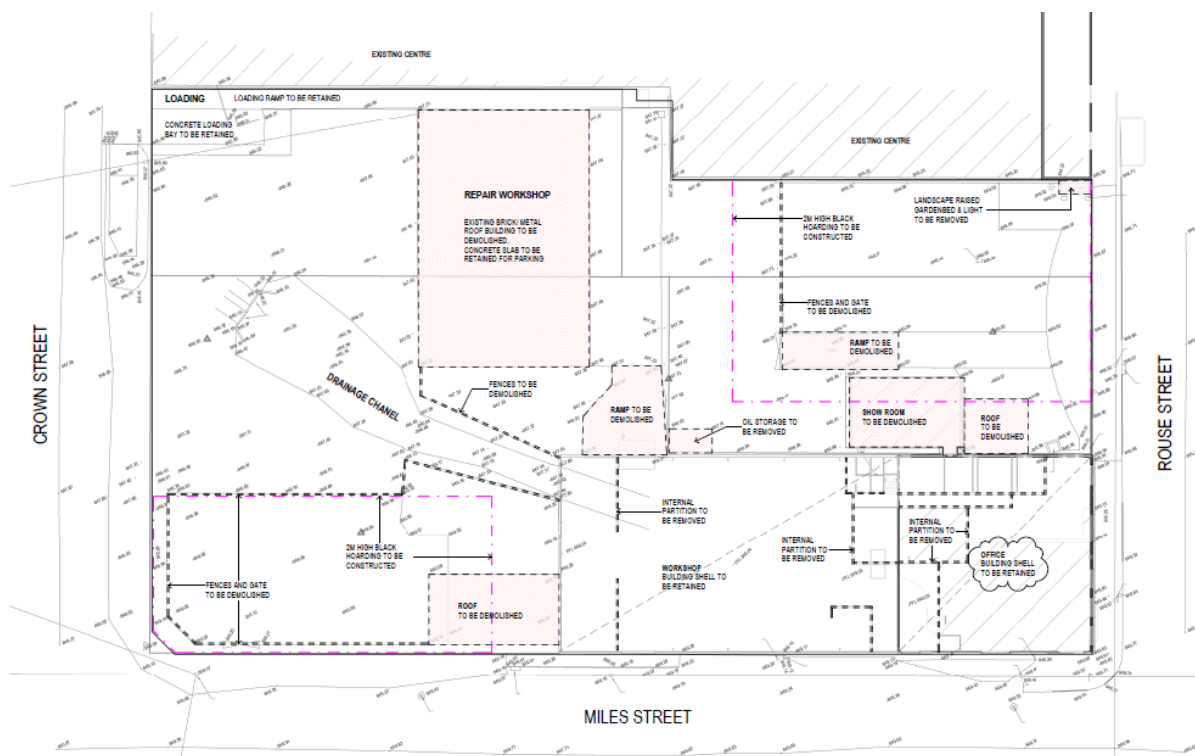
Figure 1 Extract of proposed plans – existing and demolition plan

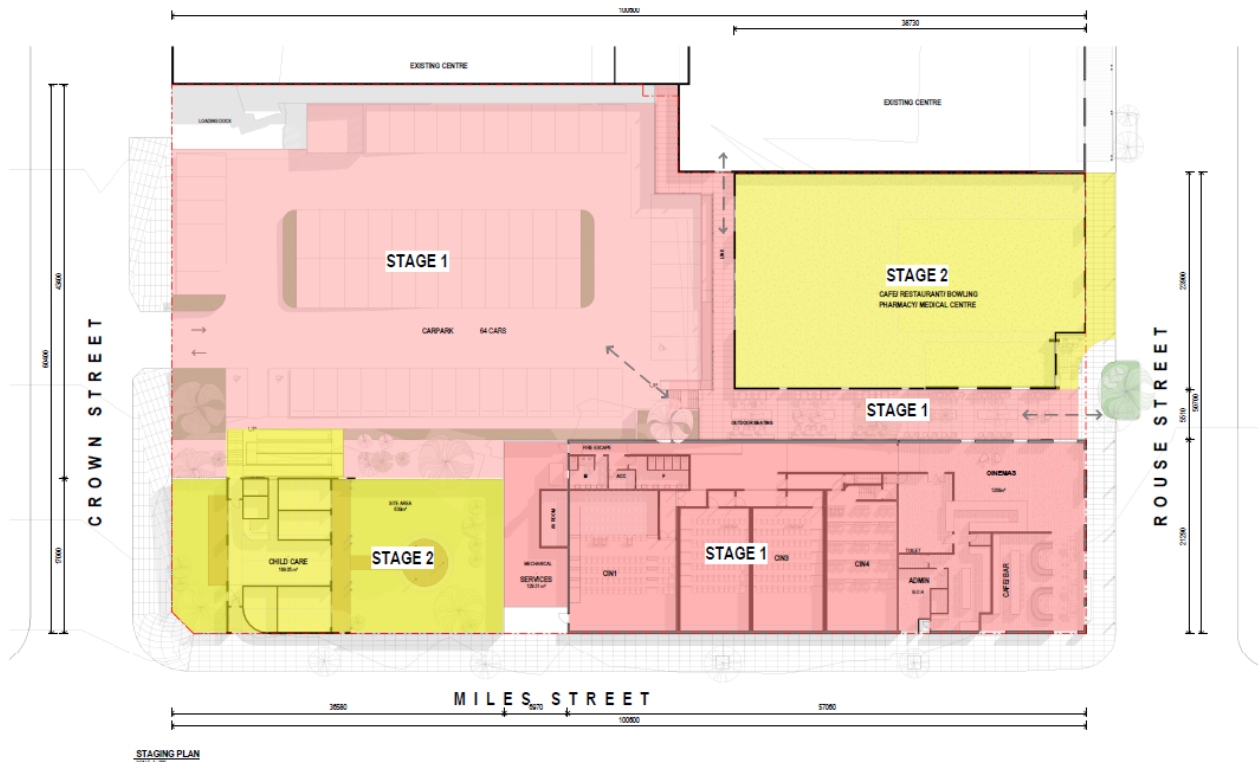
Figure 1 Extract of proposed plans – staged plans

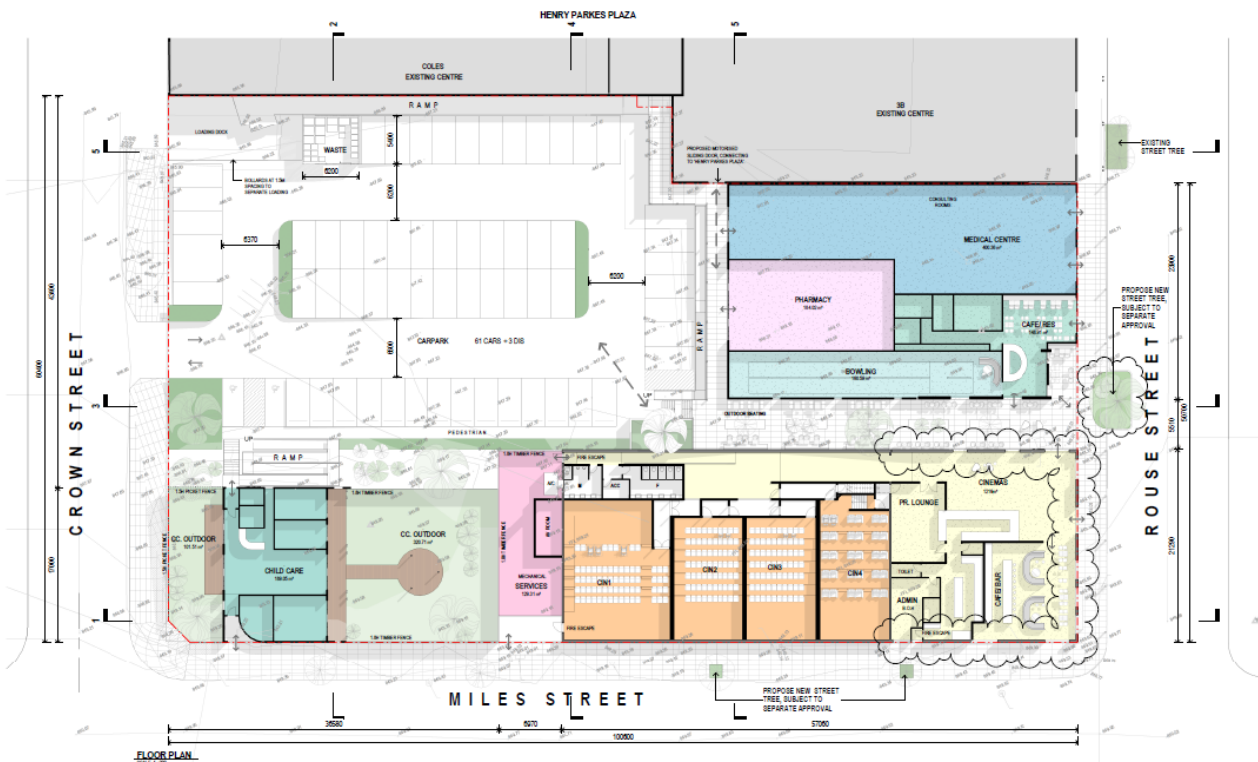
Figure 1 Extract of proposed plans – ground floor
