# Tree Assessment Report - Tree Protection Zones

Clarence Street (between High Street & East Street), Tenterfield

Report 1 of 10 - Tree ID 001-021

18.02.2026 09:00 AEST

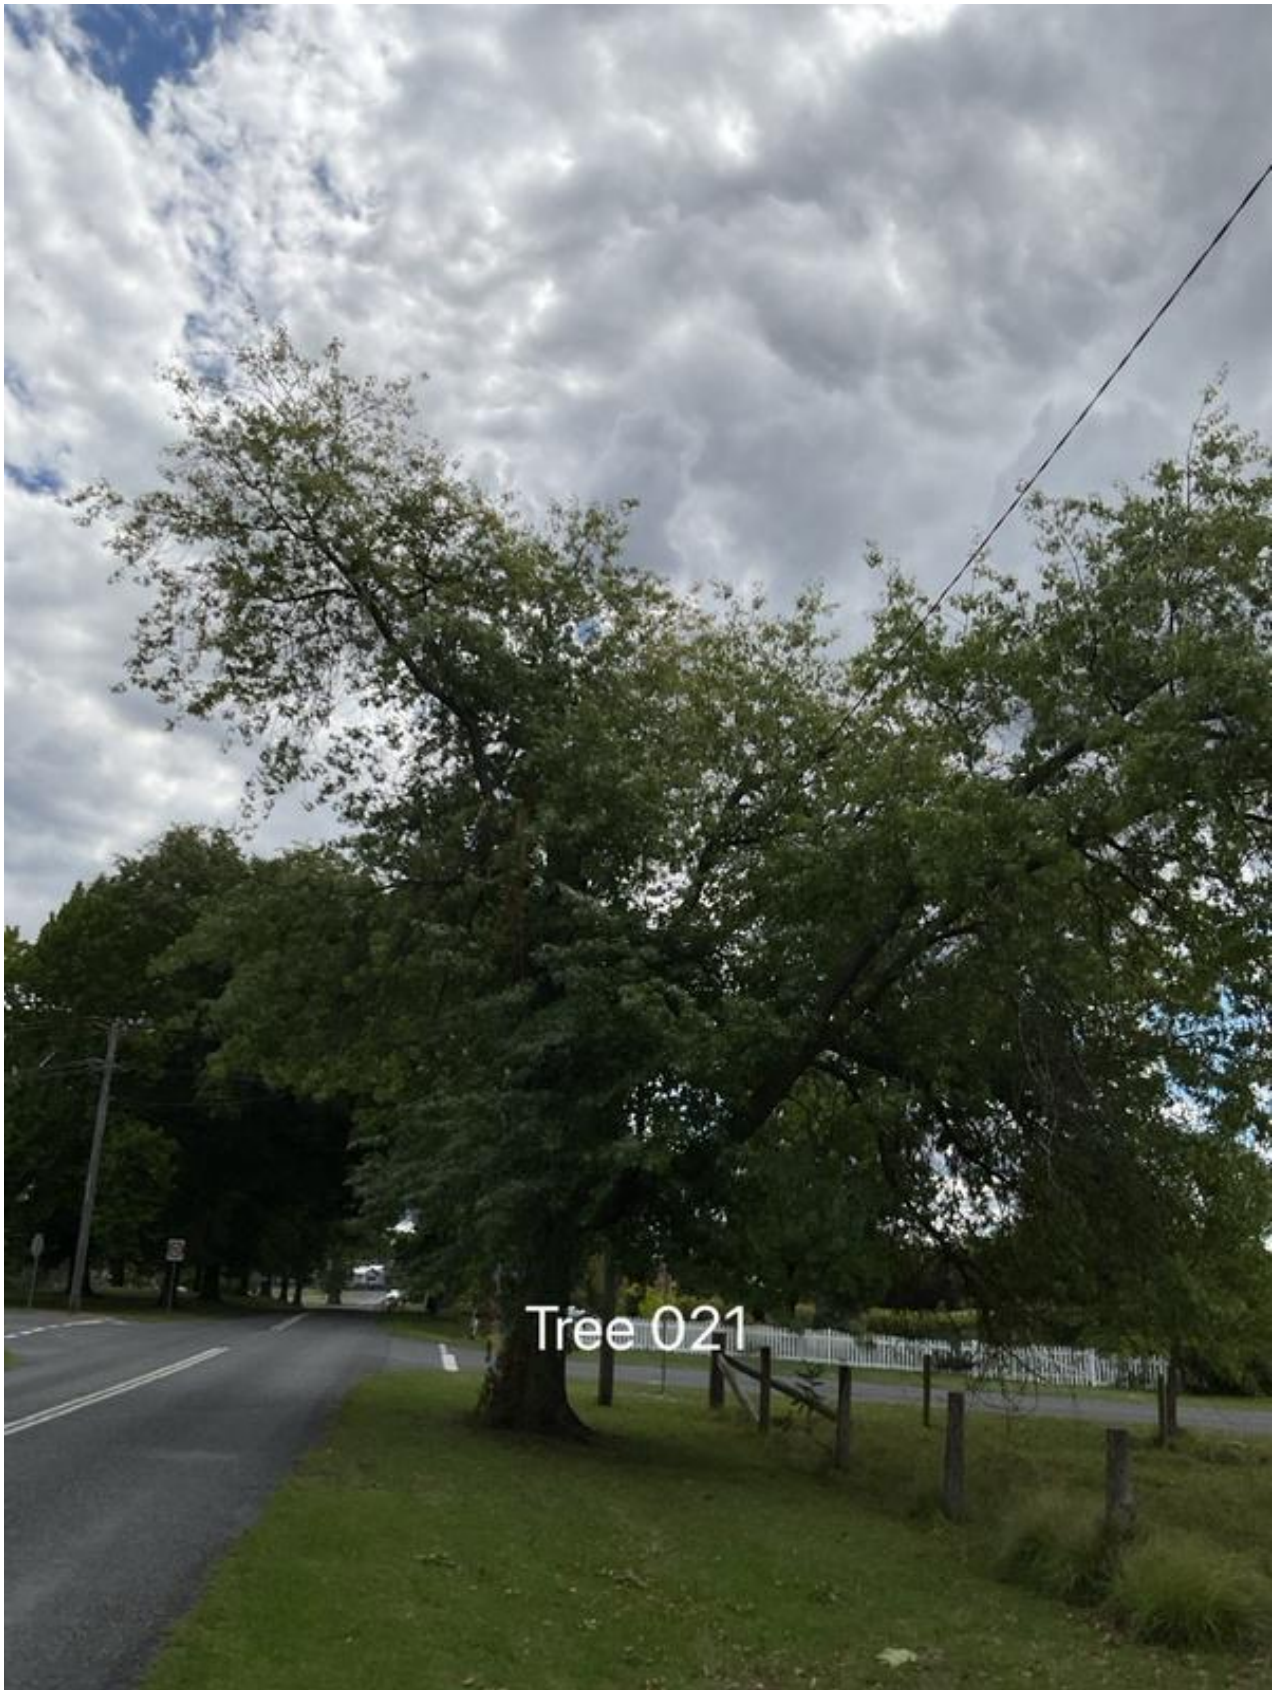
Photo 37

This tree has lost a significant limb in recent storm events. The loss of the limb has significantly damaged the tree. It is also showing signs of Armillaria and/or Phytophthora infection with dieback present in the tips of the canopy and yellowing in the foliage in the canopy. This tree is unstable and dangerous and is unsuitable for retention.
