Tree Assessment Report - Tree Protection Zones

3 Mar 2026

Cowper Street (between Pelham Street & New England Highway),
Tenterfield.

Report 10 of 10 - Tree ID 189-203

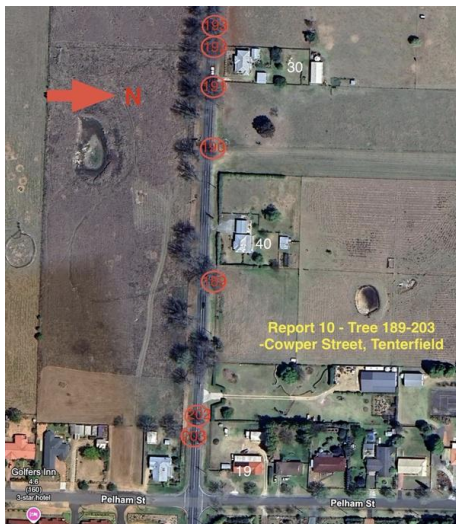
Photo 1

Risk Rating	12 High - Failure likely especially

This tree has last lost a substantial amount of its canopy in a recent storm event. There are still large dangerous broken hanging limbs present in the crown. There is decay and dieback present in the crown. It is not possible to correctly prune this tree to make the tree safe for retention. The tree is dangerous and unstable should be removed.

Remove the tree and grind the stump.
