**BUILDING CONDITION ASSESSMENT  
PREPARED FOR TENTERFIELD SHIRE COUNCIL  
PART B – BUILDING SUMMARIES & MAINTENANCE**

MARCH 2019  
STRICTLY PRIVATE & CONFIDENTIAL

Building Name **Community Centre (HACC)**

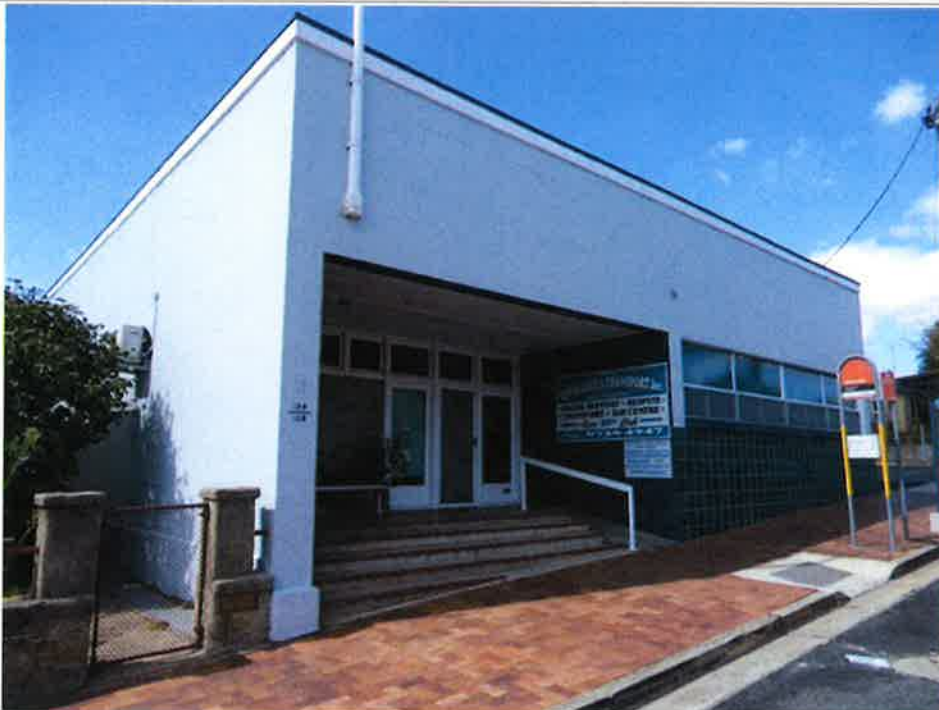
Maint Id	Item	Problem	Action	Freq(yrs)	Next Due	Est_Cost
2214	Fitout	Step edges - tiles have created overhand which may be a trip point. Does not meets disability access standards. Tiles to landing slippery when wet.	Remove all tiles and replace with new non-slip ceramic floor tiles. Ensure step treads do not overhang riser. Use contrasting tile to front of tread. Replace handrails with optical rails on both sides to standard. Install tactiles at top & bottom of both		2019	\$5,000
2217	Roof	Peeling paint to eastern wall - indication of water issues.	Investigate roof and flashings above to ensure they are sealed. Strip loose material and repaint to suit. Continue to monitor		2019	\$1,500
2216	Roof	Paint blistering to storage wall	Investigate roof and flashings above to ensure they are sealed. Strip loose material and repaint to suit. Continue to monitor		2019	\$1,200
2215	Ceiling	Skylight glass cracked	replace damaged pane		2019	\$400

2213	Wall Surf Ext	Cracking to external blockwork	Monitor to determine deterioration rates. Mark measurements and track expansion	2	2019	\$250
2218	Floor Cover	Planned Carpet Replacement Program	Replace Carpet at recommended schedules	8	2023	\$30,000
2211	Wall Surf Int	Internal Painting Program	Paint to recommended schedules	8	2024	\$18,000
2212	Wall Surf Ext	External Painting Program	Paint to recommended schedules	8	2025	\$15,000
					Grand Total	\$71,350
