URBENVILLE AND WOODENBONG FLOOD STUDY

TENTERFIELD SHIRE COUNCIL KYOGLE COUNCIL

ISSUE / Final Report
CLIENT / Tenterfield Shire Council & Kyogle Council
DATE / 09/02/2022
BG&E PROJECT NO / S20128

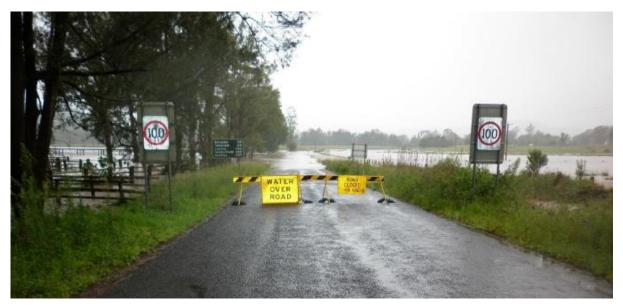
Tooloom Road north east of Tooloom Creek Bridge (flooding from overland flows) (Source: Urbenville SES)

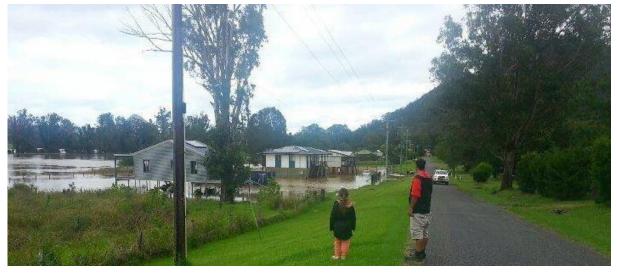
Figure 2-7: Photographs of Flooding in the Study Area – March 2017

Flooding around elevated homes on Toloom Street (Source: Urbenville SES)

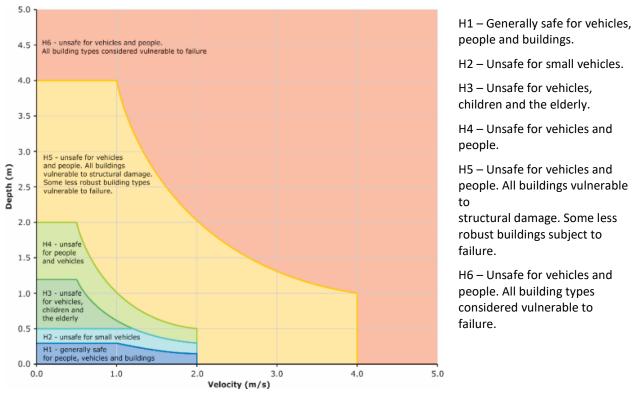
Figure 8-1: ARR2019 / AIDR General Flood Hazard Curves

Mapping of flood hazard for is included in Appendix B. Flood hazard classifications described in ARR 2016 (Book 6, Chapter 7: Safety Design Criteria) have been adopted for the Urbenville and Woodenbong Flood Study as they it provide a greater range of hazard classifications than the provisional hazard categories described in the Floodplain Development Manual 2005. The ARR2019 hazard classifications are in line with AIDR Guideline 7-3 Flood Hazard (Australian Institute for Disaster Resilience (AIDR), 2017).

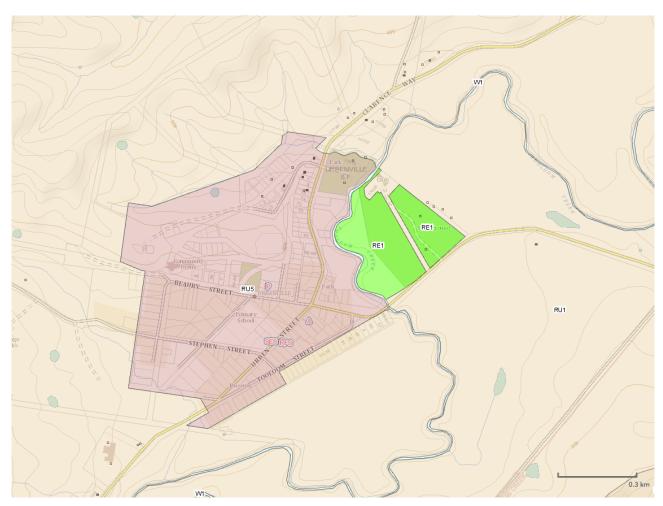
Figure 10-1: Urbenville Land Use Zones

The town of Urbenville is classified as RU5 Village with the surrounding area classified as RU1 Primary Production and areas of national park classified as E1 National Parks and Nature Reserves to the east of the town.

Where Tooloom Creek fills the floodplain in areas south of Tooloom Street it is recommended that the future Floodplain Risk Management Study and Plan consider appropriate land use zoning in this area to restrict further development in the floodway. The showground and campground is flooded frequently in the 5% and 20% event as H4 unsafe for vehicles and people. This area should not be rezoned in the future.

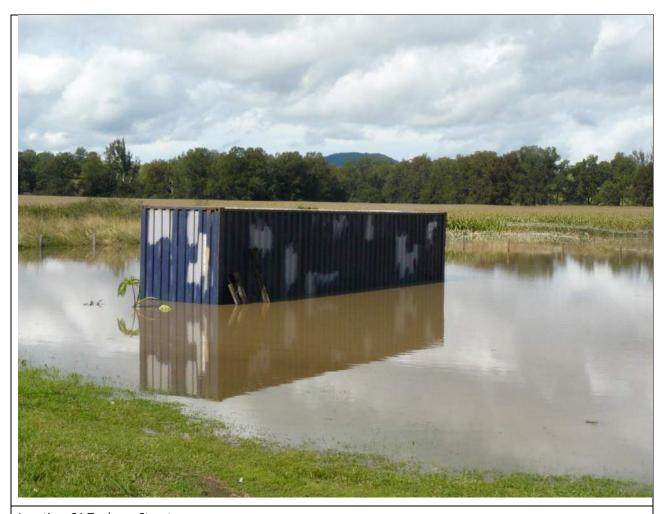
Photograph 1: 31 Tooloom Street, 2nd May, 2015.

Location: 31 Tooloom Street Supplied by: Craig Vermeulen

Date and Time Taken: 2nd May, 2015 – 12:08pm Comments: Shipping container, 31 Tooloom Street.

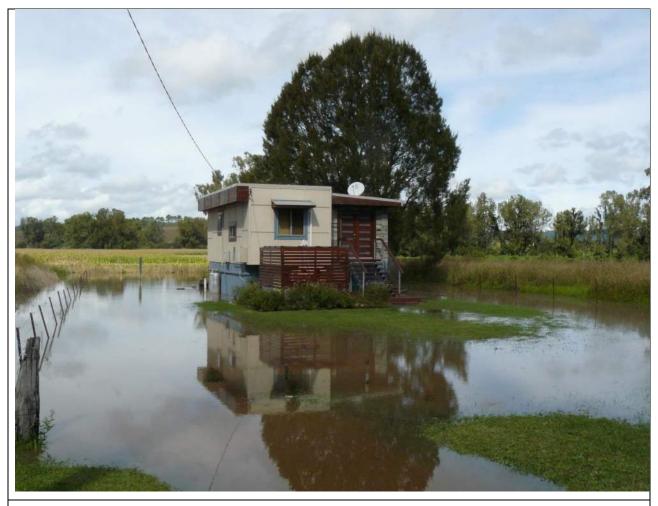
Photograph 2: 31 Tooloom Street, 2nd May 2015.

Location: Tooloom Street, property address unknown

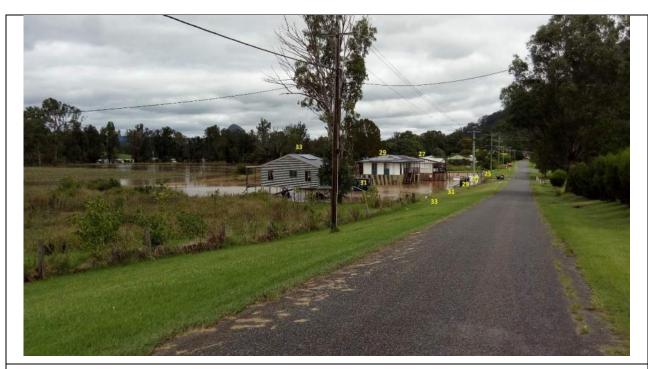
Location: Tooloom Street, looking south

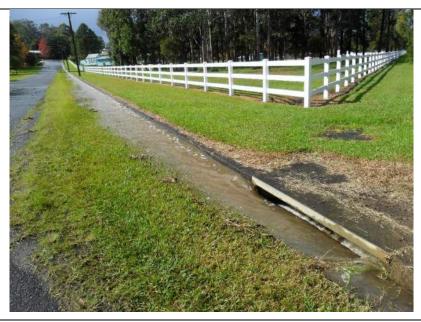
Photograph 8: Stephen Street, looking North. Urbenville Public School seen in background.

Photograph 8 and 9: Stephen and Welch Street, local stormwater pits and culverts.

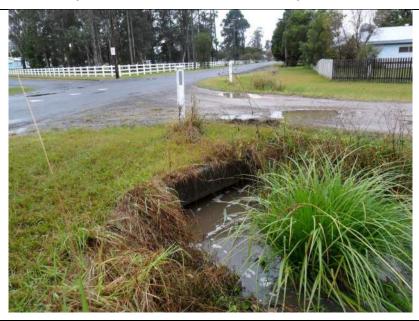
Photograph 9: Downstream culvert headwall passing under Welch Street. Looking North-East towards Urbenville Public School.

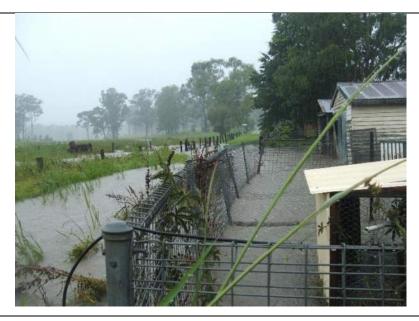
Photograph 1: Bonalbo Lane and 25/27 Richmond Street backyards, December 2010.

Location: Bonalbo Lane and backyard of 25 and 27 Richmond Street, Woodenbong

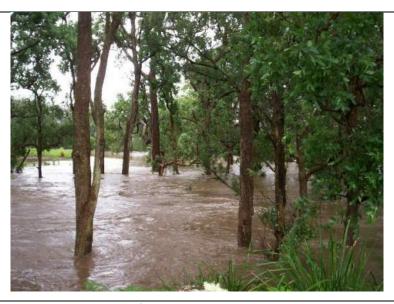
Photograph 9: Flooding near convergence of Lindsay Creek/Grahams Creek with Tooloom Creek
